**AIRCRAFT ACCIDENT INVESTIGATION REPORT**

**CRASH SHORTLY AFTER TAKE-OFF**

**TEXTRON AVIATION INC. (FORMERLY CESSNA) 172N**

**REPORT NUMBER JA-2016-01**

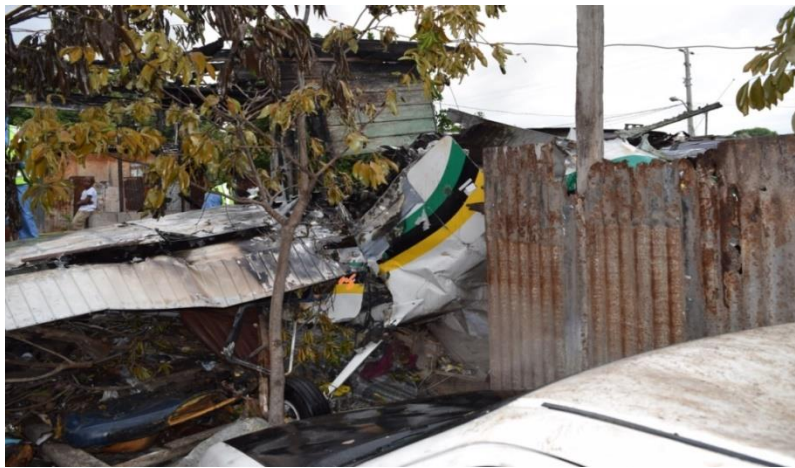
**Figure 1 Position of Aircraft on Impact**

The aircraft came to rest in a near upright position as seen in Figure 1; all four corners of the aircraft were observed at the crash site. The engine was still attached to the airplane.

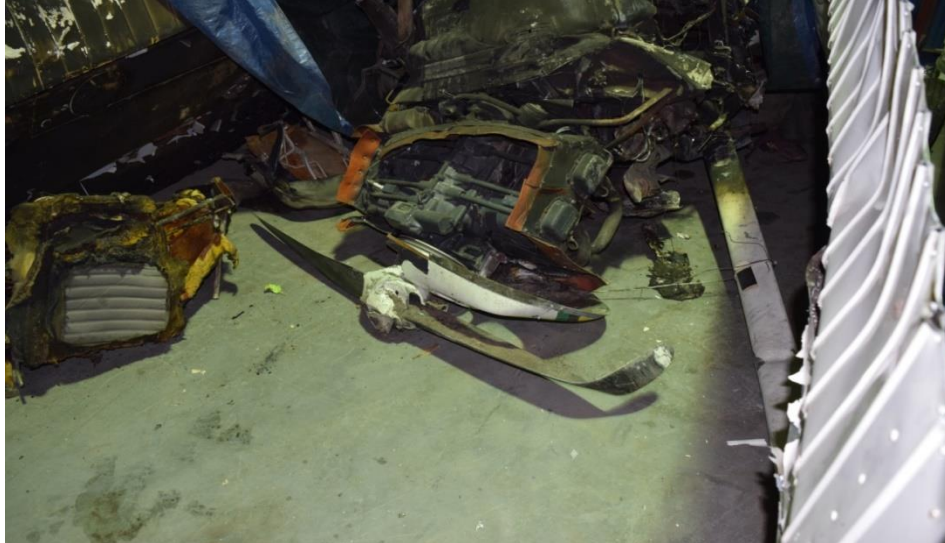
**Figure 2 Aircraft Propeller and Engine**

The nose cone of the propeller was crushed, it came to rest on the concrete base of an abandoned and partially burnt-out wooden building, the propeller was securely attached to the engine and the bolts were secured with locking wire. Blade No. 1 showed no leading edge damage or bending, Blade No. 2 was observed with the tip bended aft about 90 degrees, approximately 9 inches from the tip, there was damage to the leading edge of this blade as seen in Figure 2.

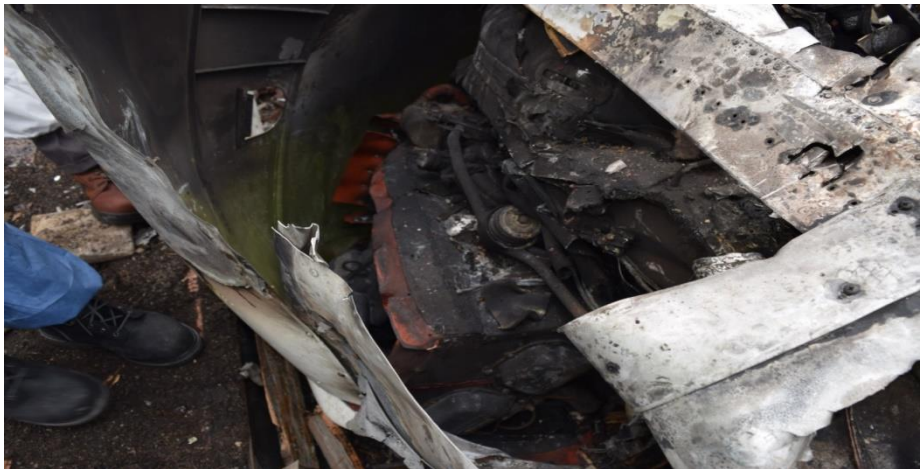
**Figure 3 Engine Compartment**

The engine cowling was partially attached to the aircraft as seen in Figure 3; the lower cowl was badly deformed and there was evidence of fire damage in the lower engine compartment, the engine was attached to the firewall, and the engine mount rods were deformed.

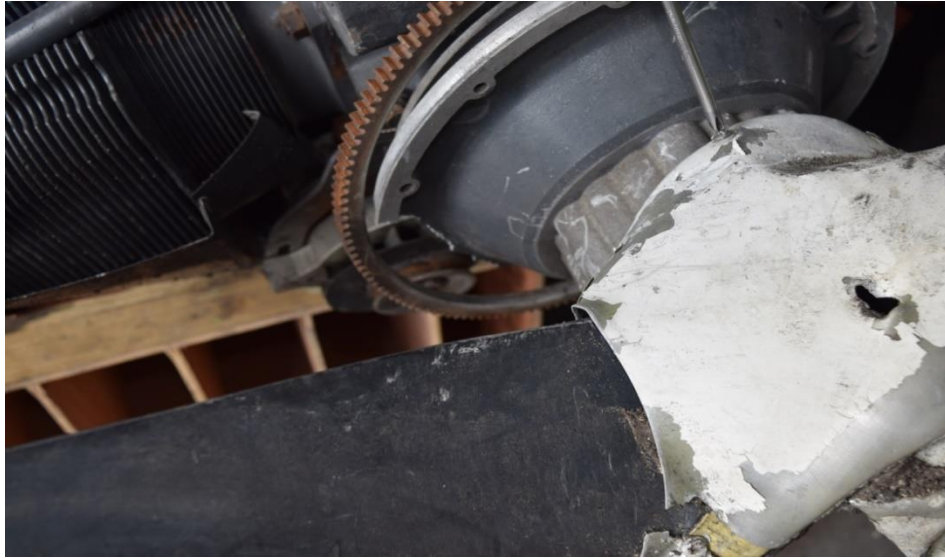
**Figure 4 Flywheel and Starter Ring Gear**

The flywheel was bolted to the crankshaft, a part of the circumference was broken off and the starter gear ring was partially detached from it as seen in Figure 4.

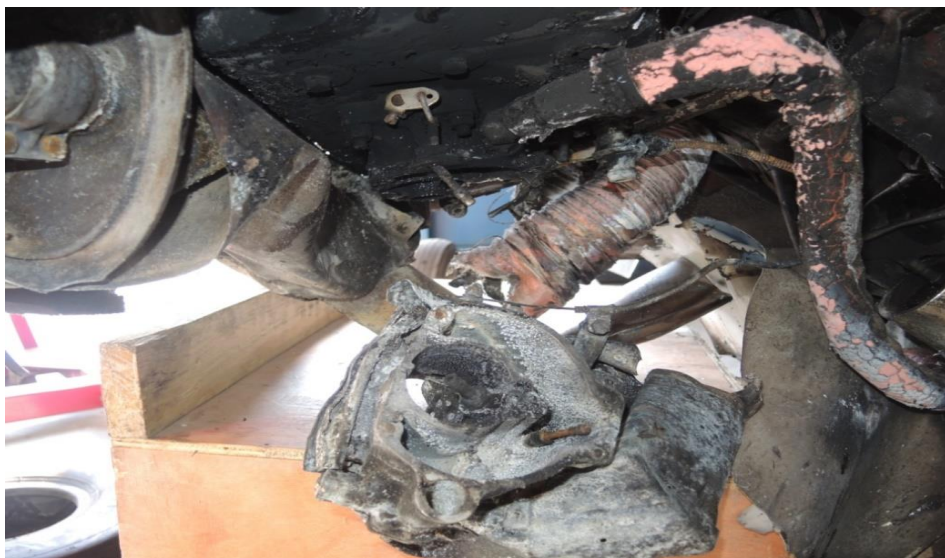
**Figure 5 Part of the Carburetor**

The carburetor was broken at the parting face to the fuel bowl as seen in Figure 5 and a part of the throttle body of the carburetor was separated from the engine; there were fire damage signatures to it, and the float was burnt. The engine throttle cable was observed to be attached to the throttle control lever; the rest of the throttle body of the carburetor was attached to the engine.

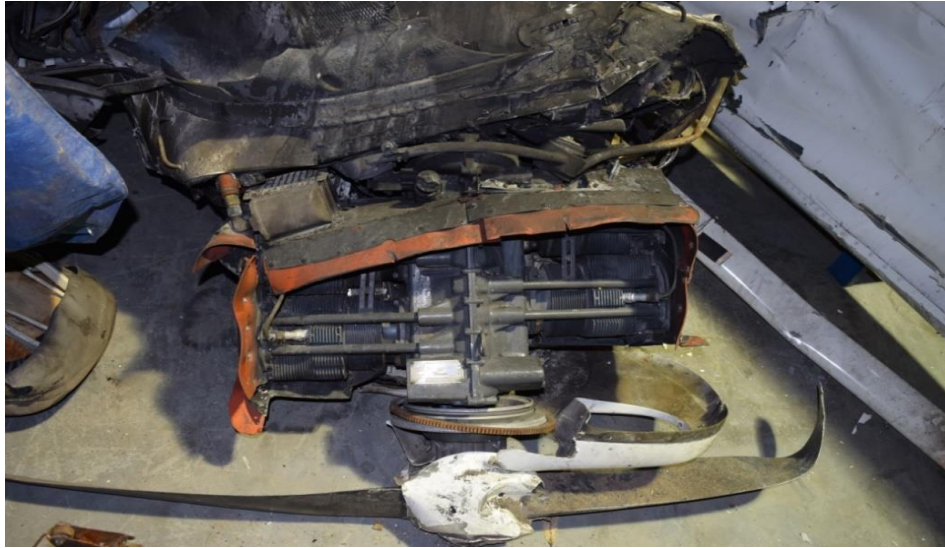
**Figure 6 Engine Crankcase with Cylinders**

All four engine cylinders were attached to the crankcase for the engine as seen in Figure 6; all eight spark plugs were installed in the cylinders with their leads attached.

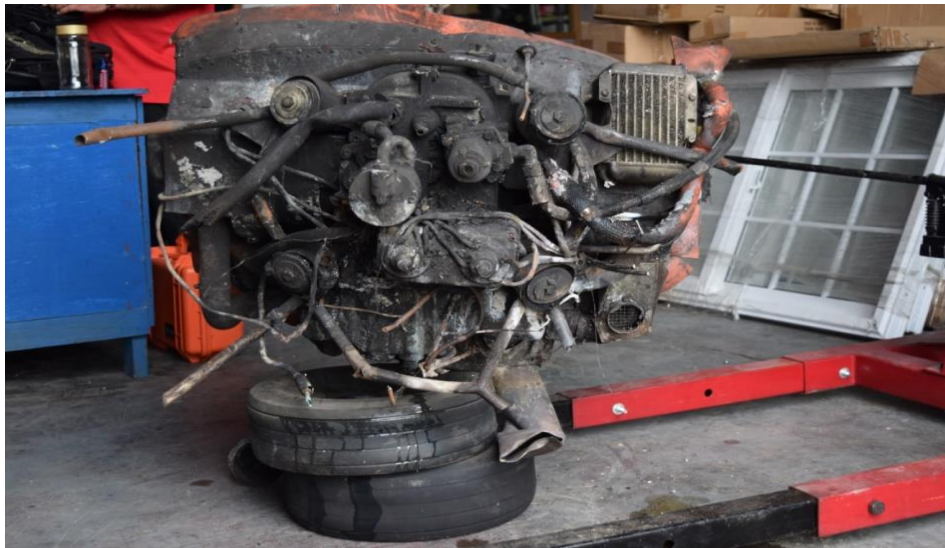
**Figure 7 Aft View of the Engine**

The dual magneto was securely attached to the aft of the engine as seen Figure 7. Fire damage to the exterior of the unit was observed.

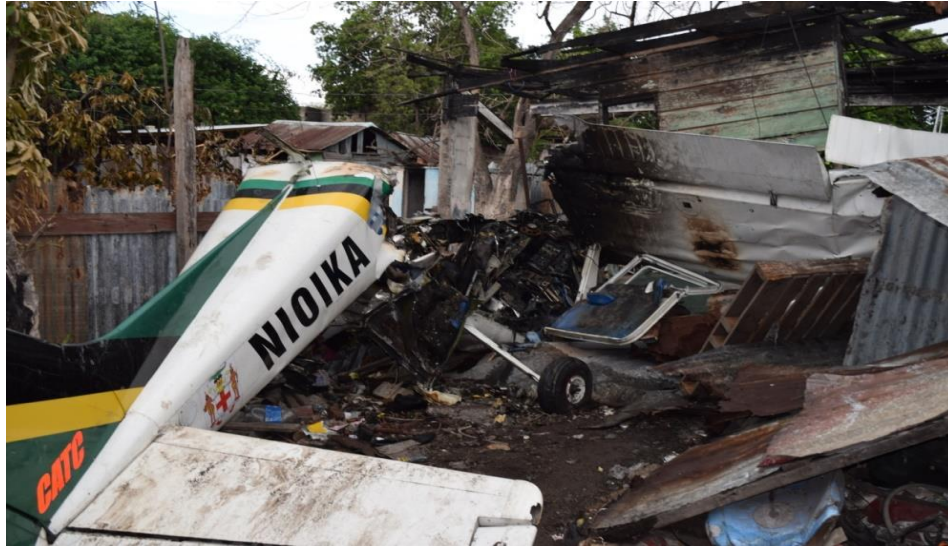
**Figure 8 Burnt Out Fuselage of the Aircraft**

There was fire damage along the fuselage from the engine to the front of the baggage door at Fuselage Station FS 90.00. The upper fuselage skin from the forward wing spar to Fuselage Station 108 was burnt out as seen in Figure 8. The lower fuselage skin showed evidence of buckling beginning at Fuselage Station 80.00; the empennage was bent downward at an angle of approximately 90 degrees at Fuselage Station 108.

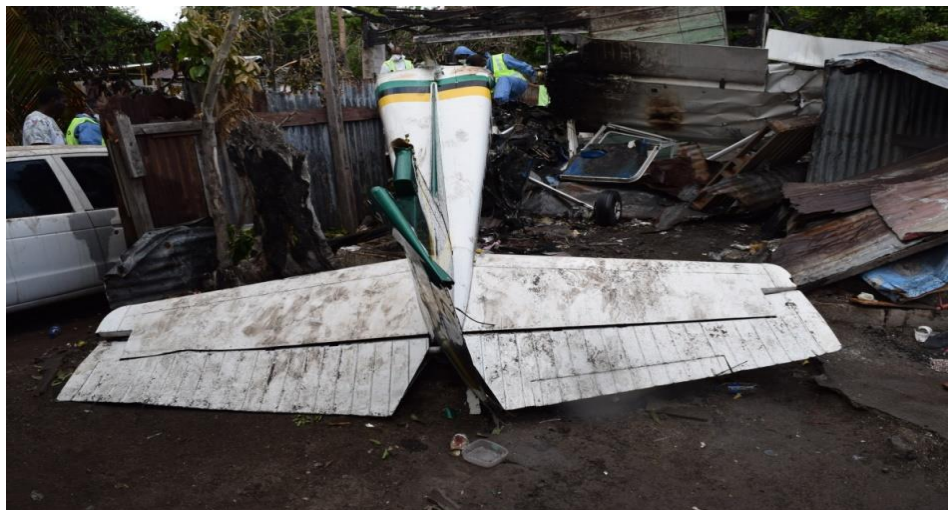
**Figure 9 Empennage with Vertical and Horizontal Stabilizers**

The vertical stabilizer along with the rudder and both horizontal stabilizers along with both elevators were securely attached to the empennage of the aircraft as seen in Figure 9. The elevator trim tab was securely attached to the R/H elevator, the flight control cables along with their pulleys were observed, flight control continuity was established from the fuselage through to the tail. The empennage was detached from the aircraft and the flight control cables were cut to facilitate removal of the aircraft from the crash site to Tinson Pen Aerodrome.

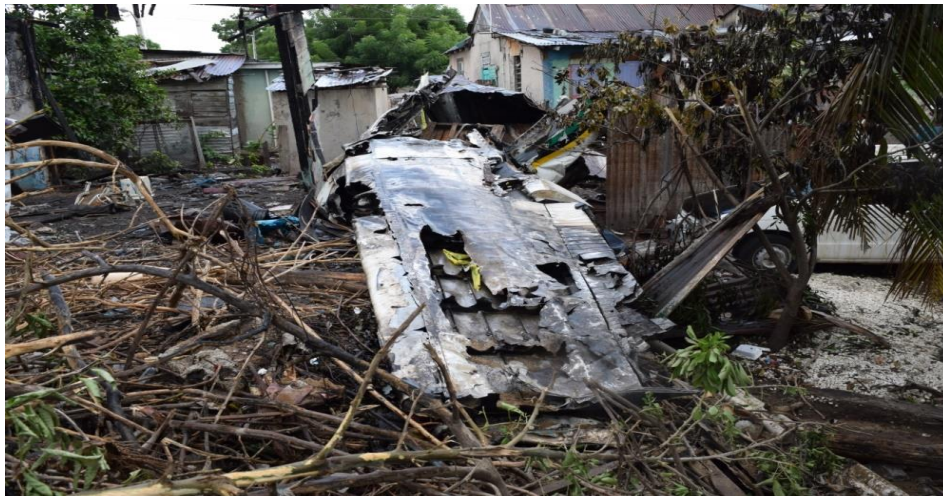
**Figure 10 Left Hand Wing**

The L/H wing had extensive fire damage to the upper and lower wing skin surfaces from the wing root to the wing tip, including the aileron, the primary and secondary flight control surfaces were deformed, but were attached to the wing surface as seen in Figure 10. The flight control cables, pulleys and bell cranks were observed and flight control continuity was established throughout the wing. The wing was detached from the aircraft and the flight control cables were cut to facilitate movement of the aircraft to the Tinson Pen Aerodrome.

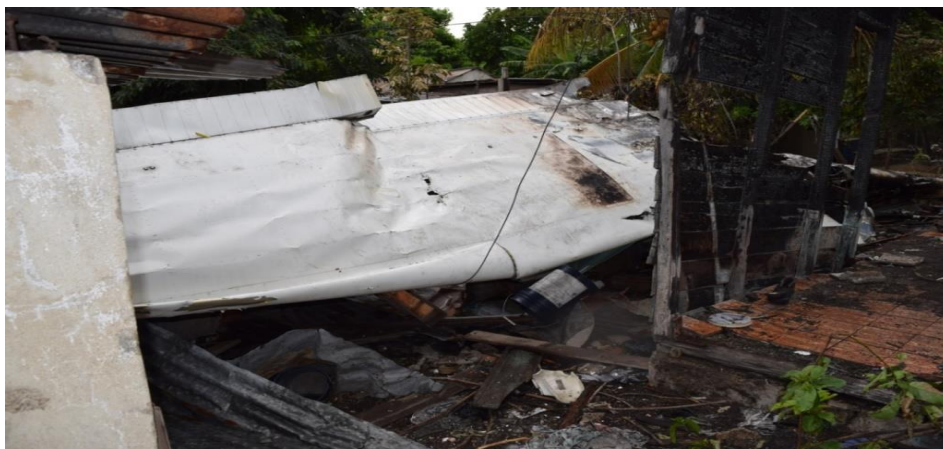
**Figure 11 Right Hand Wing**

The R/H wing had fire damage to the upper and lower skin surfaces from the wing root to Wing Station 71.37; there was impact damage to the leading edge of the wing as seen in Figure 11. There were cuts in the lower skin surface at Wing Station 172. There was a diagonal wrinkle in the upper wing surface beginning just forward of the inboard edge of the aileron and extending to the leading edge at Wing Station 172. The flight control cables, pulleys and bell cranks were observed, flight control continuity was established throughout the wing. The wing was detached from the aircraft and the flight control cables were cut to facilitate movement of the aircraft from the accident site.

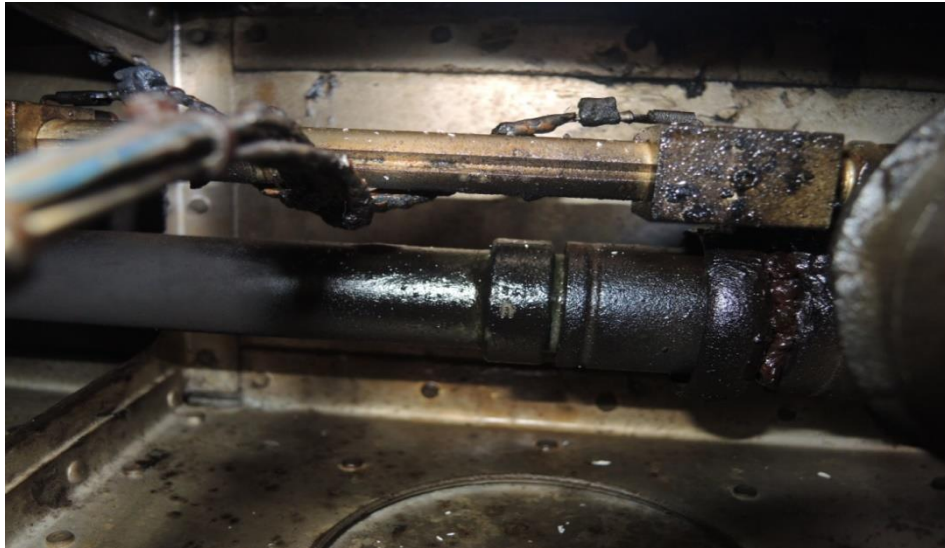
**Figure 12 Wing Flap Jackscrew**

The wing flap jackscrew is located in the right hand wing. The flap jackscrew extension was measured at 0.0 inches, corresponding to a zero degree flap extension as seen in Figure 12.

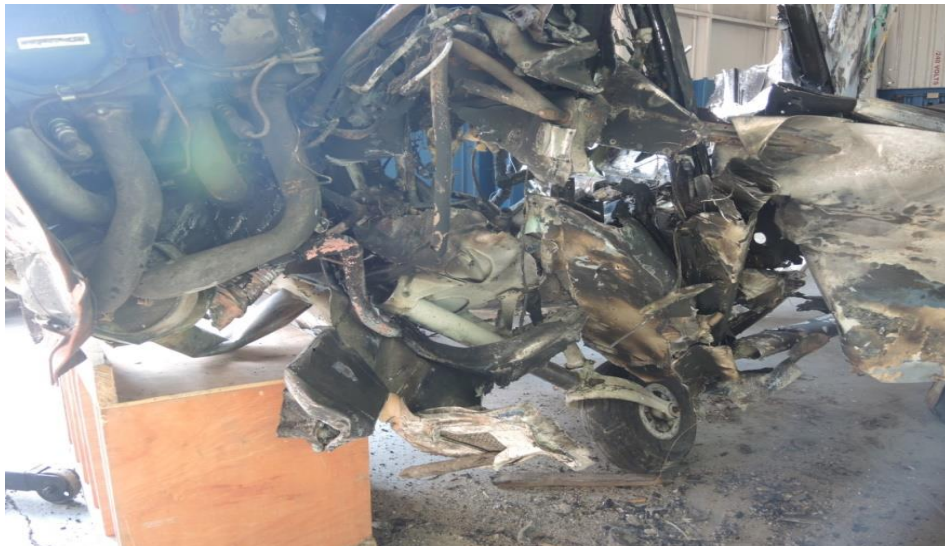
**Figure 13 Nose Landing Gear**

The Nose Landing Gear (NLG) was attached to the engine firewall which was folded under the aircraft as seen in Figure 13. The shimmy dampener was still intact, and the steering rod actuator was sheared at the NLG attachment. The torque links were attached, the strut was inflated as well as the tyre.

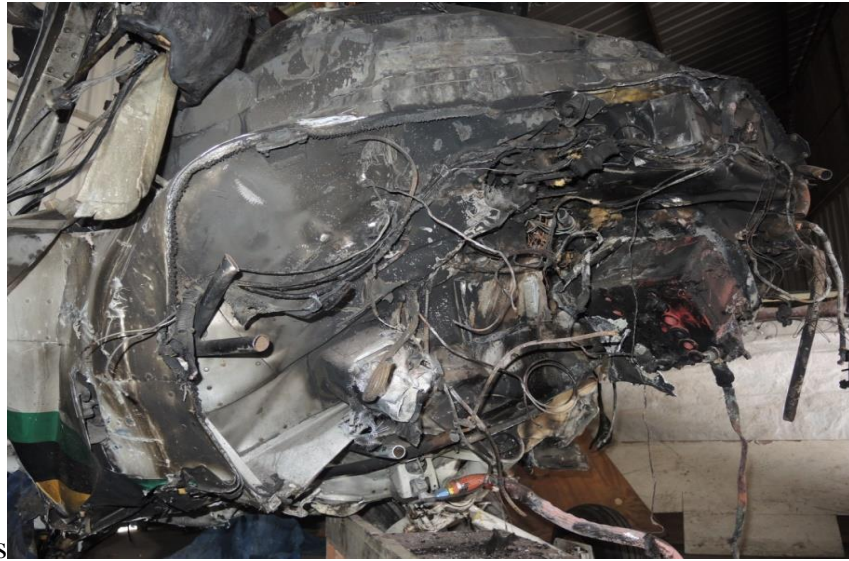
**Figure 14 Engine Firewall**

The engine firewall was deformed and displaced rearward; it was extensively damaged by fire as seen in Figure 14. The battery box was deformed and the battery was partially burnt.

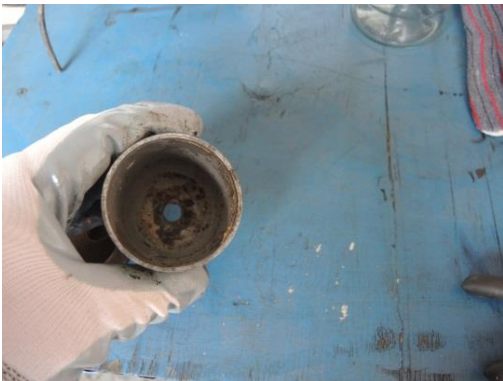
**Figure 15 Fuel Bowl**

The fuel strainer assembly which was secured to the lower R/H side of the engine firewall was disassembled and inspected; areas of pitting were observed on the inside of the fuel bowl as seen in Figure 15. The filter was dirty as seen in Figure 16.

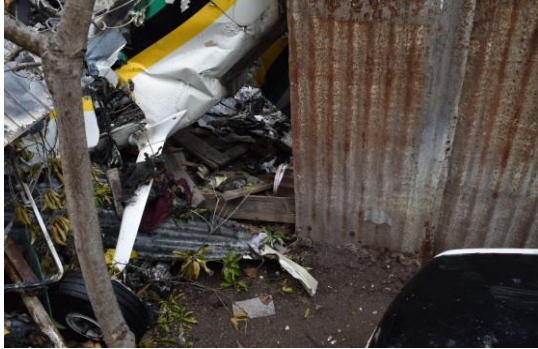
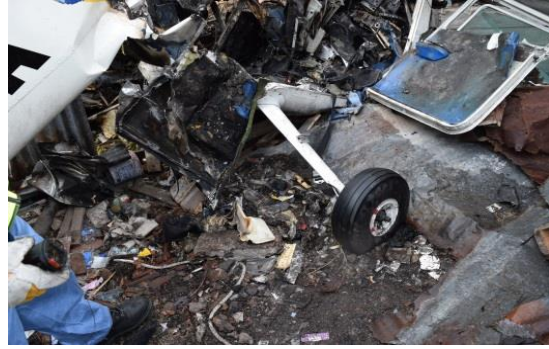
The L/H and R/H main landing gear (MLG) were securely attached to the fuselage, the wheels and brakes were attached to the units and both tyres were inflated as seen in Figures 17 and 18.

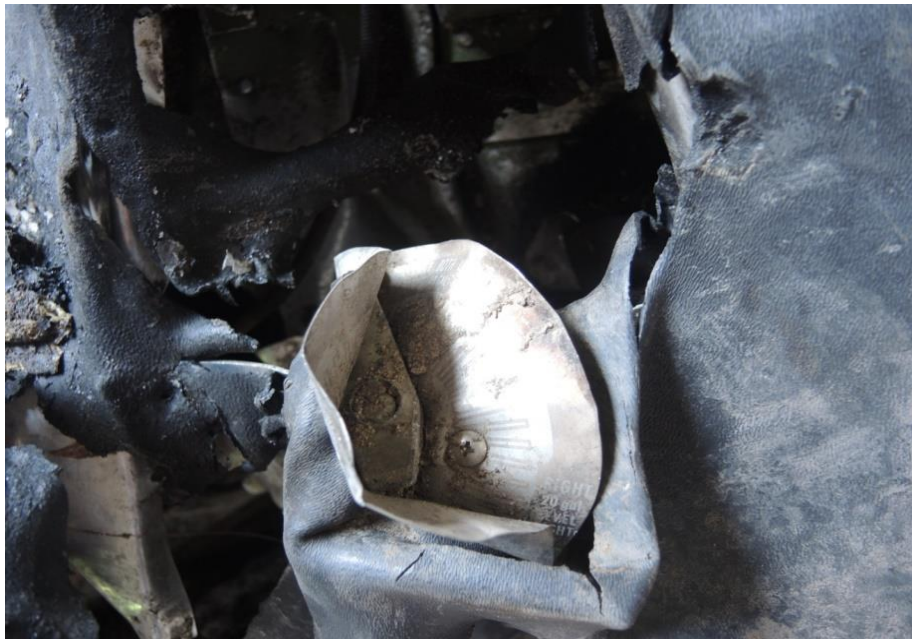
**Figure 19 Fuel Selector**

The fuel selector handle was observed in the “both” position as seen in Figure 19.

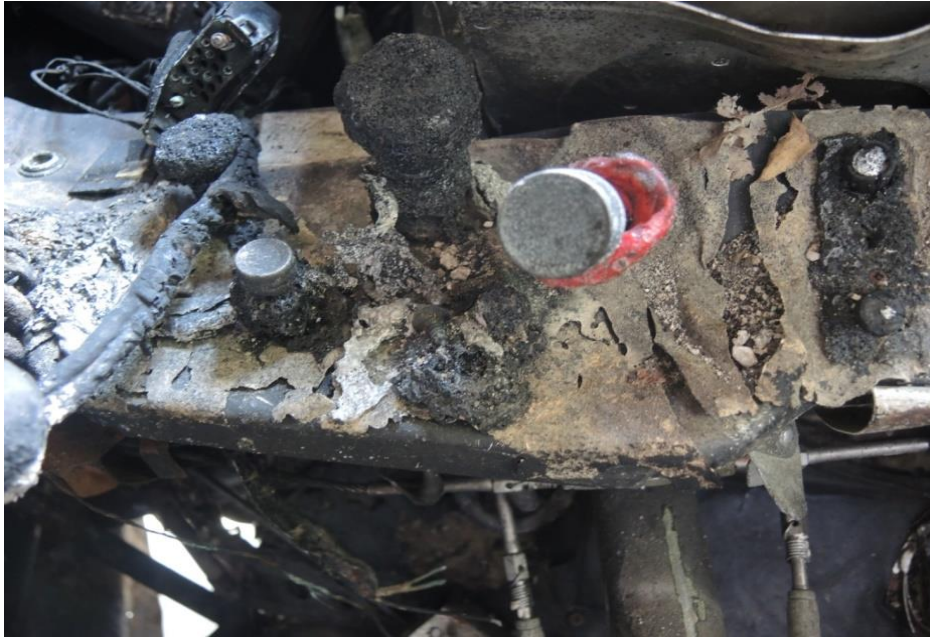
**Figure 20** Engine Controls

The engine throttle and mixture controls were fire damaged and appeared to be in the full forward position as seen in Figure 20.

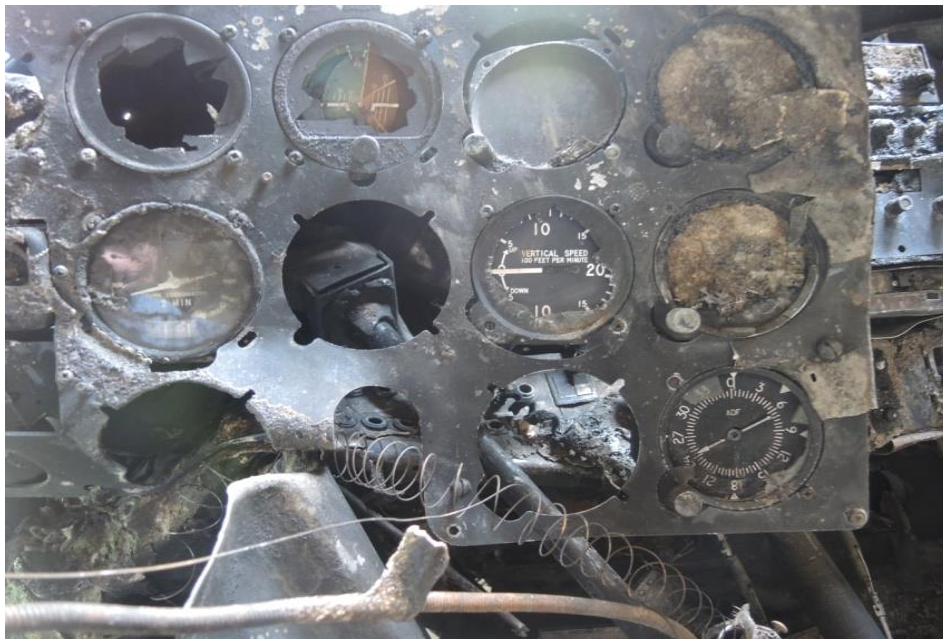
**Figure 21** Engine, Navigation, Instruments and Radios

The engine instruments, navigational instruments and the radios were fire damaged as seen in Figure 21.

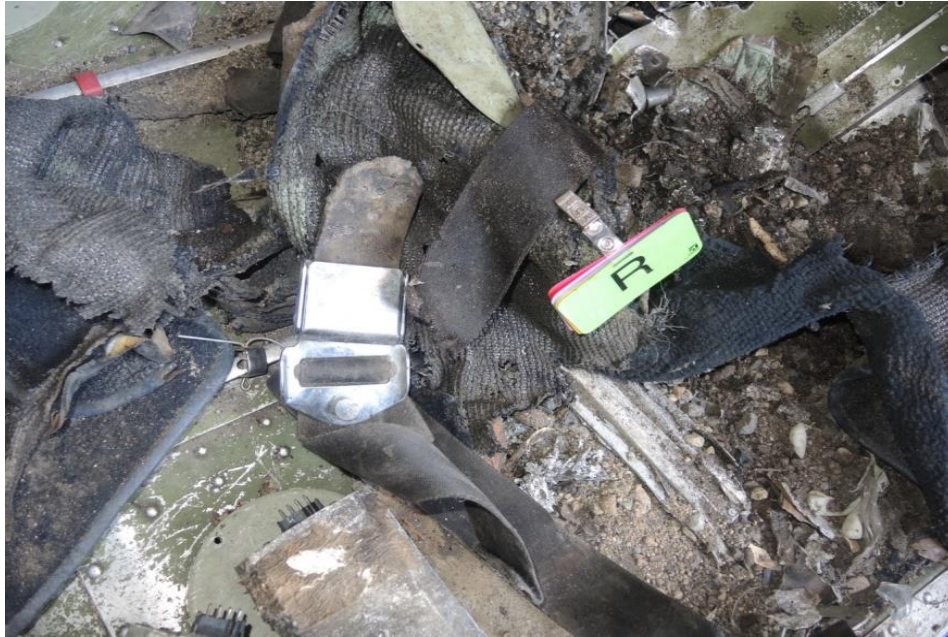
**Figure 22      The Right Hand Seat Safety Restraint Belt**

The R/H seat safety restraint buckle was observed in the latched configuration and the webbing was cut and damaged by fire as seen in Figure 22.

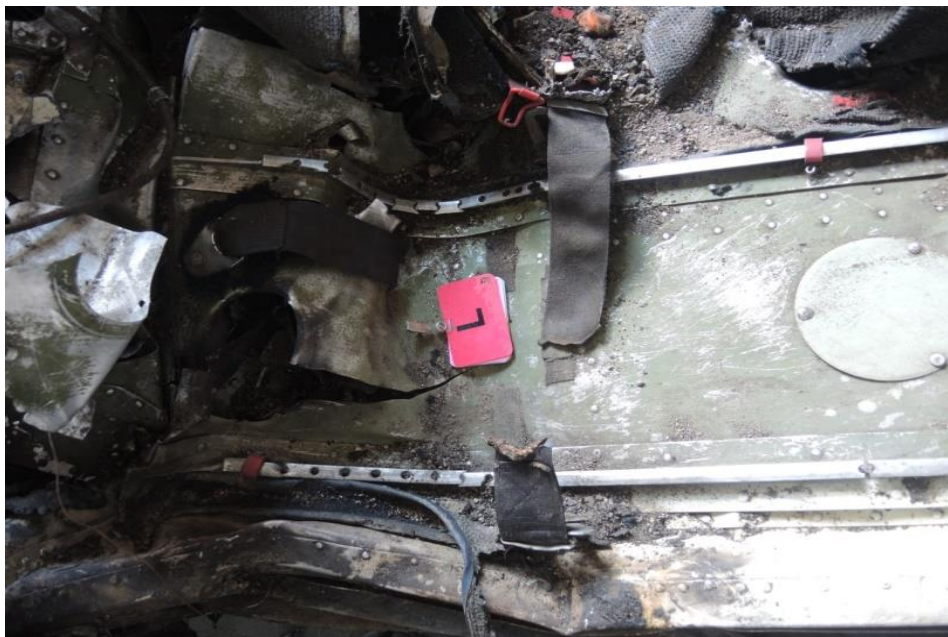
**Figure 23      The Left Hand Seat Safety Restraint Belt**

The L/H seat safety restraint webbing was observed to be cut and damaged by fire as seen in Figure 23; the buckle was not found.

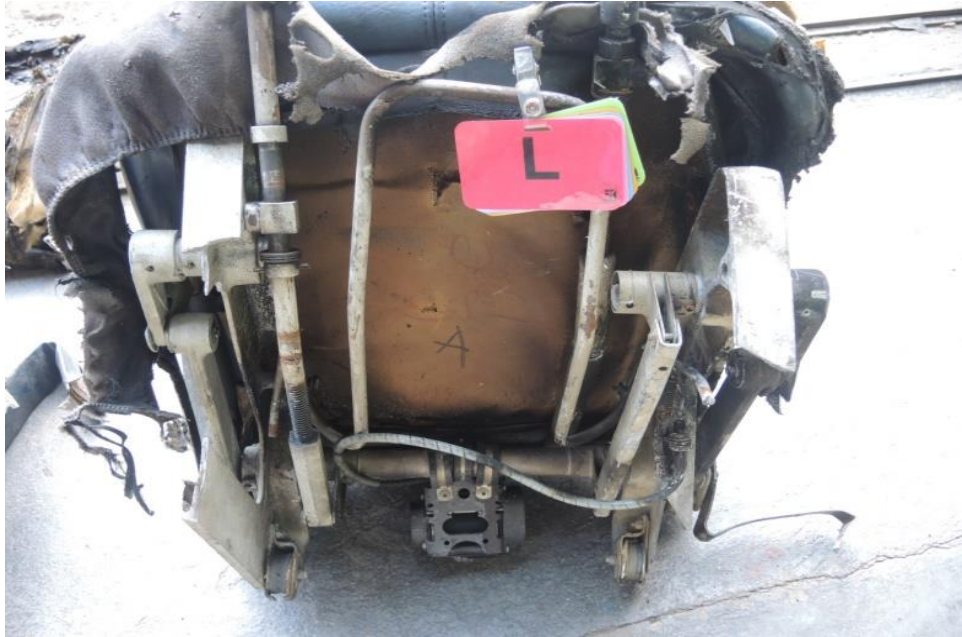
**Figure 24 Left Front Seat**

The L/H seat back was intact; the seat was fitted with a secondary stop as seen in Figure 24.

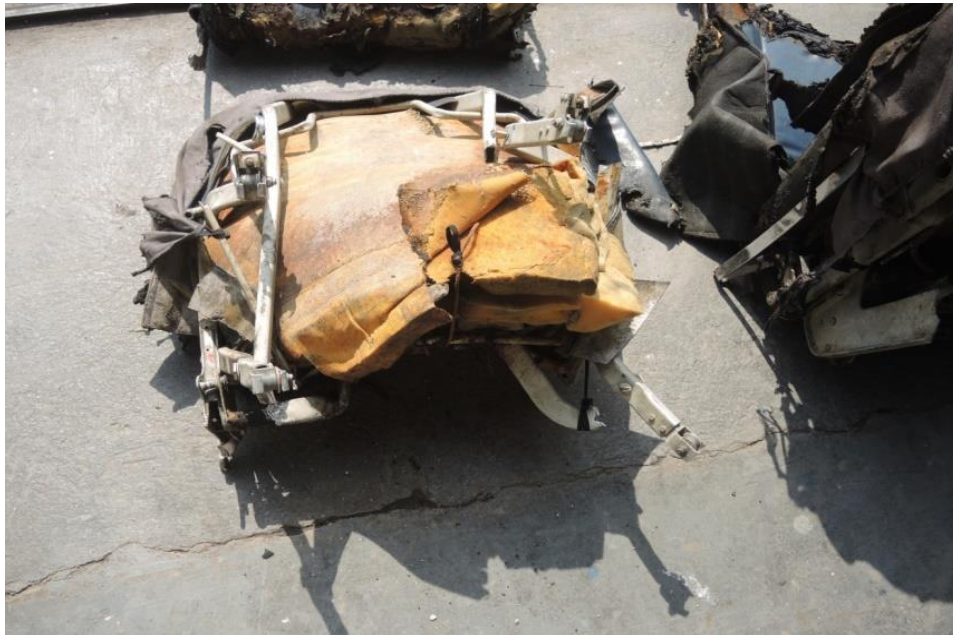
**Figure 25 Right Front Seat**

The R/H seat back was broken and there was impact damage to the seat frame as seen in Figure 25. No secondary stop was observed on this seat.

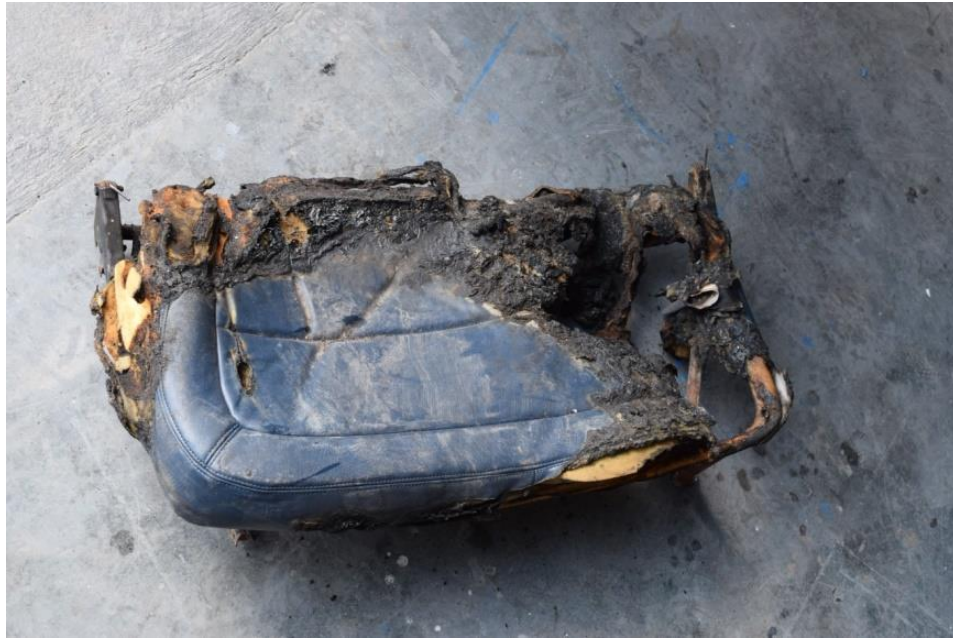
**Figure 26 Rear Passenger Seat**

The L/H side of the rear passenger seat had extensive burns as seen in Figure 26.

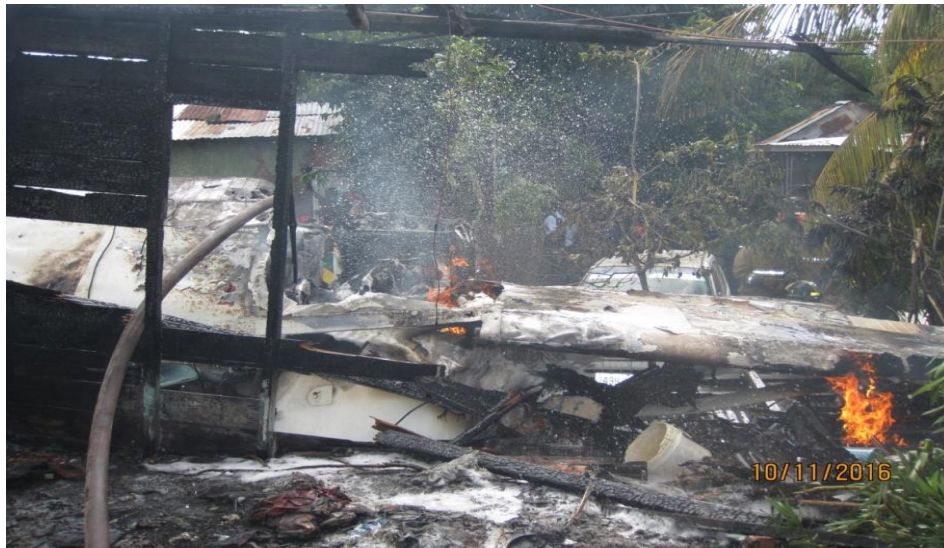
**Figure 27 Fire Damage to the Aircraft Fuselage**

Ground witnesses stated that the fire occurred after the aircraft made impact with the ground, the left hand wing upper and lower surfaces were extensively damaged by fire, the right hand wing had fire damage on both the upper surface and the lower surface from the wing root to wing station 71.37. There was fire damage along the fuselage from the lower engine cowl to fuselage station 108.00 as seen in Figure 27.

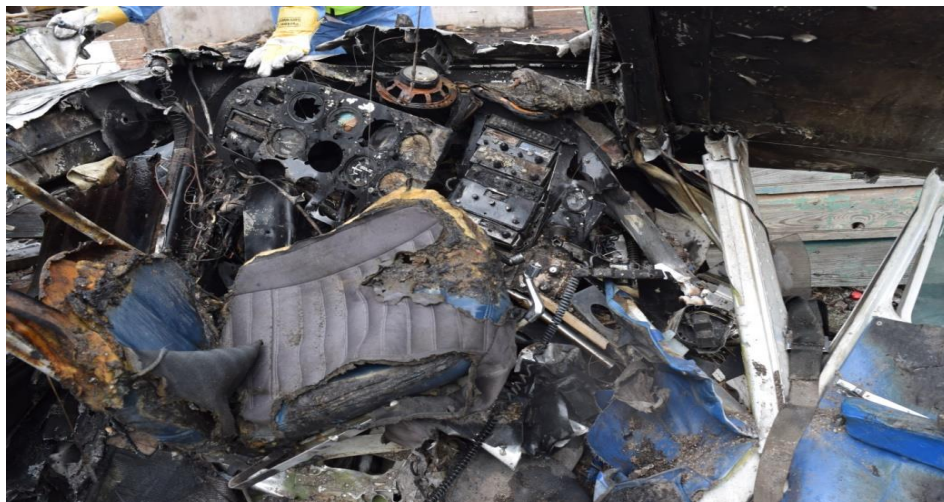
**Figure 28 Aircraft Cockpit**

The cockpit of the aircraft was extensively damaged by fire as seen in Figure 28.

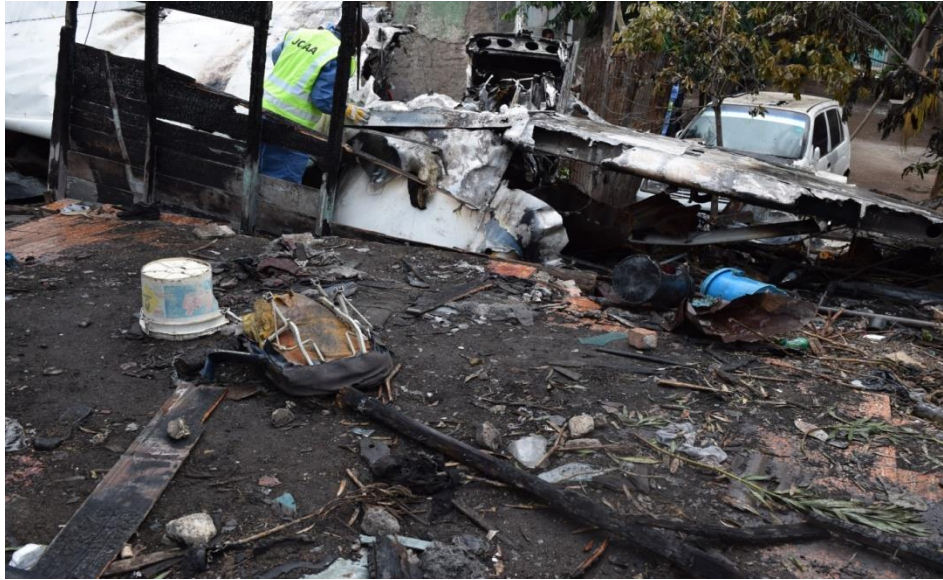
**Figure 29** Damaged Perimeter Fence and Car on Adjacent Property

There was also fire damage to the zinc perimeter fence on which the aircraft made impact with the ground and to the car in the adjacent property as seen in Figure 29.

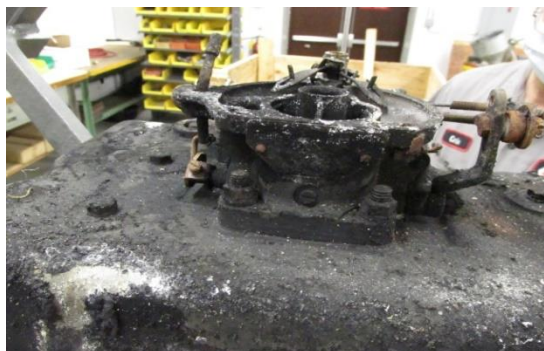
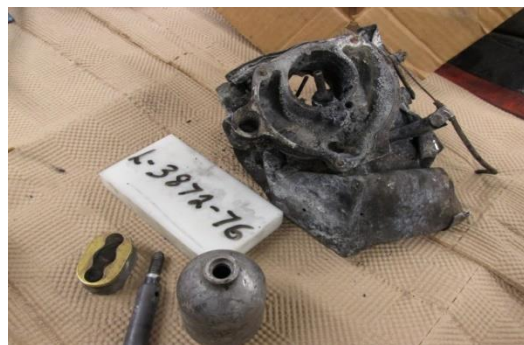
The carburetor showed fire damage signatures along with varying amounts of impact damage. The venturi remained attached to the oil sump, but the floats were missing as shown in Figure 30. The engine control positions were undetermined due to impact damage and component damage. The carburetor bowl was separated from the aircraft as seen in Figure 31. The air box was destroyed by impact and could not be further examined.

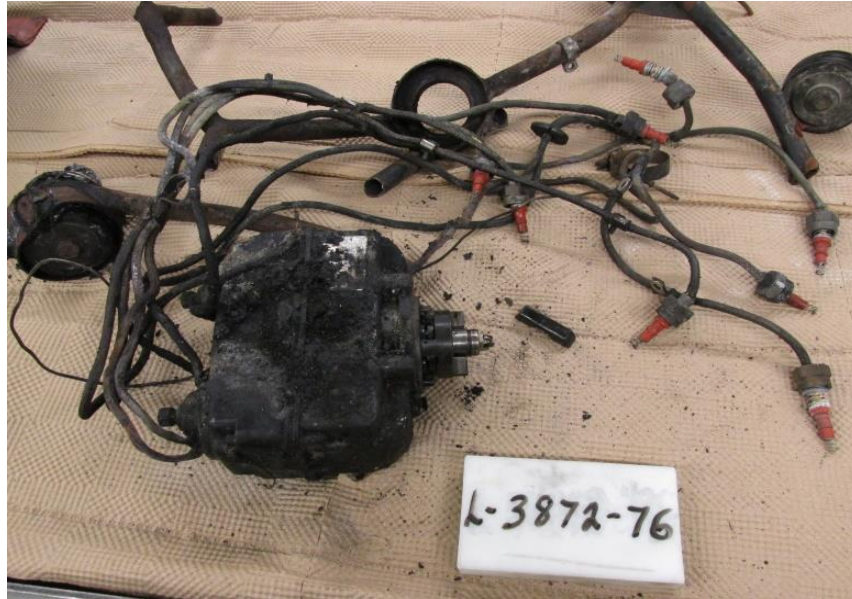
**Figure 32 Engine Magneto**

The magneto was secure in its mount at time of examination, the magneto hold down nuts were tight at the time of removal. Heavy fire damage as seen in Figure 32 precluded timing of the magneto due to internal damage and fire consumed parts. The magneto could not rotate at the time of examination.

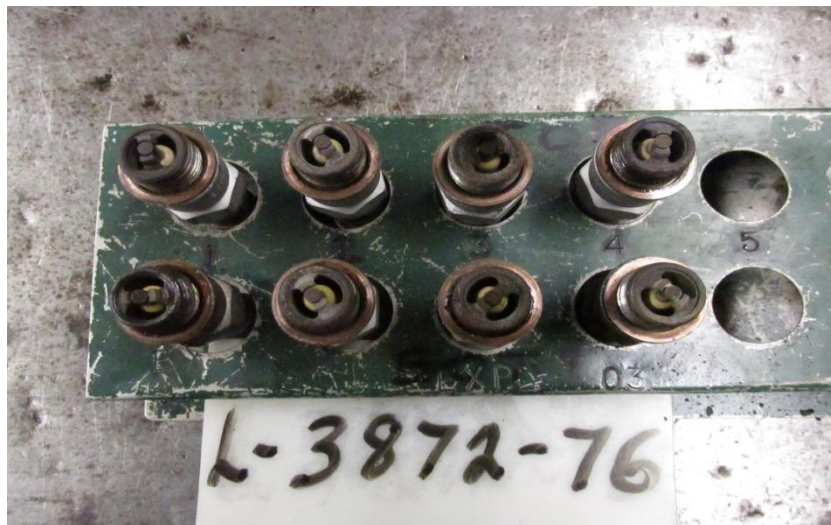
**Figure 33 Engine Spark Plugs**

The spark plugs were secure at each position. The spark plugs were removed, examined and photographed as seen in Figure 33. The spark plug electrodes remained mechanically undamaged, and according to the Champion Spark Plugs “Check-A-Plug” chart AV-27, the spark plug electrodes displayed coloration consistent with normal operation. The static oil soaking of the spark plugs (as noted) could be attributed to the engine positioning at mishap site and post recovery. Light corrosion was observed, this was likely due to post impact fire and heat.

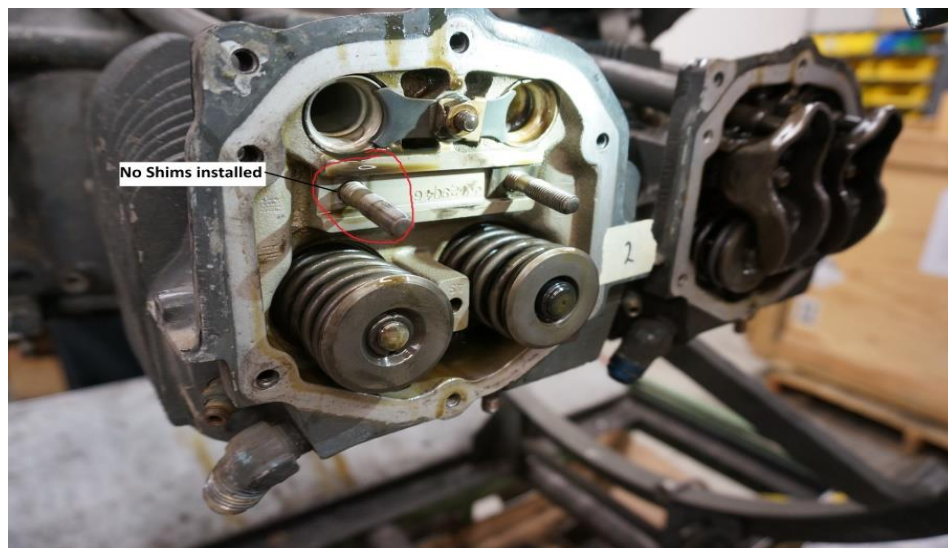
**Figure 34 No. 2 Engine Cylinder**

The No. 2 cylinder intake rocker arm did not have any shims under the rocker arm as seen in Figure 34.

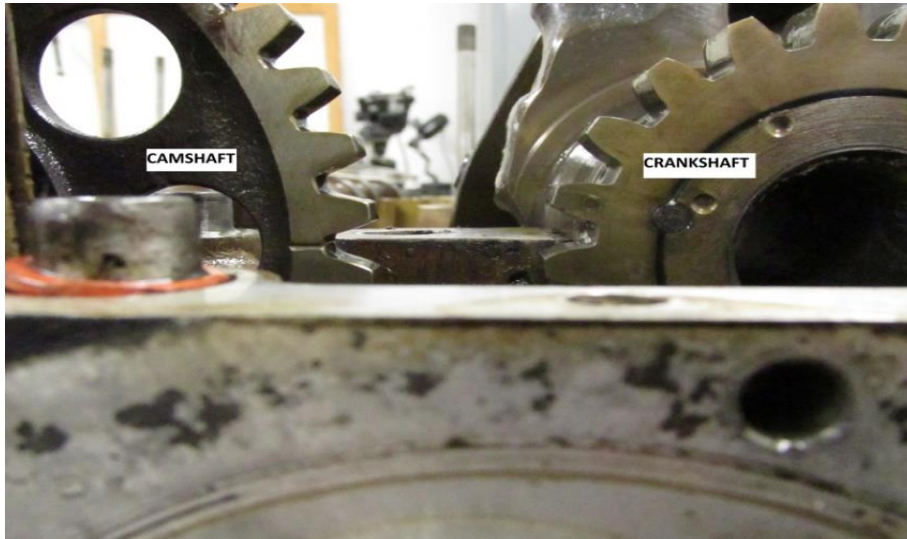
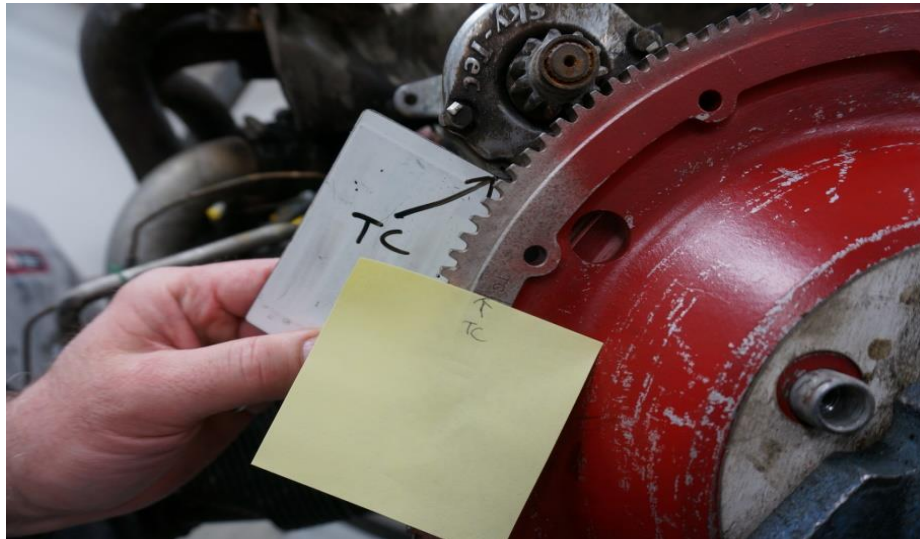
The engine internal timing was found to be out of time by one tooth between the crankshaft and camshaft as seen in Figure 35. This caused the timing mark on the starter ring gear support assembly to be about 7 teeth out of alignment with alignment dot (hole) on the starter bendix gear housing as seen in Figure 36; this translates to approximately 16.8 degrees out of time.

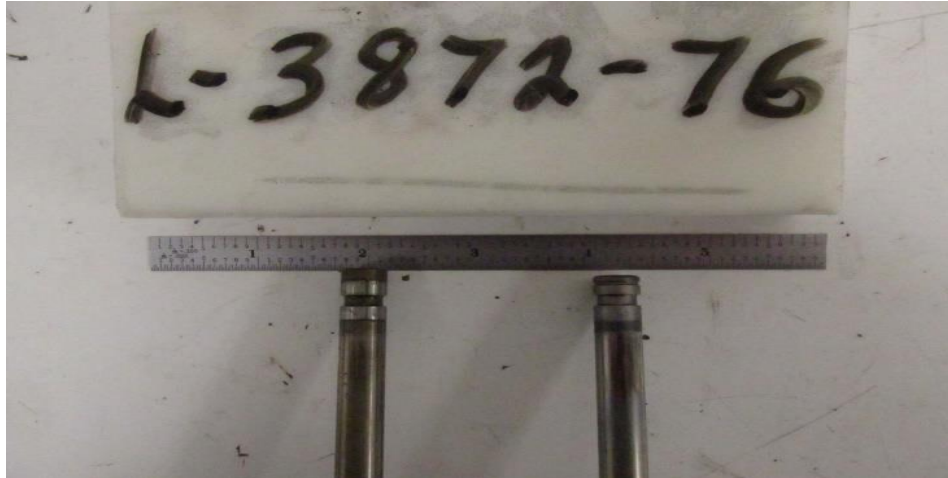
**Figure 37 No. 2 Intake Valve as compared to another Intake Valve**

The intake valve installed in the No. 2 engine cylinder was incorrect as indicated by its short length when compared to the other intake valves as seen in Figure 37; this suspect part has a Lycoming part number, but is not correct for this engine model or type certificate.

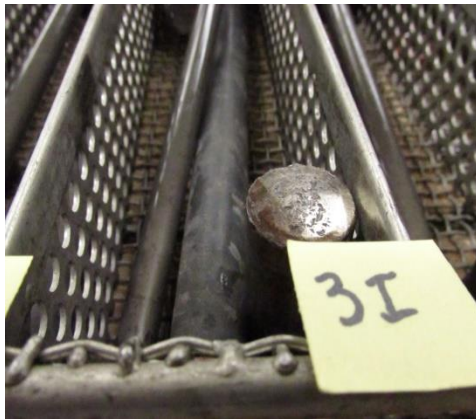
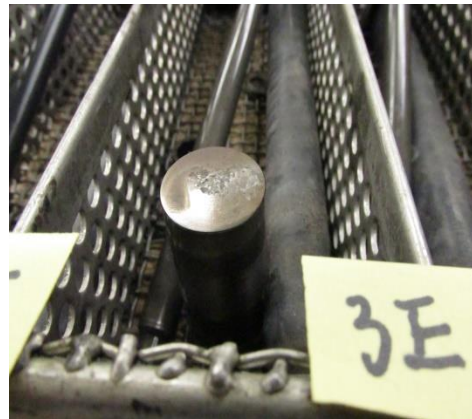
The No. 3 cylinder intake and exhaust tappets were heavily pitted on the face and showed damage to the edges as seen in Figures 38 and 39.

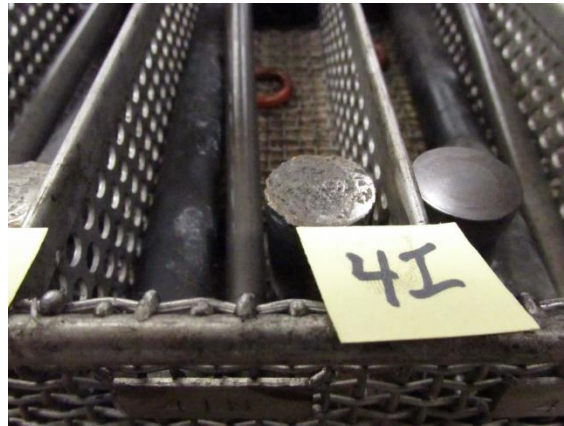
**Figure 40 No.4 Intake Tappet**

The No. 4 cylinder intake tappet was heavily pitted on the face with jagged edges along the circumference of the tappet as seen in Figure 40.

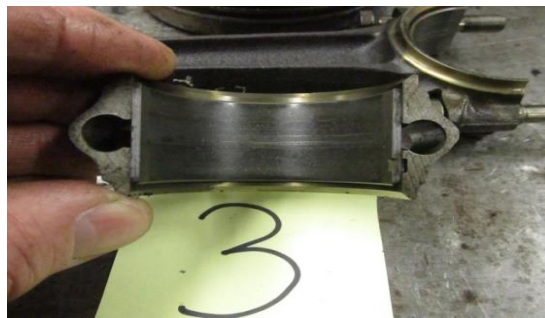
**Figure 41 Connecting Rod Bushing**

The connecting rod bushings showed some signs scratching as seen in Figure 41. There was also scoring of the piston skirts.

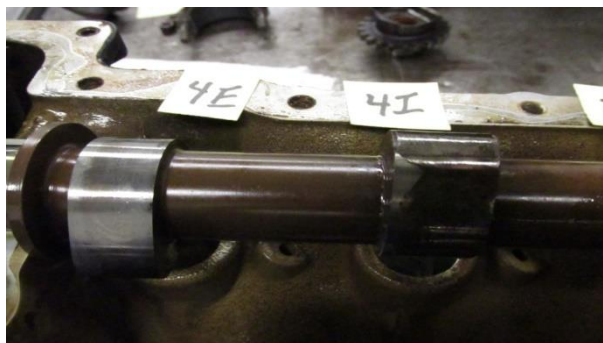
**Figure 42 Engine Camshaft**

The camshaft shows damage to all lobes of varying degrees, both to the face and edges of the lobes. The No. 4 intake lobe showed the greatest amount of damage. Spalling and worn edges were observed along with corrosion as seen in Figure 42.

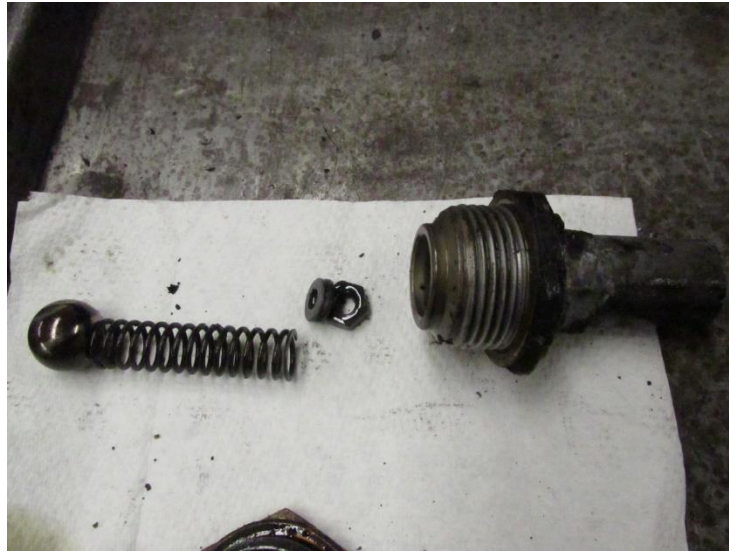
**Figure 43 Oil Pressure Relief Valve**

The oil pressure relief valve had a hexagonal nut and two washers installed in lieu of the specified washers as stated in the Illustrated Parts Catalog (IPC) for spring tension adjustment as seen in Figure 43.
