AVIATION ACCIDENT INVESTIGATION REPORT

RUNWAY OVERRUN ON LANDING

FLIGHT AA331

REPORT NUMBER JA-2009-09

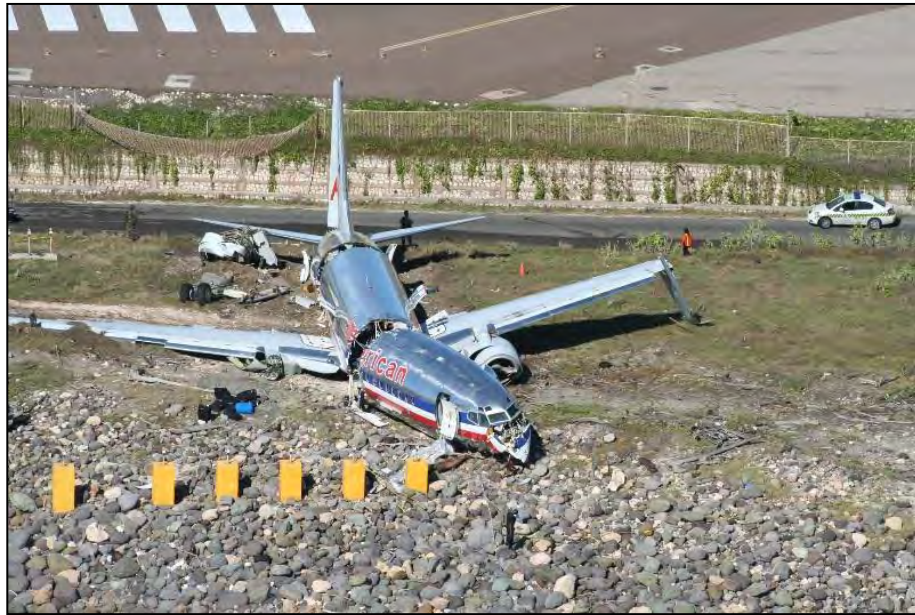
The forward section of the aircraft came to rest on a track of 088 degrees magnetic and the centre and aft sections were on a track of 128 degrees magnetic.

Photo 2 Aircraft Wreckage

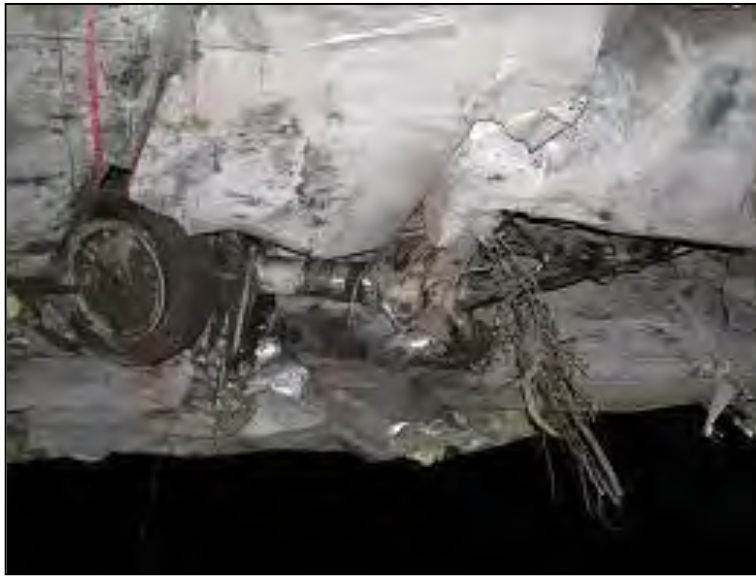
The nose gear was folded back by impact forces, but the FDR indicated that it was down and locked before impact. The wear on the tires was typical of in-service tires. The left tire pressure was 200 psi, and the right was 0 psi.

Photo 8 Nose Landing Gear

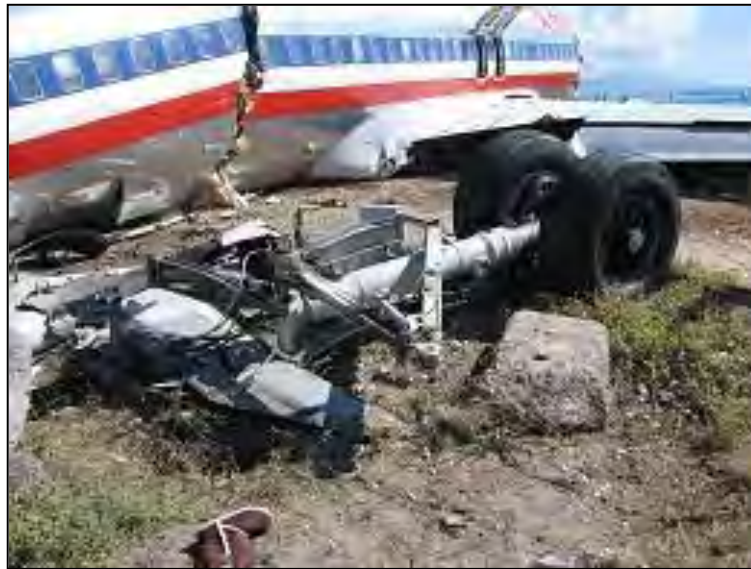
13/32 inch and 7/32 inch, respectively. The measured tire pressure was 210 psi. The serial side shoulder rib had heavy abrasion and melted rubber balls 360° around the tire. The non-serial side shoulder rib also exhibited heavy abrasion and melted rubber balls 360° around the tire, however, there was not as much abrasion as on the serial side shoulder rib. The centre tread rib demonstrated typical abrasion wear for a rolling tire. There was some heavy abrasion on the shoulders similar to that identified on the shoulder ribs but very little evidence of melted rubber balls.

There was no evidence of pre-impact damage to, or pre-impact failure of, any part of the right main landing gear system, including the tires and the brakes.

Photo 9 Right Main Landing Gear

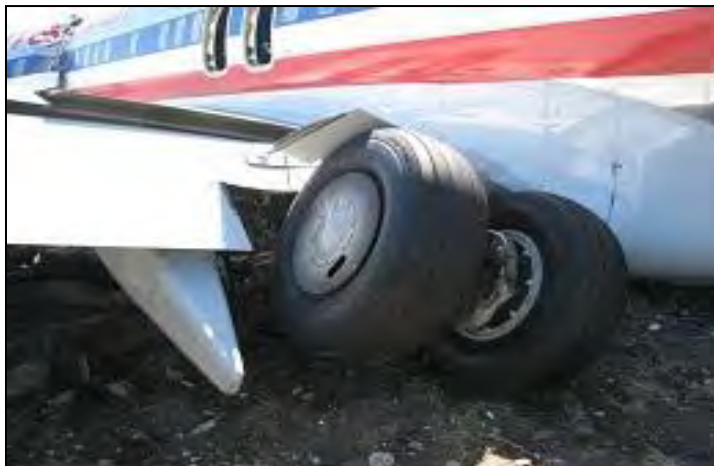
The outboard tire had retread level R2 dated 9/2009. The following measurements of the remaining tread depths were recorded (measured outboard to inboard): 6/32 inch, 12/32 inch, 12/32 inch and 2/32 inch. The measured tire pressure was 204 psi. Both side shoulder ribs had heavy abrasion 360° around the tire, but there was no evidence of melted rubber. The centre tread rib exhibited typical abrasion wear for a rolling tire.

There was no evidence of pre-impact damage to, or pre-impact failure of, any part of the left main landing gear system, including the tires and the brakes.

Photo 10 Left Hand Main Landing Gear

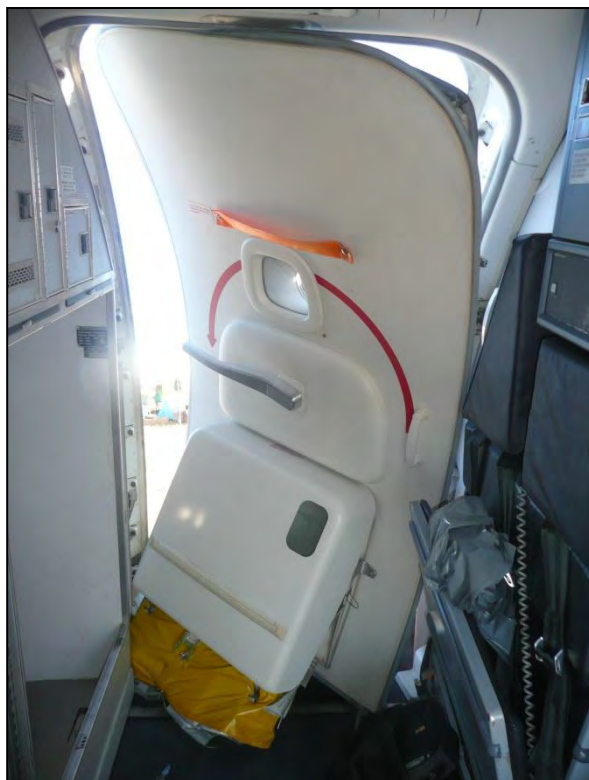
The escape slide pack was jammed into the doorway on the aft corner of the escape slide and was not able to fall free from the door sill ⁴⁵. Once the escape slide pack had been removed, the door was tested for operation. It was found to operate to the open position, but could not be fully closed in the locked position

Photo 11 Forward Left Door (L1)

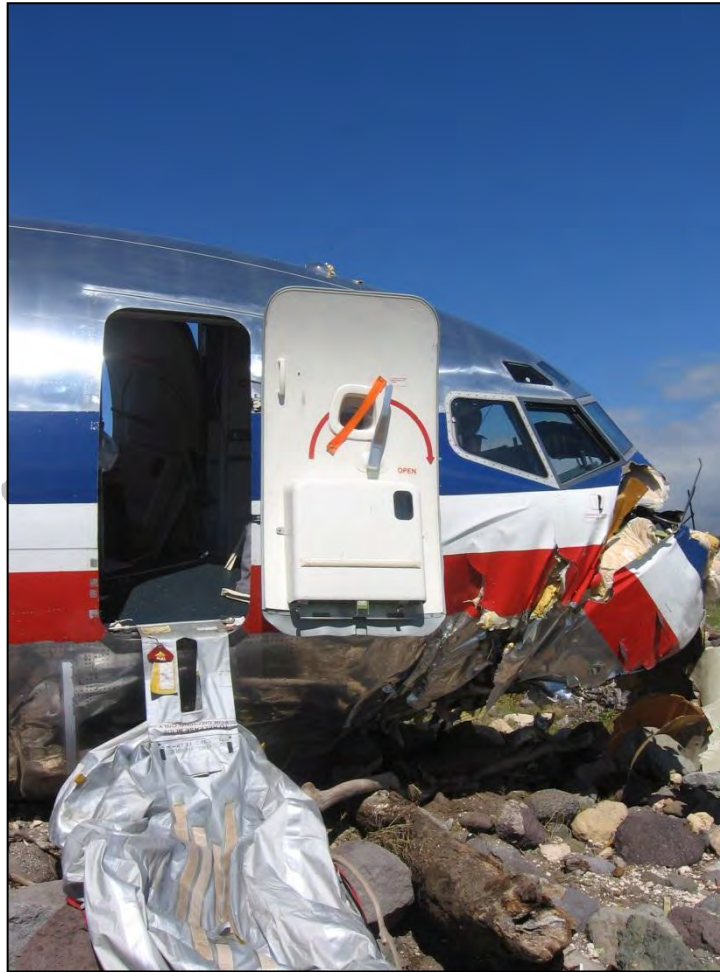
The escape slide pack had been released from the escape slide compartment. The escape slide was found deflated, but there was evidence that the slide had been inflated post impact.⁴⁶

Photo 12 Forward Right Door (R1)

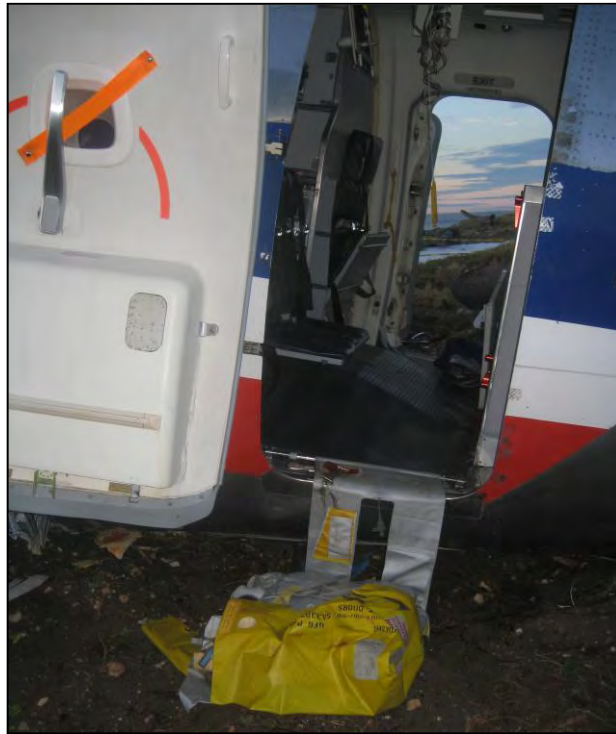
The L2 escape slide pack was found on the ground, released from the slide pack compartment, but the slide was not inflated.

After the accident the aft fuselage of the airplane was too close to the ground for the slide to fall far enough to activate the inflation mechanism.

Photo 13 Aft Left Door (L2)

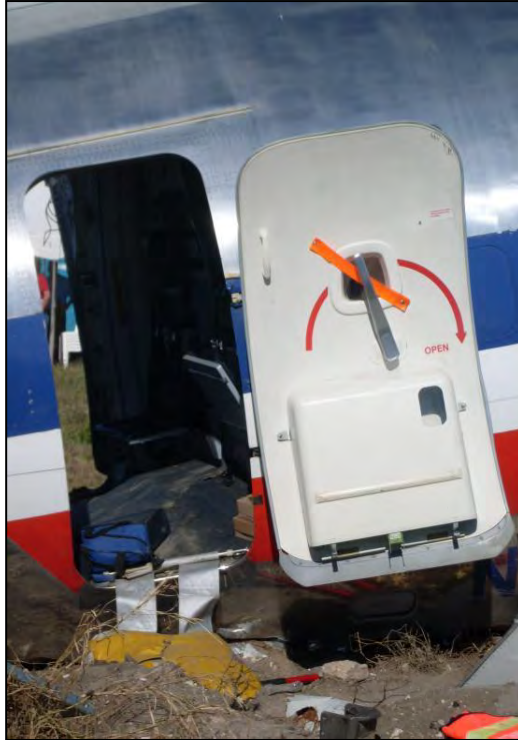
The R2 door was found in the fully open position with the handle positioned between the open and locked positions. The caution strap was found snapped across the viewing area. The operation of the door was checked and was found to open normally.

The R2 escape slide pack was found on the ground, released from the slide pack compartment, but the slide was not inflated. After the accident the aft fuselage of the airplane was too close to the ground for the slide to fall far enough to activate the inflation mechanism.

Photo 14 Aft Right Door (R2)

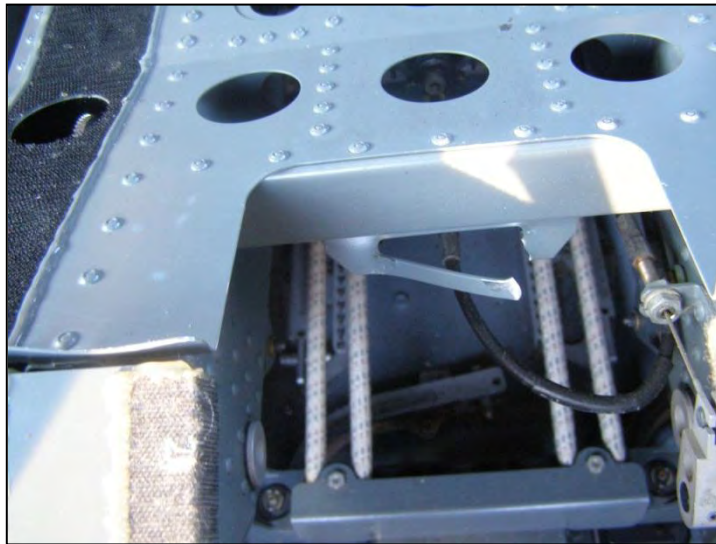
The captain's seat crotch belt was found broken loose from the seat structure because the captain's crotch belt bracket was broken.⁴⁷ Both the crotch belt and the outboard shoulder harness were found buckled. The captain's outboard shoulder harness was locked in the extended position and the inboard shoulder harness retracted normally.

Photo 16 The captain's crotch belt bracket

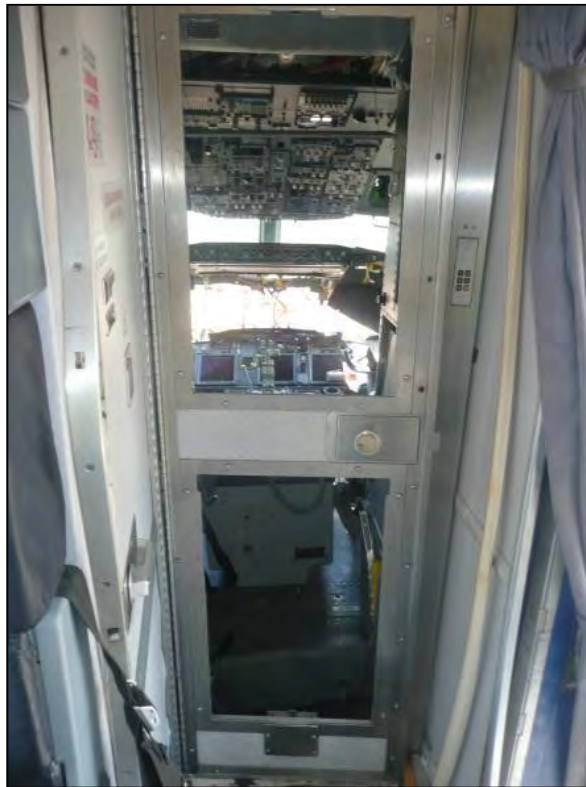
The forward entry area floor buckled laterally about midway through the R1 doorway. The buckling continued clear across the cabin flooring from left to right. Most of the buckling was in the R1 entry area and in the aisle to the flight deck door.

In the galley area, forward of R1, it was evident that the structure was buckled, causing some items to be jammed in position. Both of the cabin crew members seated at L1 reported that they were unable to retrieve their flashlights because the doors to the emergency equipment compartments under their jump seats were jammed due to the buckling of the floor.

Photo 17 Flight Deck Door

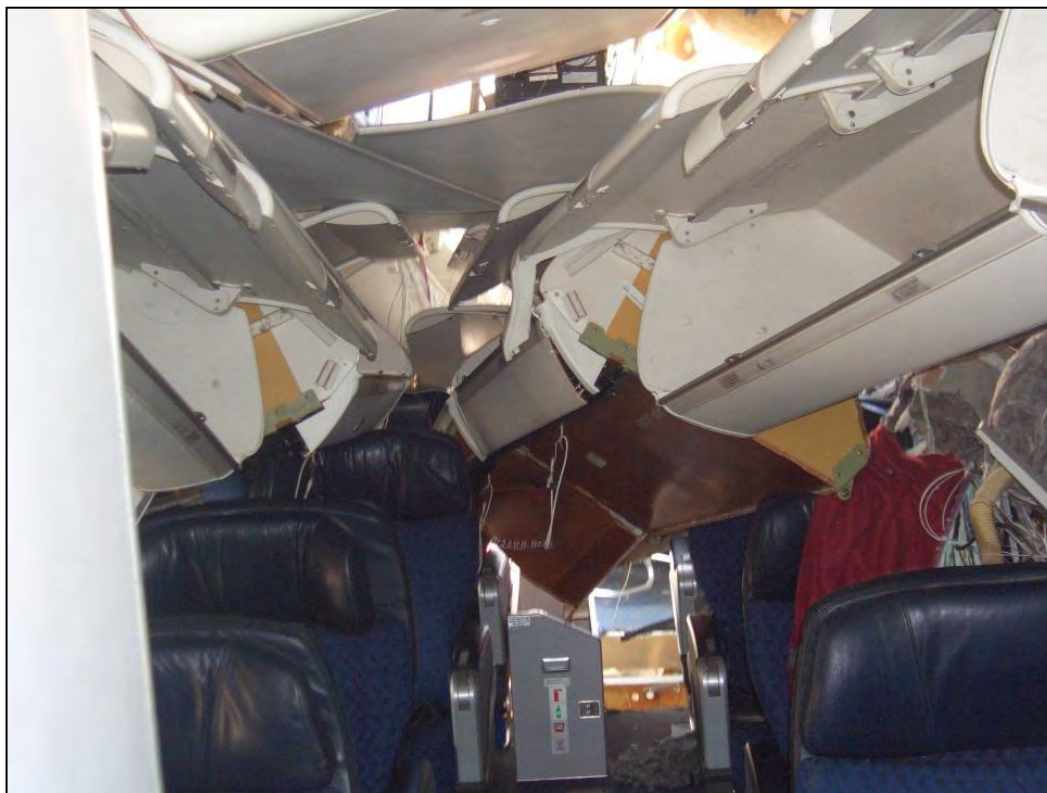
The interior of the forward section sustained the heaviest damage compared to the centre and aft sections. This section of the aircraft was angled about 40 degrees to the left of the centre section, leaving an opening on the right side about 6 feet wide, and no opening on the left side. The ceiling panels, overhead stowage bins, passenger service units (PSUs), and spacer panels were found displaced. The forward video monitor was stowed. The aft ceiling mounted video monitor remained attached to the stringer and the monitor shroud was displaced downward. The life raft was found in its stowage compartment in the ceiling above Rows 3 and 4. The attachments on the left side of the life raft compartment remained attached to the stringers, but the right side was detached from the stringers.

Photo 18 First Class Cabin

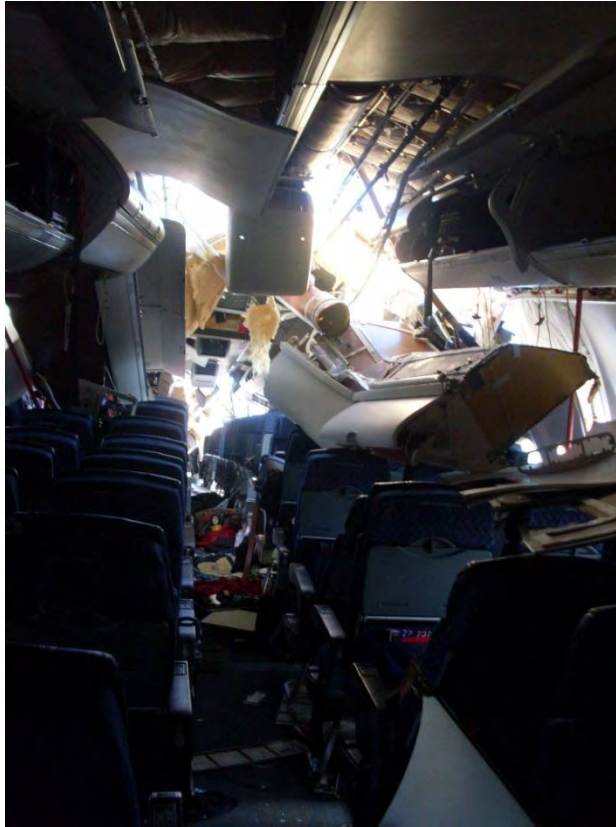
The aft-most portion of floor between the lavatories had buckled exposing a gap between cabin floor panels and the aft galley floor. The majority of the seats in this area were in good condition, with exceptions throughout the section.

Photo 20 Aft Section
