AVIATION ACCIDENT INVESTIGATION REPORT

REPORT OF SMOKE IN THE COCKPIT

FLIGHT JBU 876

REPORT NUMBER JA-2014-01

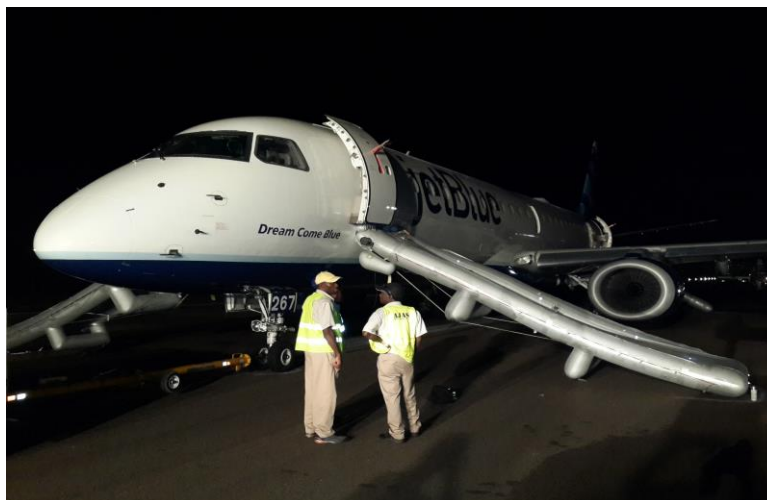
Forward Left Door (1L)

The 1L door was open and the slide fully deployed and used for passenger evacuation. The slide was illuminated with the escape slide lights.

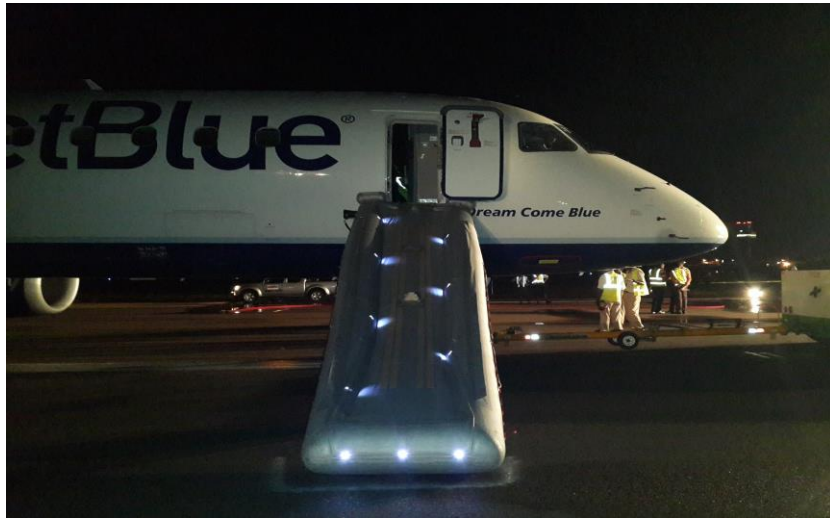
Forward Right Door (1R)

The 1R door was open and the slide fully deployed and used for passenger evacuation. The slide was illuminated with the escape slide lights.

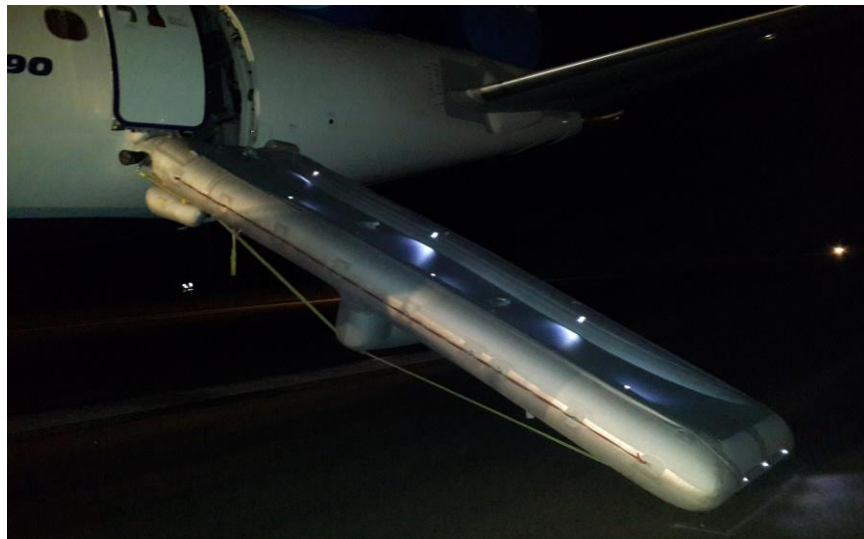
Aft Left Door (2L)

However, the flight attendant positioned at 2L reported after opening the 2L door she was unable to control the evacuation in an orderly manner, this caused her to abandon any attempt to open and use the 2R door. She also reported that some passengers attempted to take their baggage with them.

The 2L door was open and the slide fully deployed and used for passenger evacuation. The slide was illuminated with the escape slide lights.

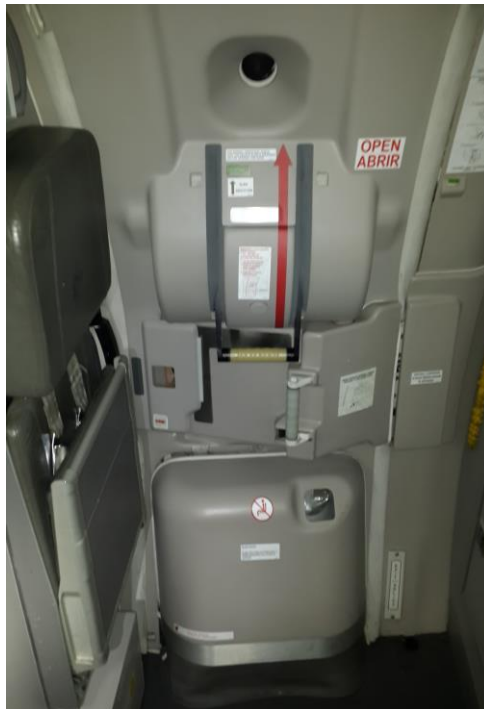
Aft Right Door (2R)

This door remained closed and was not used during the passenger evacuation. The flight attendant assigned to position number 2, at the rear of the aircraft, stated that it was not safely possible for her to open 2R, as there were too many people coming at her and if she let go of the 'assist handle' she would have been pushed out of the aircraft.

1. That the flight attendant training for the JetBlue ERJ 190 aircraft should recognize that, when there is one flight attendant at the 2L and 2R doors, it may be possible that the flight attendant has difficulty in ensuring both doors are opened, and train the flight attendants to ensure that both 2L and 2R doors are opened before an emergency evacuation commences.
2. That JetBlue Airways improves their analysis of recurring defects.

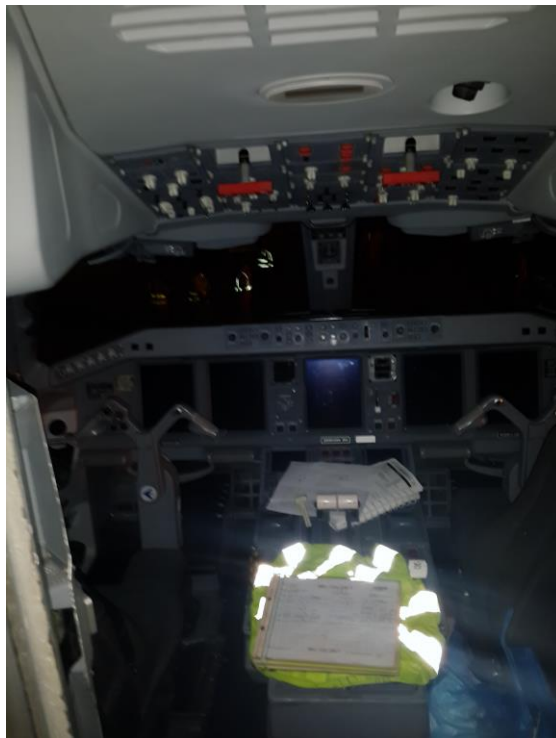
Flight Deck

The flight deck remained intact. There was no evidence of damage to the flight deck door, seats, floor, sidewalls, windows, windscreen or instrument panels.

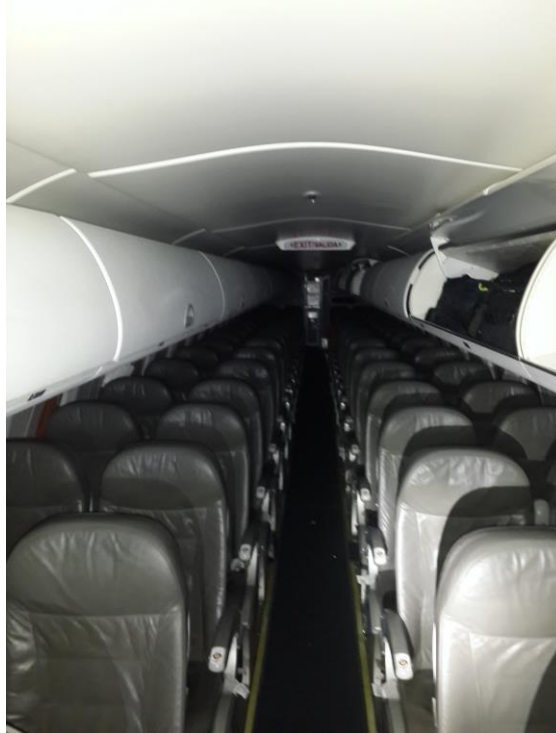
Main Cabin

There was no evidence of damage to the main cabin.

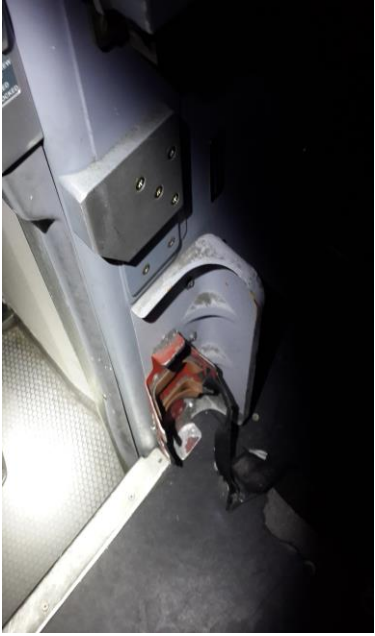
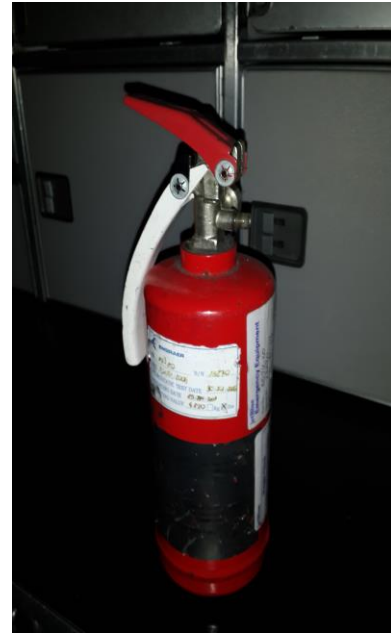
Emergency Equipment

All of the emergency equipment contained in the cabin was found to be correctly secured. A halon extinguisher was removed from its stowage location in the flight deck and was found on the galley counter in the forward galley area.

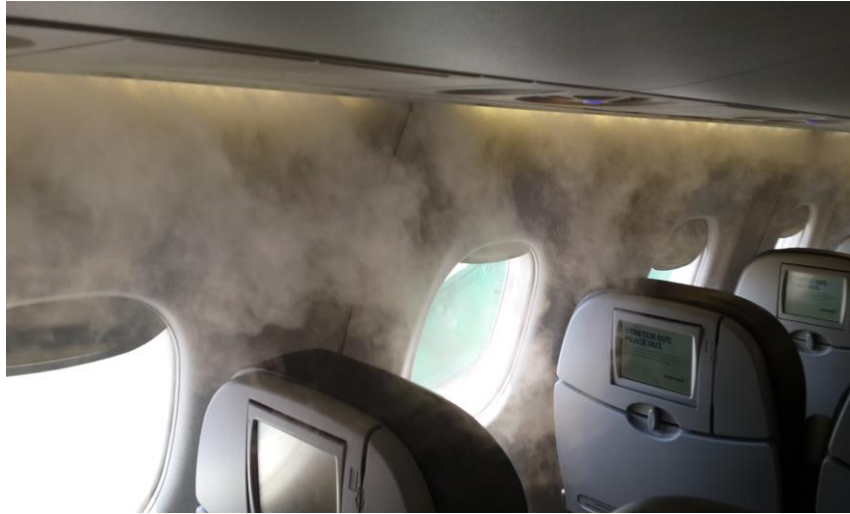
Aircraft cabin

After it was determined that it was safe to apply power to the aircraft, both air condition packs were operated, individually at first and then together. These tests were done about thirty six hours after the aircraft had landed and the burning smell no longer existed in the cockpit or cabin. Pneumatics from the APU was used to operate the packs at full cold. There was a noticeable heavy mist in the cabin and cockpit when the left pack was in operation. The mist was far less with the right pack operating. In addition, drops of water could be felt coming from the air outlets when the left pack was in operation. No burning smell or smoke was observed.

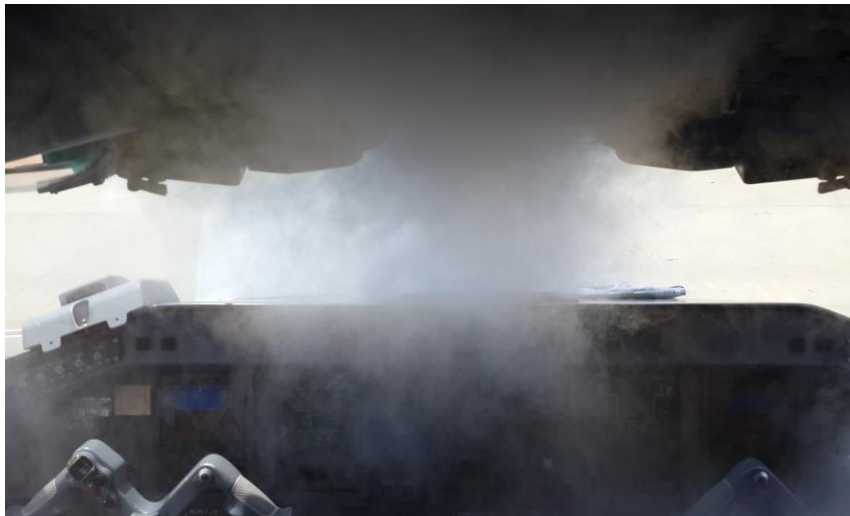
Aircraft cockpit

The engines were run at approximately cruise power and the same process was repeated in the operation of the packs. The heavy mist was not present when using the engines to supply pneumatics. The pack flow was slightly less as the air pressure was less than that supplied by the APU. No burning smell or smoke was observed during the operation of the packs using engine pneumatics.

Prior to the engines being shut down, the APU was restarted and the packs then switched back to the APU supplying pneumatics. Shortly afterwards, a loud grinding noise emanated from the left ACM and a faint burning smell was also observed, however there was no smoke seen.
