AIRCRAFT ACCIDENT INVESTIGATION REPORT

CRASH SHORTLY AFTER TAKE-OFF

TEXTRON AVIATION INC. (FORMERLY CESSNA) 172N

REPORT NUMBER JA-2016-01

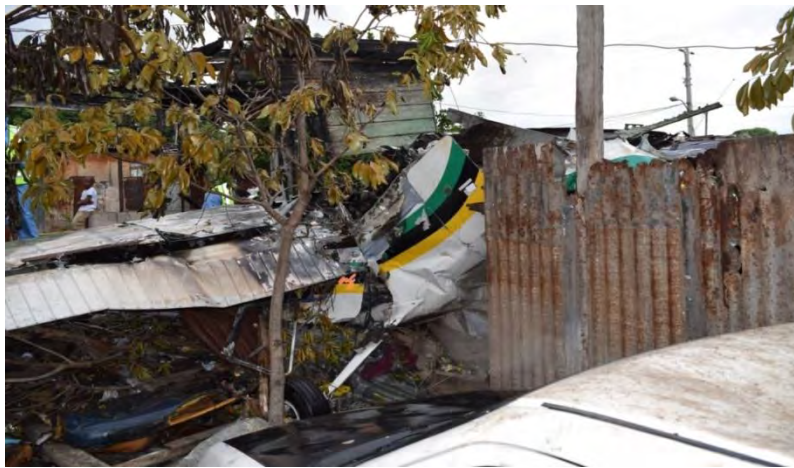
Figure 1 Position of Aircraft on Impact

The aircraft came to rest in a near upright position as seen in Figure 1; all four corners of the aircraft were observed at the crash site. The engine was still attached to the airplane.

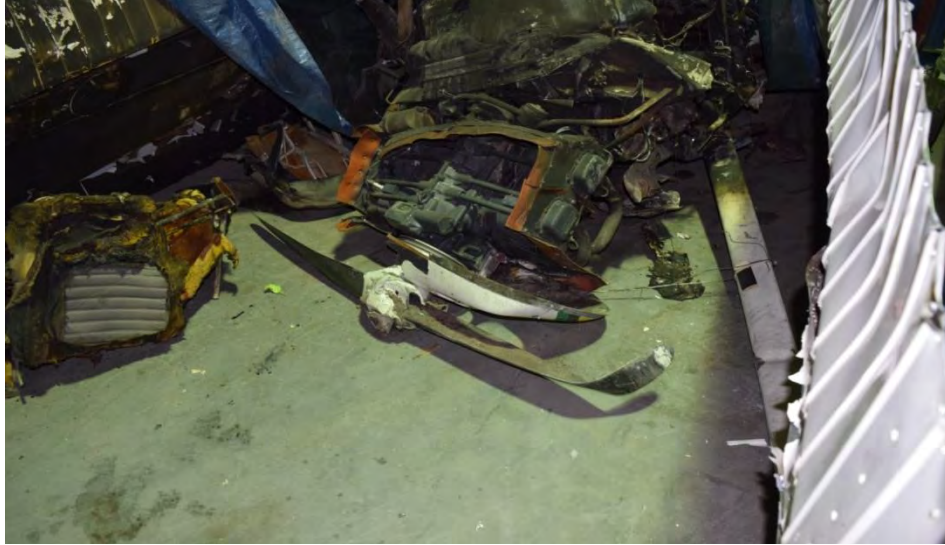
Figure 2 Aircraft Propeller and Engine

The nose cone of the propeller was crushed, it came to rest on the concrete base of an abandoned and partially burnt-out wooden building, the propeller was securely attached to the engine and the bolts were secured with locking wire. Blade No. 1 showed no leading edge damage or bending, Blade No. 2 was observed with the tip bended aft about 90 degrees, approximately 9 inches from the tip, there was damage to the leading edge of this blade as seen in Figure 2.

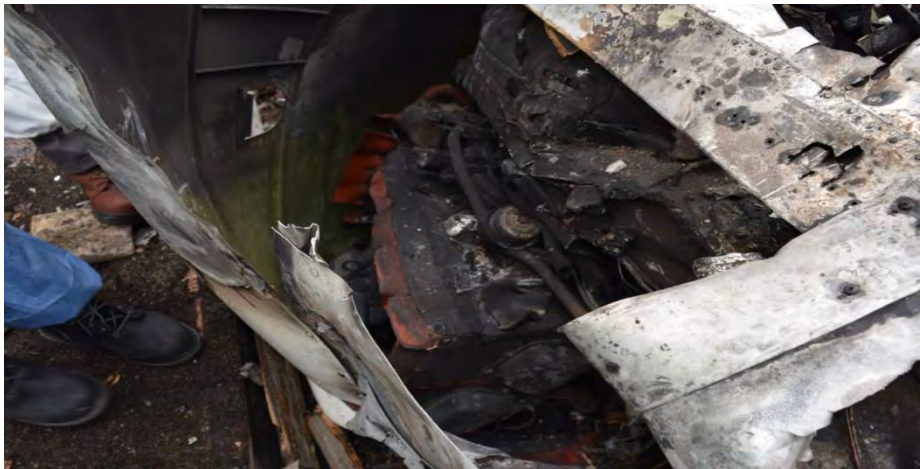
Figure 3 Engine Compartment

The engine cowling was partially attached to the aircraft as seen in Figure 3; the lower cowl was badly deformed and there was evidence of fire damage in the lower engine compartment, the engine was attached to the firewall, and the engine mount rods were deformed.

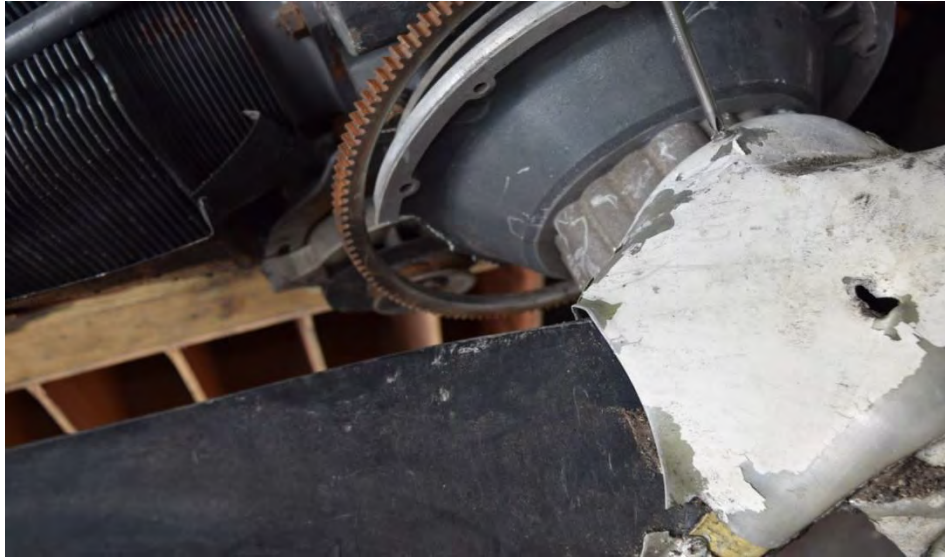
Figure 4 Flywheel and Starter Ring Gear

The flywheel was bolted to the crankshaft, a part of the circumference was broken off and the starter gear ring was partially detached from it as seen in Figure 4.

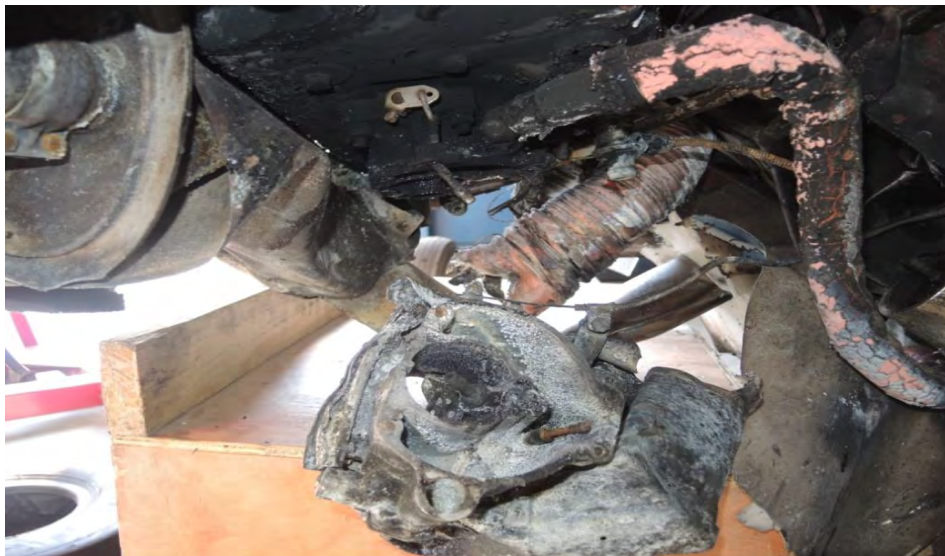
Figure 5 Part of the Carburetor

The carburetor was broken at the parting face to the fuel bowl as seen in Figure 5 and a part of the throttle body of the carburetor was separated from the engine; there were fire damage signatures to it, and the float was burnt. The engine throttle cable was observed to be attached to the throttle control lever; the rest of the throttle body of the carburetor was attached to the engine.

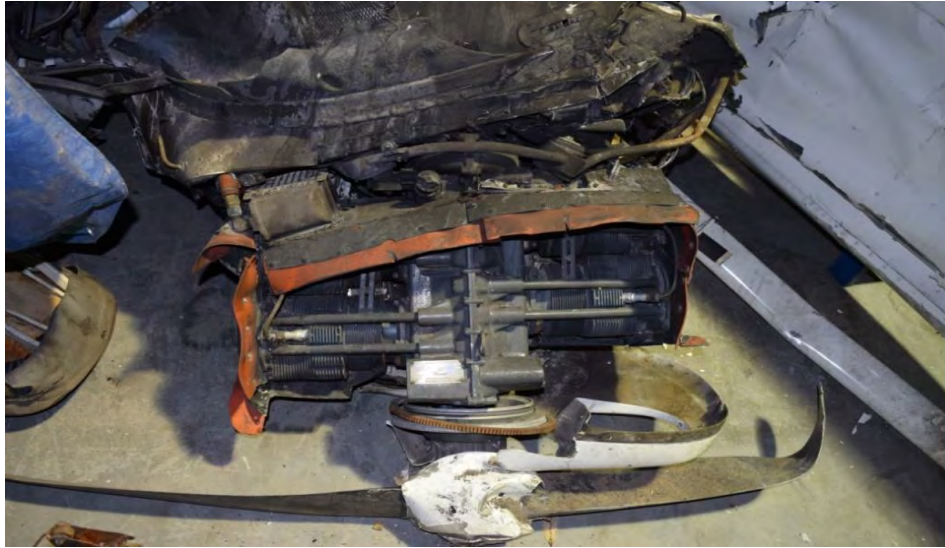
Figure 6 Engine Crankcase with Cylinders

All four engine cylinders were attached to the crankcase for the engine as seen in Figure 6; all eight spark plugs were installed in the cylinders with their leads attached.

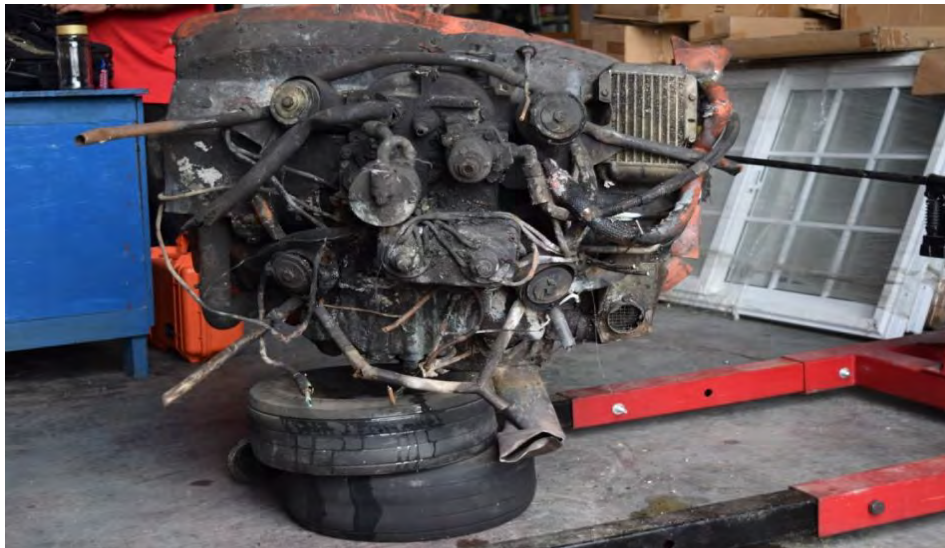
Figure 7 Aft View of the Engine

The dual magneto was securely attached to the aft of the engine as seen Figure 7. Fire damage to the exterior of the unit was observed.

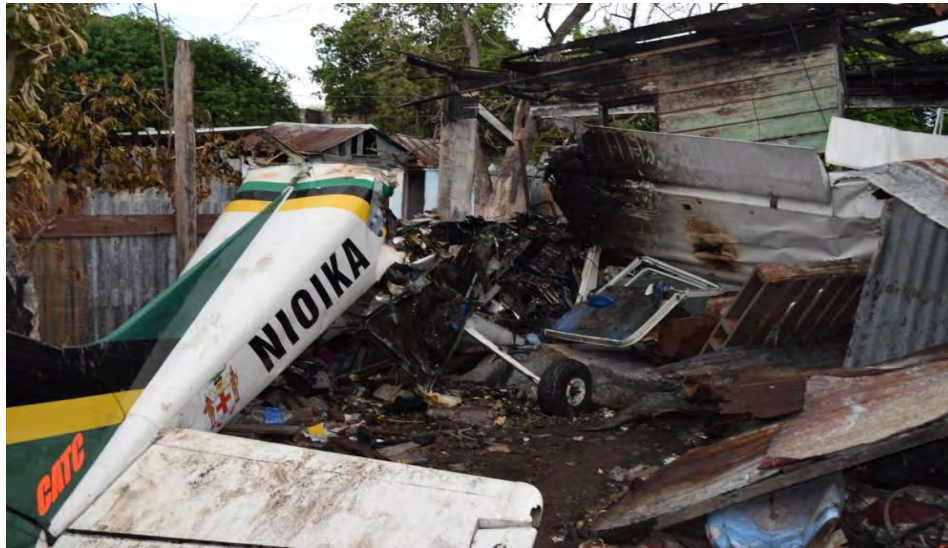
Figure 8 Burnt Out Fuselage of the Aircraft

There was fire damage along the fuselage from the engine to the front of the baggage door at Fuselage Station FS 90.00. The upper fuselage skin from the forward wing spar to Fuselage Station 108 was burnt out as seen in Figure 8. The lower fuselage skin showed evidence of buckling beginning at Fuselage Station 80.00; the empennage was bent downward at an angle of approximately 90 degrees at Fuselage Station 108.

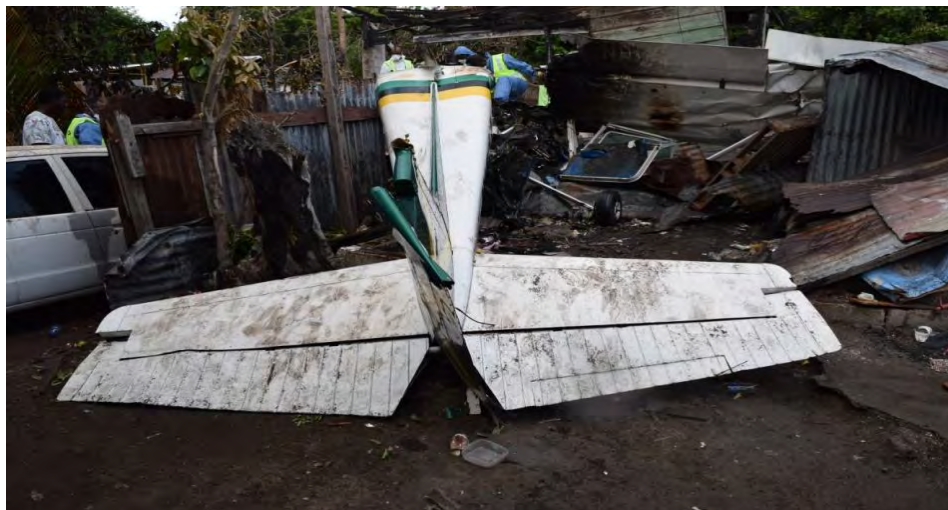
Figure 9 Empennage with Vertical and Horizontal Stabilizers

The vertical stabilizer along with the rudder and both horizontal stabilizers along with both elevators were securely attached to the empennage of the aircraft as seen in Figure 9. The elevator trim tab was securely attached to the R/H elevator, the flight control cables along with their pulleys were observed, flight control continuity was established from the fuselage through to the tail. The empennage was detached from the aircraft and the flight control cables were cut to facilitate removal of the aircraft from the crash site to Tinson Pen Aerodrome.

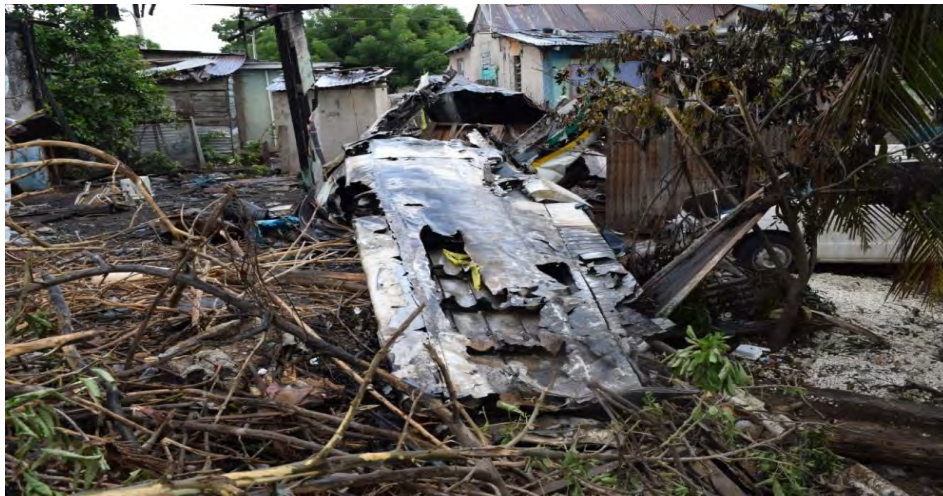
Figure 10 Left Hand Wing

The L/H wing had extensive fire damage to the upper and lower wing skin surfaces from the wing root to the wing tip, including the aileron, the primary and secondary flight control surfaces were deformed, but were attached to the wing surface as seen in Figure 10. The flight control cables, pulleys and bell cranks were observed and flight control continuity was established throughout the wing. The wing was detached from the aircraft and the flight control cables were cut to facilitate movement of the aircraft to the Tinson Pen Aerodrome.

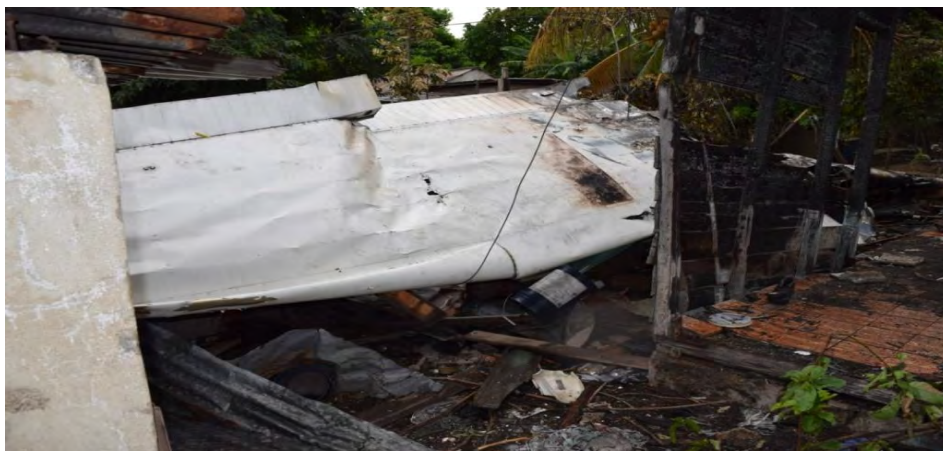
Figure 11 Right Hand Wing

The R/H wing had fire damage to the upper and lower skin surfaces from the wing root to Wing Station 71.37; there was impact damage to the leading edge of the wing as seen in Figure 11. There were cuts in the lower skin surface at Wing Station 172. There was a diagonal wrinkle in the upper wing surface beginning just forward of the inboard edge of the aileron and extending to the leading edge at Wing Station 172. The flight control cables, pulleys and bell cranks were observed, flight control continuity was established throughout the wing. The wing was detached from the aircraft and the flight control cables were cut to facilitate movement of the aircraft from the accident site.

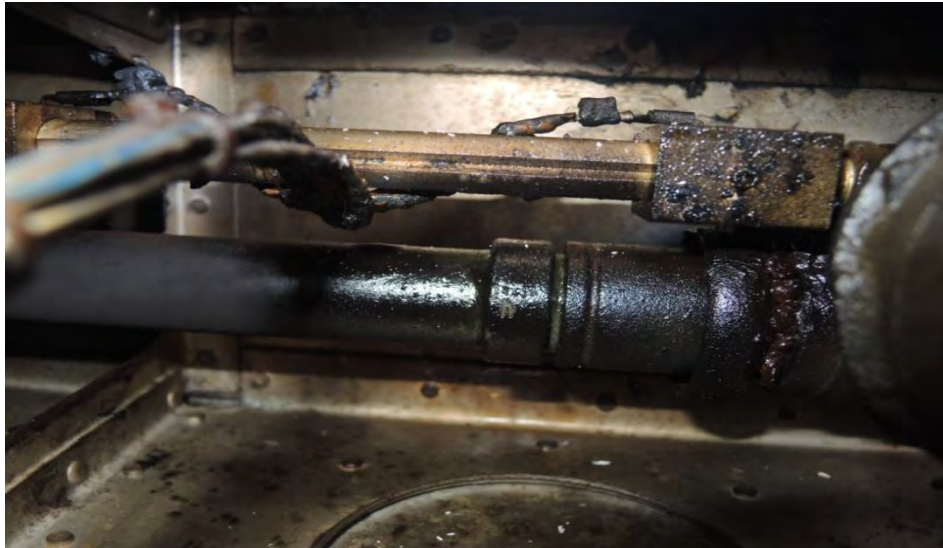
Figure 12 Wing Flap Jackscrew

The wing flap jackscrew is located in the right hand wing. The flap jackscrew extension was measured at 0.0 inches, corresponding to a zero degree flap extension as seen in Figure 12.

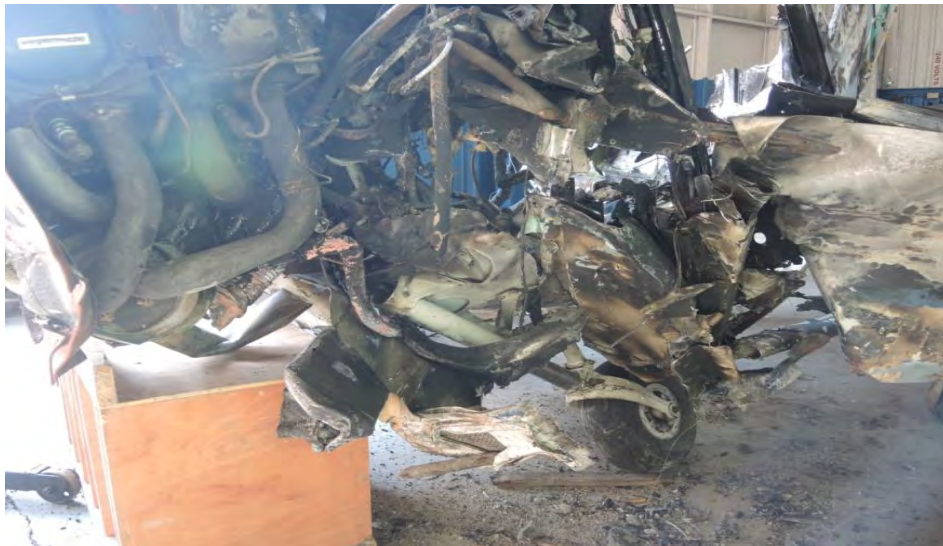
Figure 13 Nose Landing Gear

The Nose Landing Gear (NLG) was attached to the engine firewall which was folded under the aircraft as seen in Figure 13. The shimmy dampener was still intact, and the steering rod actuator was sheared at the NLG attachment. The torque links were attached, the strut was inflated as well as the tyre.

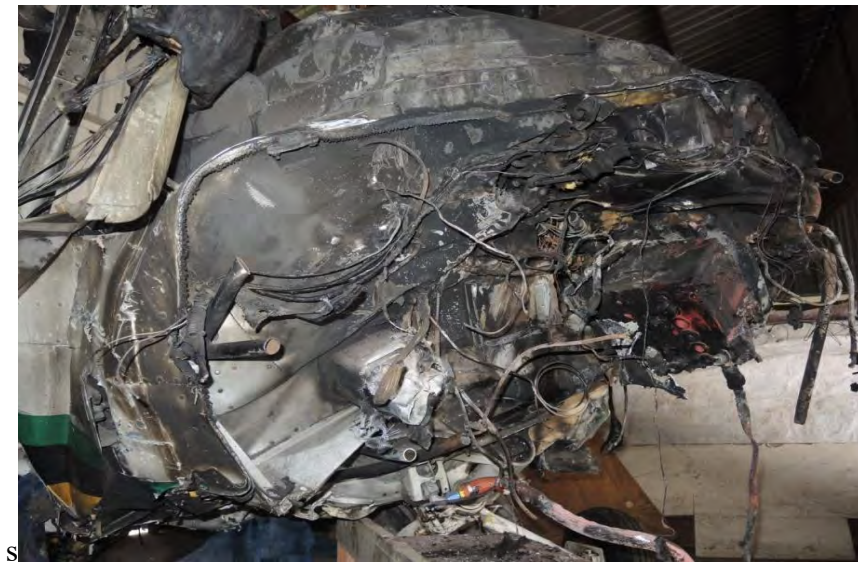
Figure 14 Engine Firewall

The engine firewall was deformed and displaced rearward; it was extensively damaged by fire as seen in Figure 14. The battery box was deformed and the battery was partially burnt.

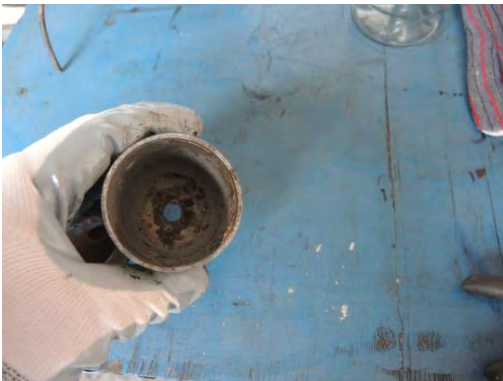
Figure 15 Fuel Bowl

The fuel strainer assembly which was secured to the lower R/H side of the engine firewall was disassembled and inspected; areas of pitting were observed on the inside of the fuel bowl as seen in Figure 15. The filter was dirty as seen in Figure 16.

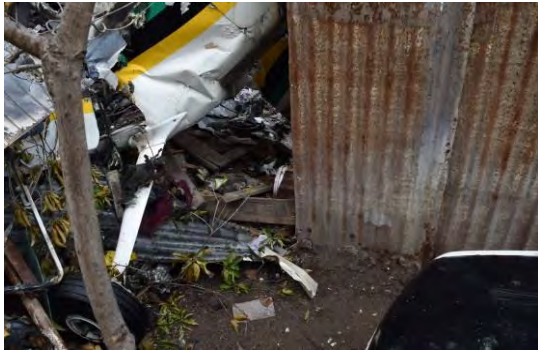
Figure 17 Left Hand Main Landing Gear

The L/H and R/H main landing gear (MLG) were securely attached to the fuselage, the wheels and brakes were attached to the units and both tyres were inflated as seen in Figures 17 and 18.

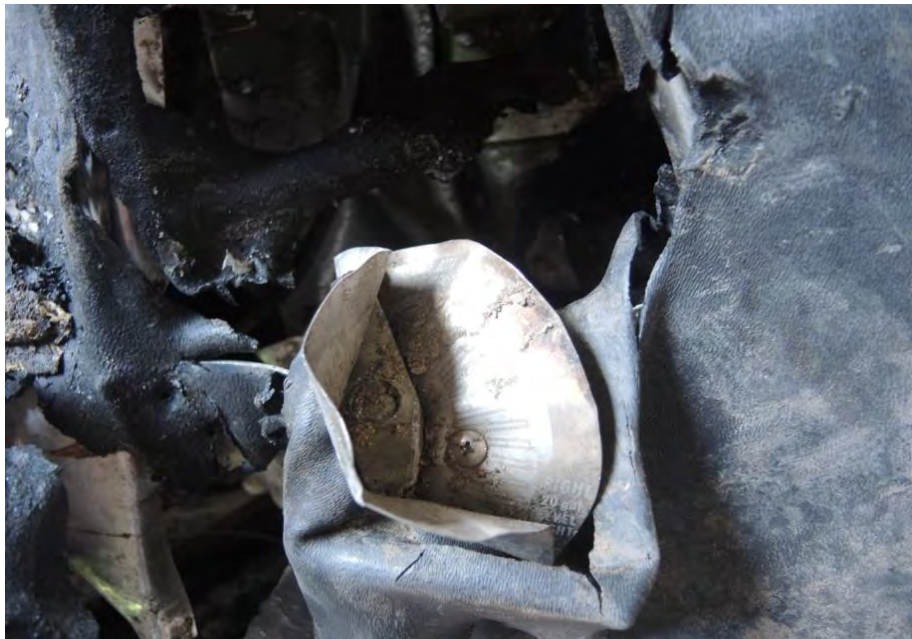
Figure 19 Fuel Selector

The fuel selector handle was observed in the “both” position as seen in Figure 19.

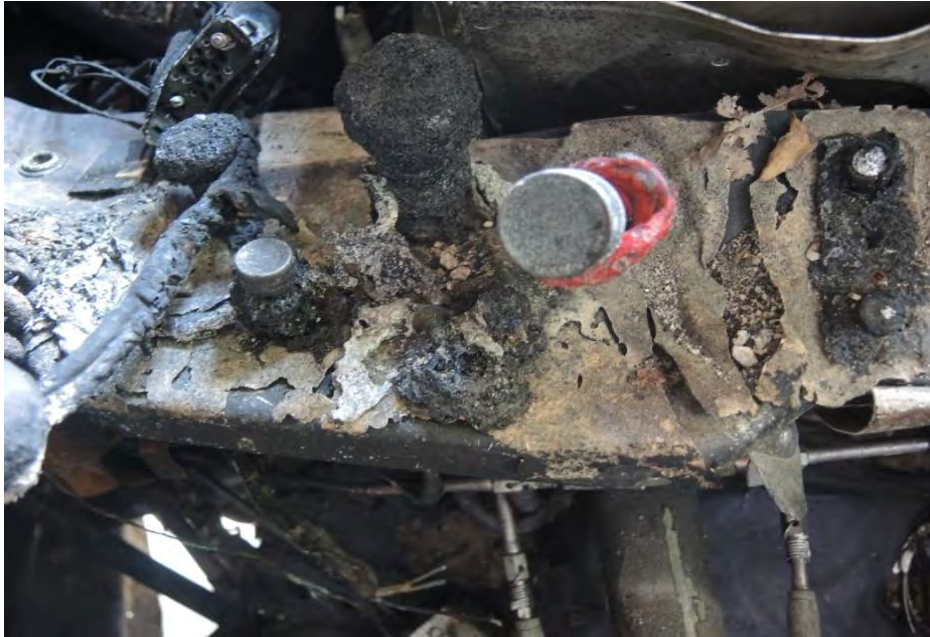
Figure 20 Engine Controls

The engine throttle and mixture controls were fire damaged and appeared to be in the full forward position as seen in Figure 20.

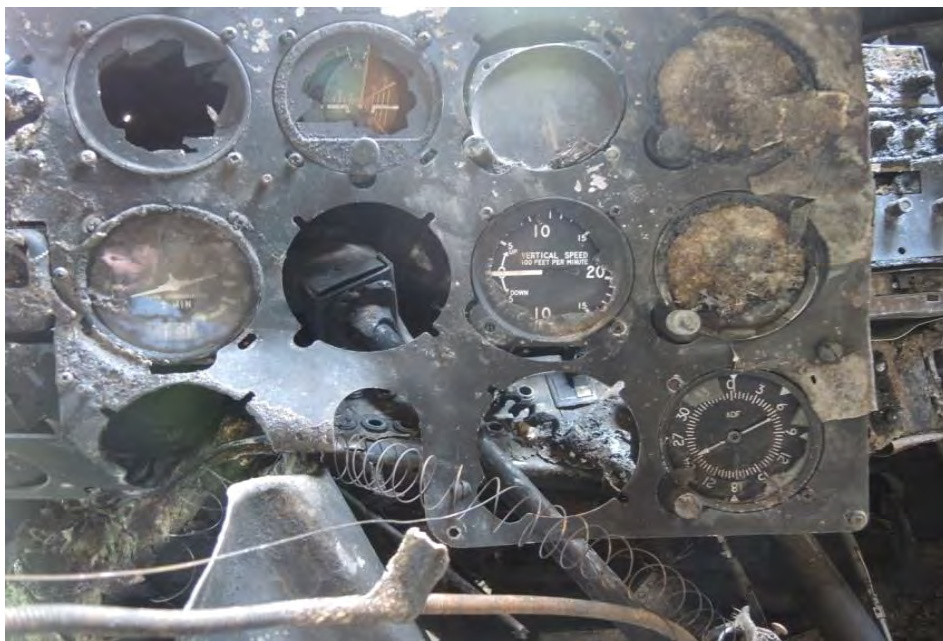
Figure 21 Engine, Navigation, Instruments and Radios

The engine instruments, navigational instruments and the radios were fire damaged as seen in Figure 21.

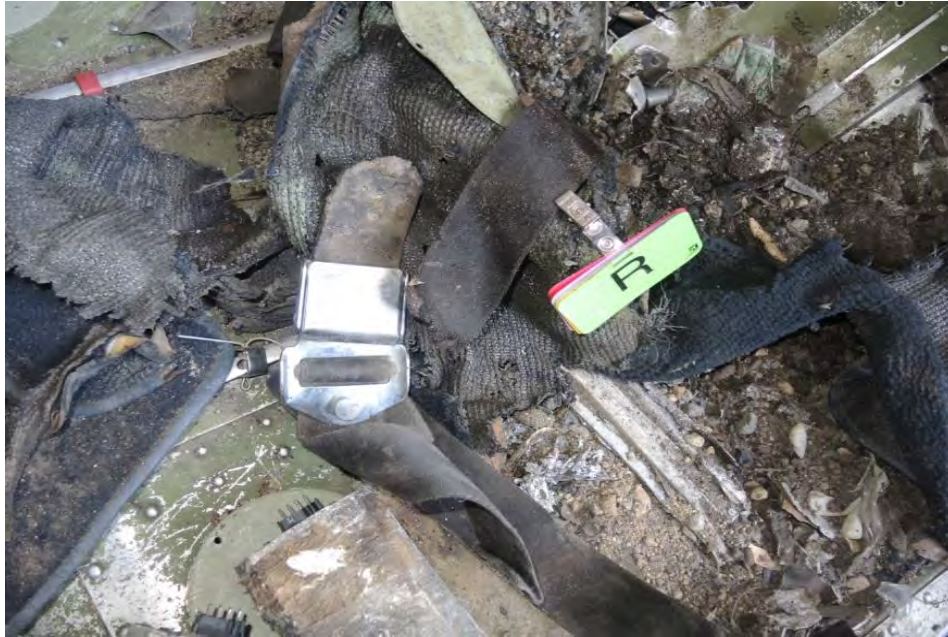
Figure 22 The Right Hand Seat Safety Restraint Belt

The R/H seat safety restraint buckle was observed in the latched configuration and the webbing was cut and damaged by fire as seen in Figure 22.

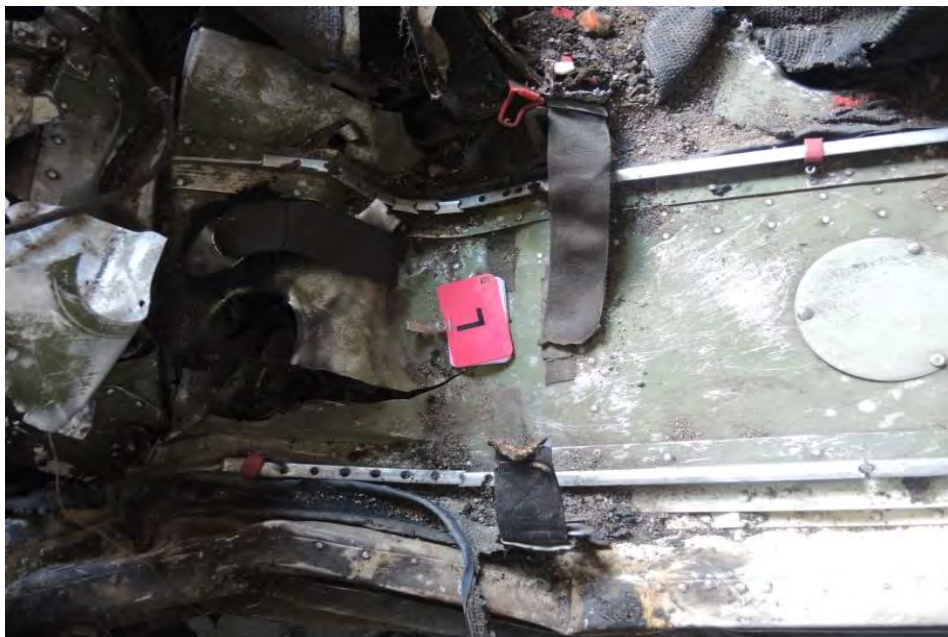
Figure 23 The Left Hand Seat Safety Restraint Belt

The L/H seat safety restraint webbing was observed to be cut and damaged by fire as seen in Figure 23; the buckle was not found.

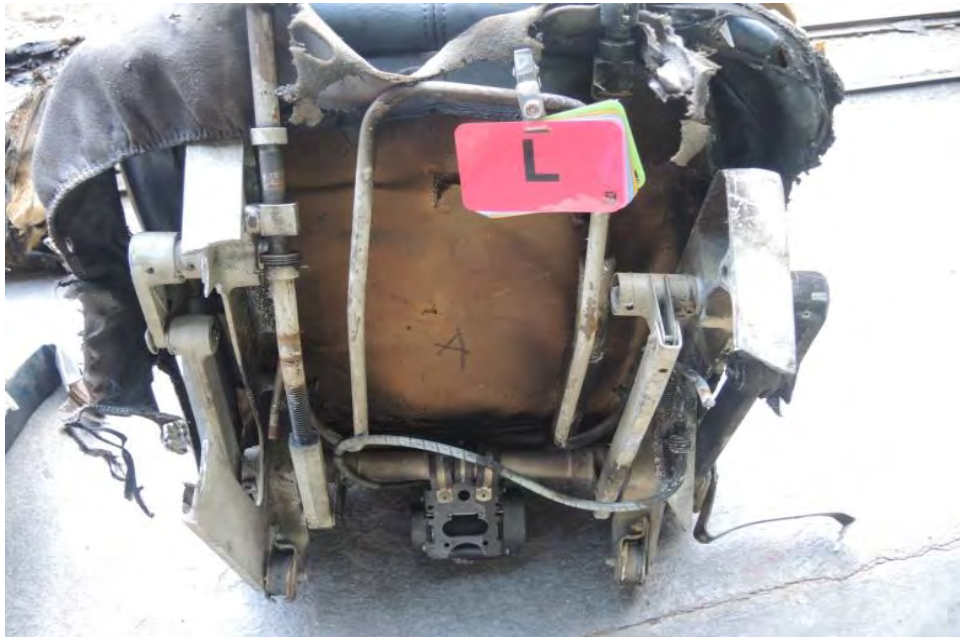
Figure 24 Left Front Seat

The L/H seat back was intact; the seat was fitted with a secondary stop as seen in Figure 24.

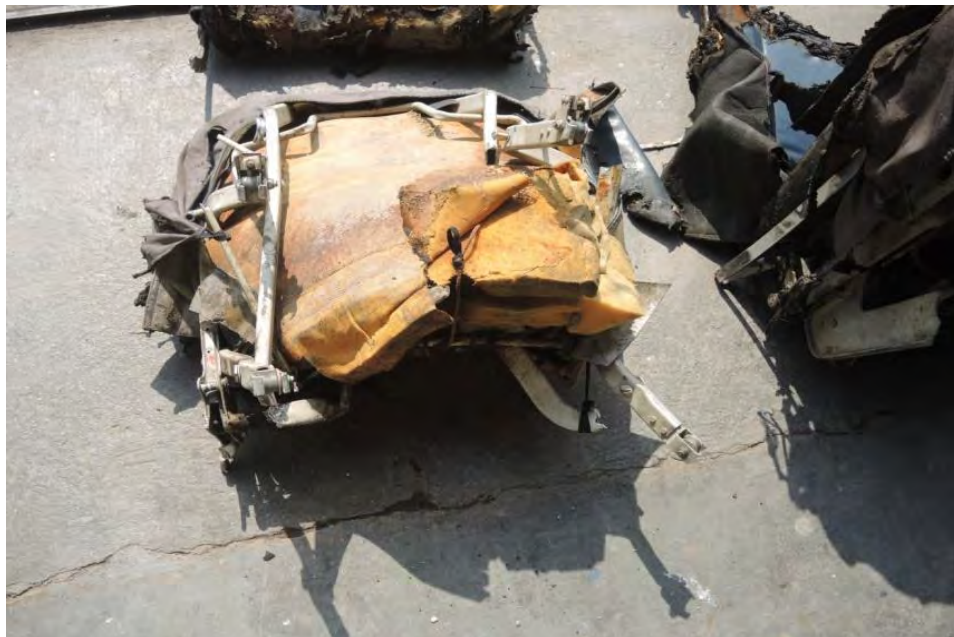
Figure 25 Right Front Seat

The R/H seat back was broken and there was impact damage to the seat frame as seen in Figure 25. No secondary stop was observed on this seat.

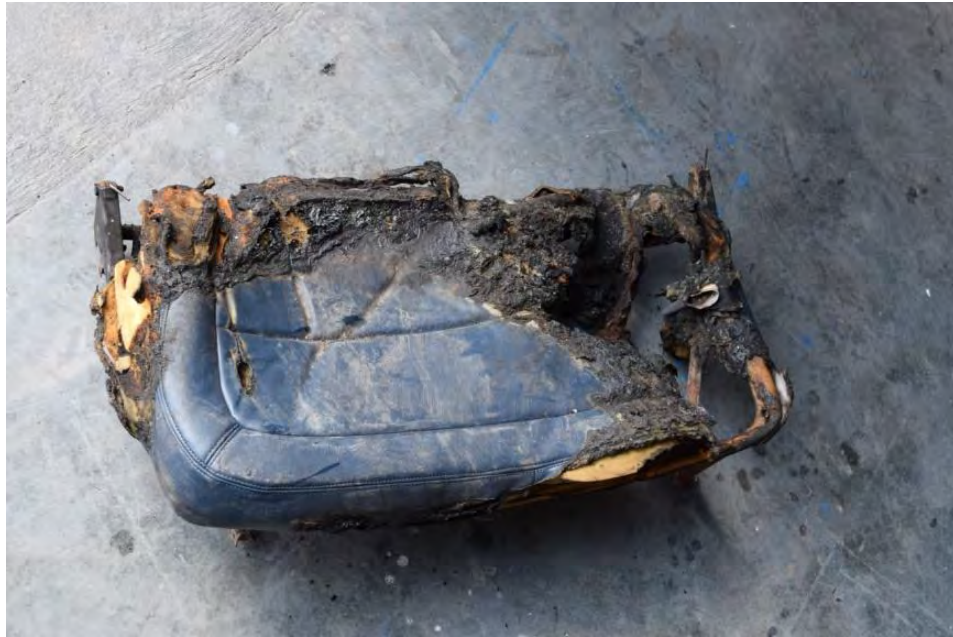
Figure 26 Rear Passenger Seat

The L/H side of the rear passenger seat had extensive burns as seen in Figure 26.

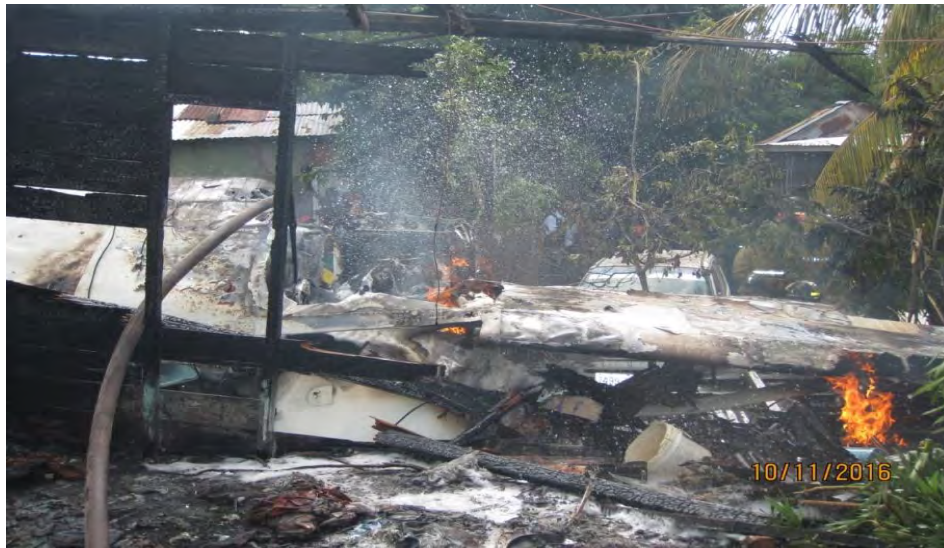
Figure 27 Fire Damage to the Aircraft Fuselage

Ground witnesses stated that the fire occurred after the aircraft made impact with the ground, the left hand wing upper and lower surfaces were extensively damaged by fire, the right hand wing had fire damage on both the upper surface and the lower surface from the wing root to wing station 71.37. There was fire damage along the fuselage from the lower engine cowl to fuselage station 108.00 as seen in Figure 27.

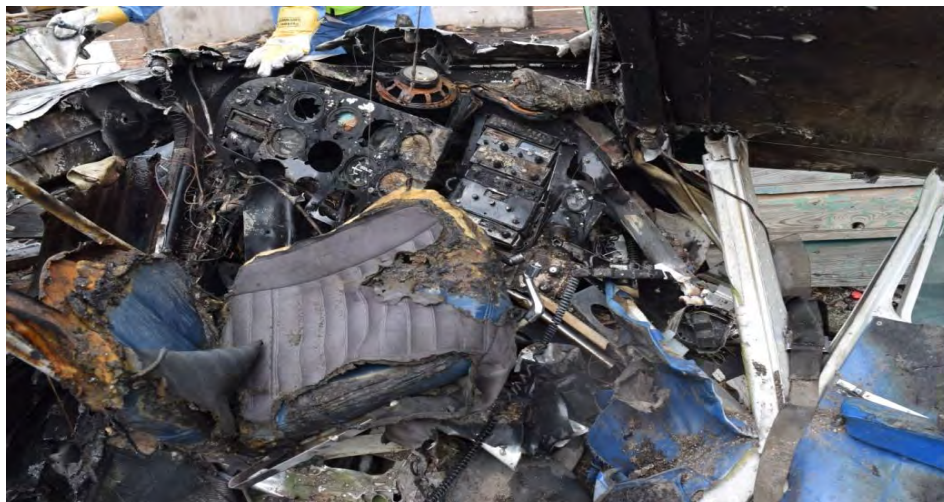
Figure 28 Aircraft Cockpit

The cockpit of the aircraft was extensively damaged by fire as seen in Figure 28.

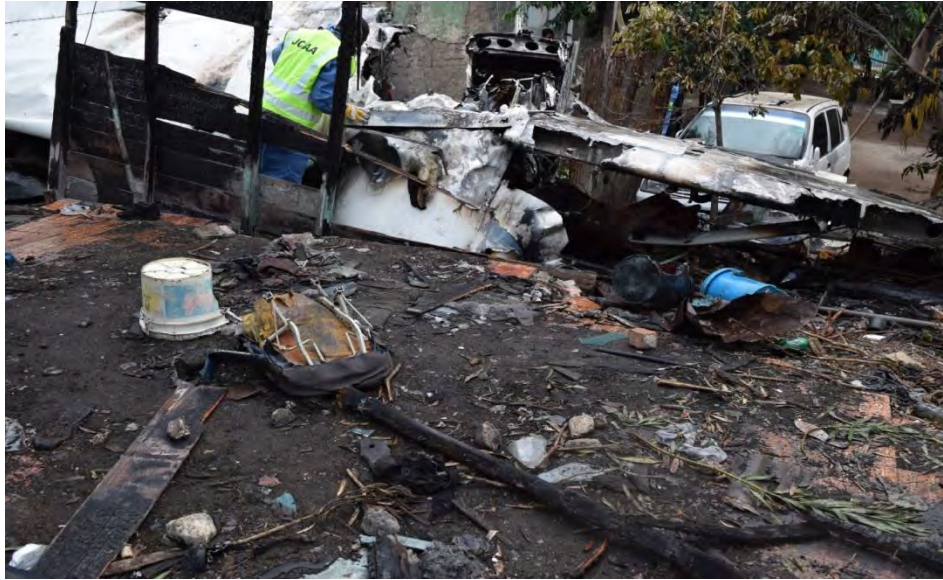
Figure 29 Damaged Perimeter Fence and Car on Adjacent Property

There was also fire damage to the zinc perimeter fence on which the aircraft made impact with the ground and to the car in the adjacent property as seen in Figure 29.

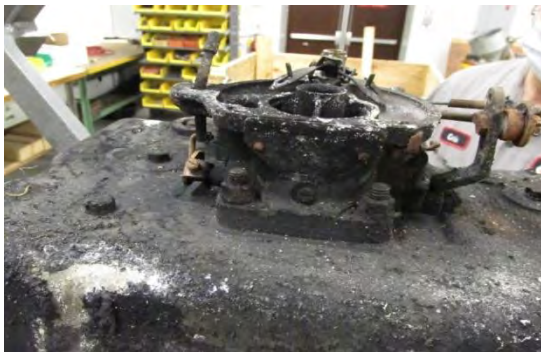
Figure 30 Carburetor Venturi

The carburetor showed fire damage signatures along with varying amounts of impact damage. The venturi remained attached to the oil sump, but the floats were missing as shown in Figure 30. The engine control positions were undetermined due to impact damage and component damage. The carburetor bowl was separated from the aircraft as seen in Figure 31. The air box was destroyed by impact and could not be further examined.

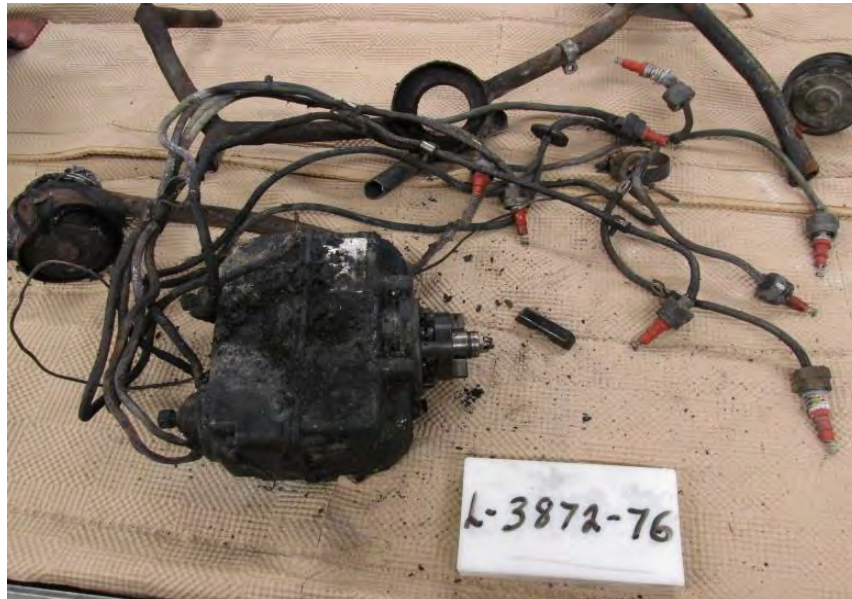
Figure 32 Engine Magneto

The magneto was secure in its mount at time of examination, the magneto hold down nuts were tight at the time of removal. Heavy fire damage as seen in Figure 32 precluded timing of the magneto due to internal damage and fire consumed parts. The magneto could not rotate at the time of examination.

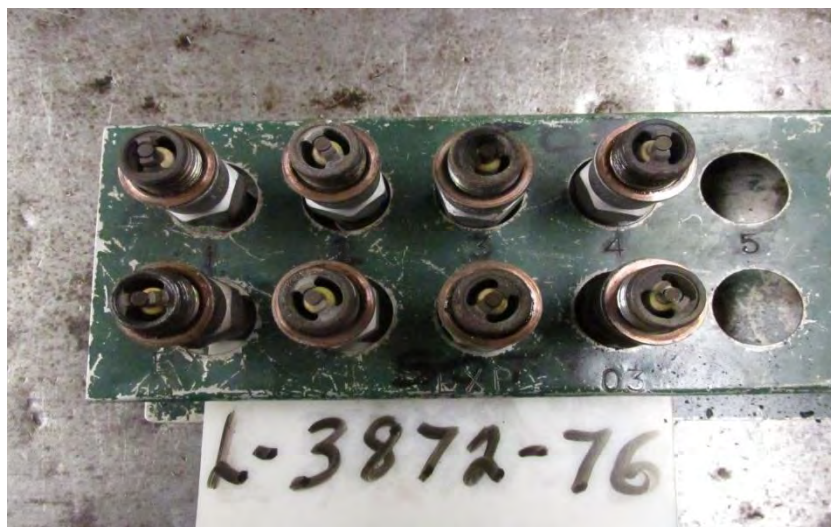
Figure 33 Engine Spark Plugs

The spark plugs were secure at each position. The spark plugs were removed, examined and photographed as seen in Figure 33. The spark plug electrodes remained mechanically undamaged, and according to the Champion Spark Plugs “Check-A-Plug” chart AV-27, the spark plug electrodes displayed coloration consistent with normal operation. The static oil soaking of the spark plugs (as noted) could be attributed to the engine positioning at mishap site and post recovery. Light corrosion was observed, this was likely due to post impact fire and heat.

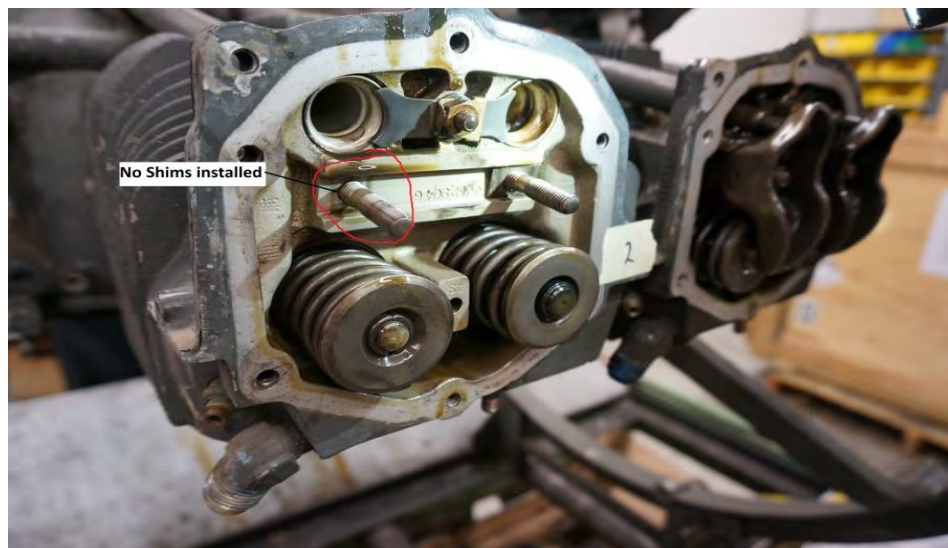
Figure 34 No. 2 Engine Cylinder

The No. 2 cylinder intake rocker arm did not have any shims under the rocker arm as seen in Figure 34.

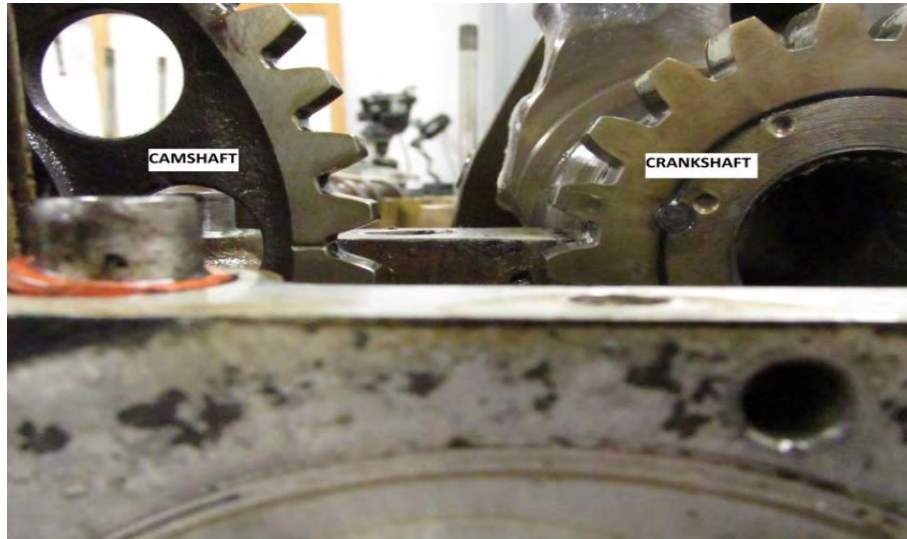
Figure 35 Engine Crankshaft and Camshaft

The engine internal timing was found to be out of time by one tooth between the crankshaft and camshaft as seen in Figure 35. This caused the timing mark on the starter ring gear support assembly to be about 7 teeth out of alignment with alignment dot (hole) on the starter bendix gear housing as seen in Figure 36; this translates to approximately 16.8 degrees out of time.

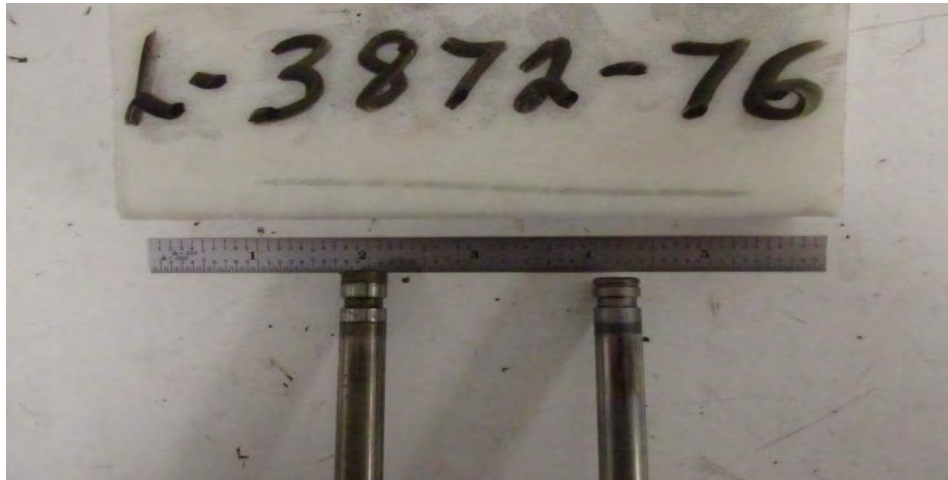
Figure 37 No. 2 Intake Valve as compared to another Intake Valve

The intake valve installed in the No. 2 engine cylinder was incorrect as indicated by its short length when compared to the other intake valves as seen in Figure 37; this suspect part has a Lycoming part number, but is not correct for this engine model or type certificate.

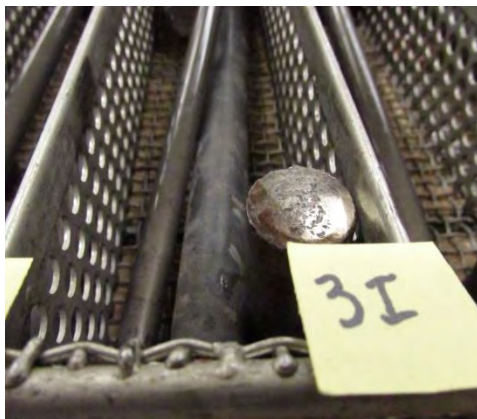
Figure 38 No. 3 Intake Tappet

The No. 3 cylinder intake and exhaust tappets were heavily pitted on the face and showed damage to the edges as seen in Figures 38 and 39.

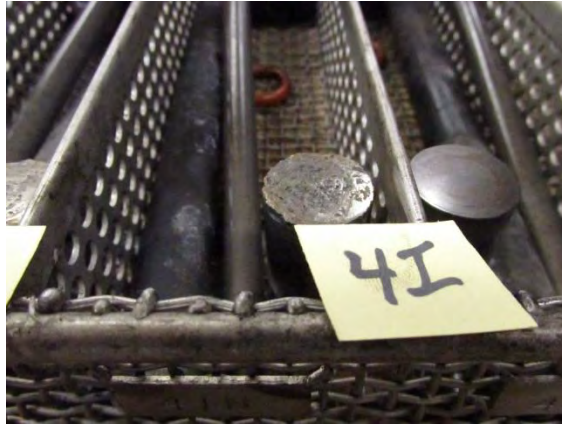
Figure 40 No.4 Intake Tappet

The No. 4 cylinder intake tappet was heavily pitted on the face with jagged edges along the circumference of the tappet as seen in Figure 40.

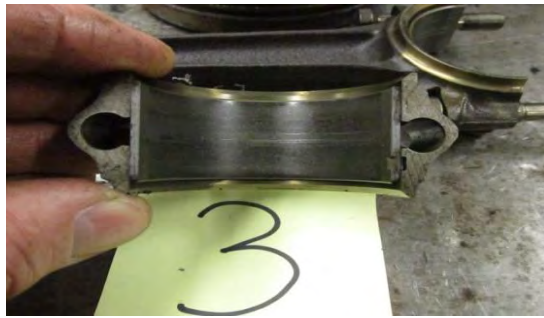
Figure 41 Connecting Rod Bushing

The connecting rod bushings showed some signs scratching as seen in Figure 41. There was also scoring of the piston skirts.

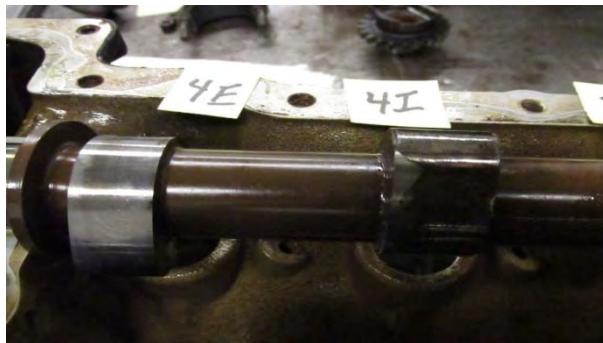
Figure 42 Engine Camshaft

The camshaft shows damage to all lobes of varying degrees, both to the face and edges of the lobes. The No. 4 intake lobe showed the greatest amount of damage. Spalling and worn edges were observed along with corrosion as seen in Figure 42.

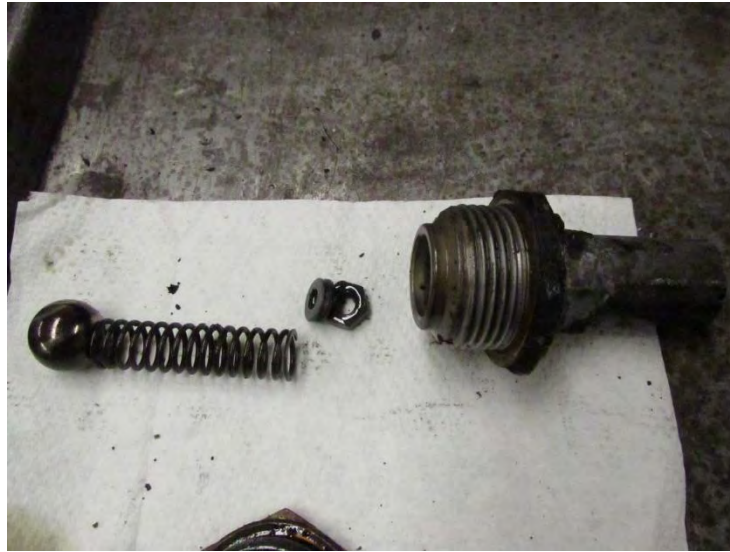
Figure 43 Oil Pressure Relief Valve

The oil pressure relief valve had a hexagonal nut and two washers installed in lieu of the specified washers as stated in the Illustrated Parts Catalog (IPC) for spring tension adjustment as seen in Figure 43.
