FINAL REPORT

AIRCRAFT ACCIDENT INVESTIGATION REPORT

Report / File. No:	- AAIU: 3/1/22/3
Name of Operator	- FLY JAMAICA AIRWAYS
Aircraft Manufacturer	- BOEING AIRCRAFT COMPANY
Aircraft Model/Type	- BOEING 757-200
Nationality & Registration Marks	- N524AT
Place of Accident/Region	- CHEDDI JAGAN INTERNATIONAL AIRPORT (ICAO REFERENCE SYCJ), DISTRICT REGION 4, TIMEHRI, EAST BANK DEMERARA, GUYANA, SOUTH AMERICA
Date of Accident	- 9TH NOVEMBER 2018
Time of Accident	- 06:53 UTC (02:53 GST)

REPORT / FILE #: AAIU 3/1/22/3

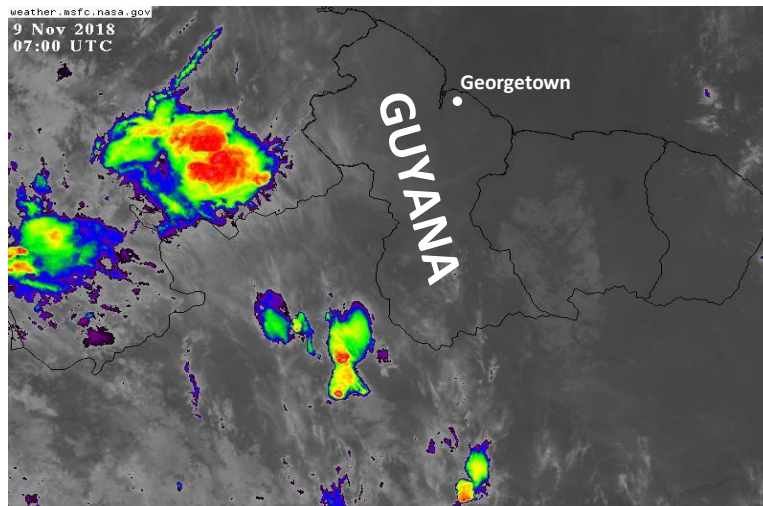
Figure 1: Infrared satellite image valid at 07:00 UTC 9th November 2018

This infrared satellite image valid 07:00 UTC 9th November 2018 indicated that there were no convective clouds within the Georgetown FIR at the time of the emergency landing, thus there was no need for the issuance of a convective SIGMET message in the Georgetown FIR.

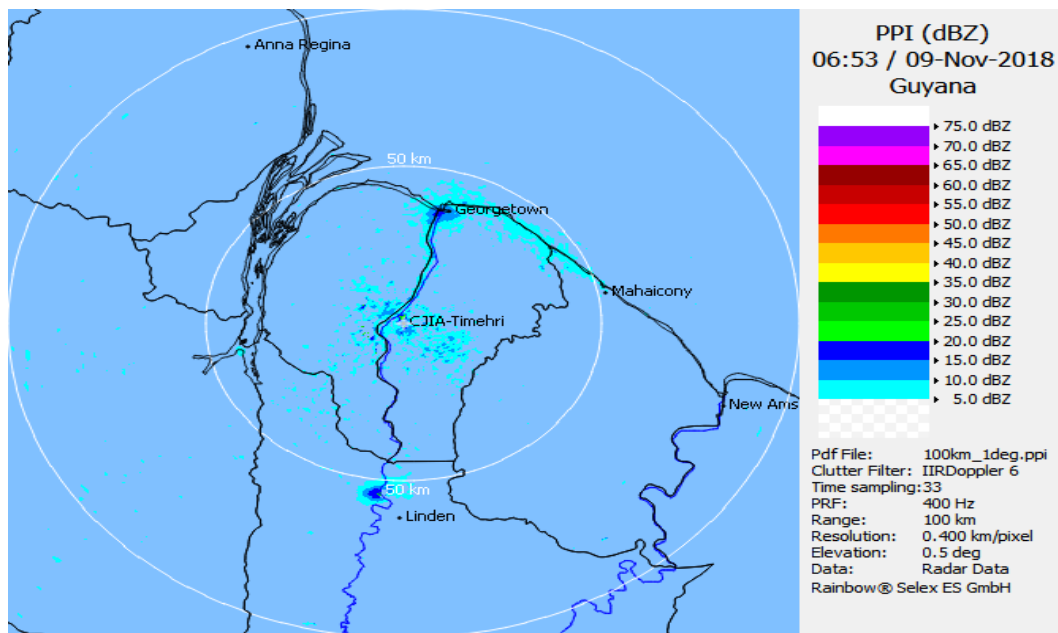
Figure 2: Radar generated Plan Position Indicator (PPI) Scan valid 06:53 UTC 9th November 2018.

The PPI image valid 06:53 UTC 9th November 2018 shows no meteorological target within a 100 Km radius of the CJIA.

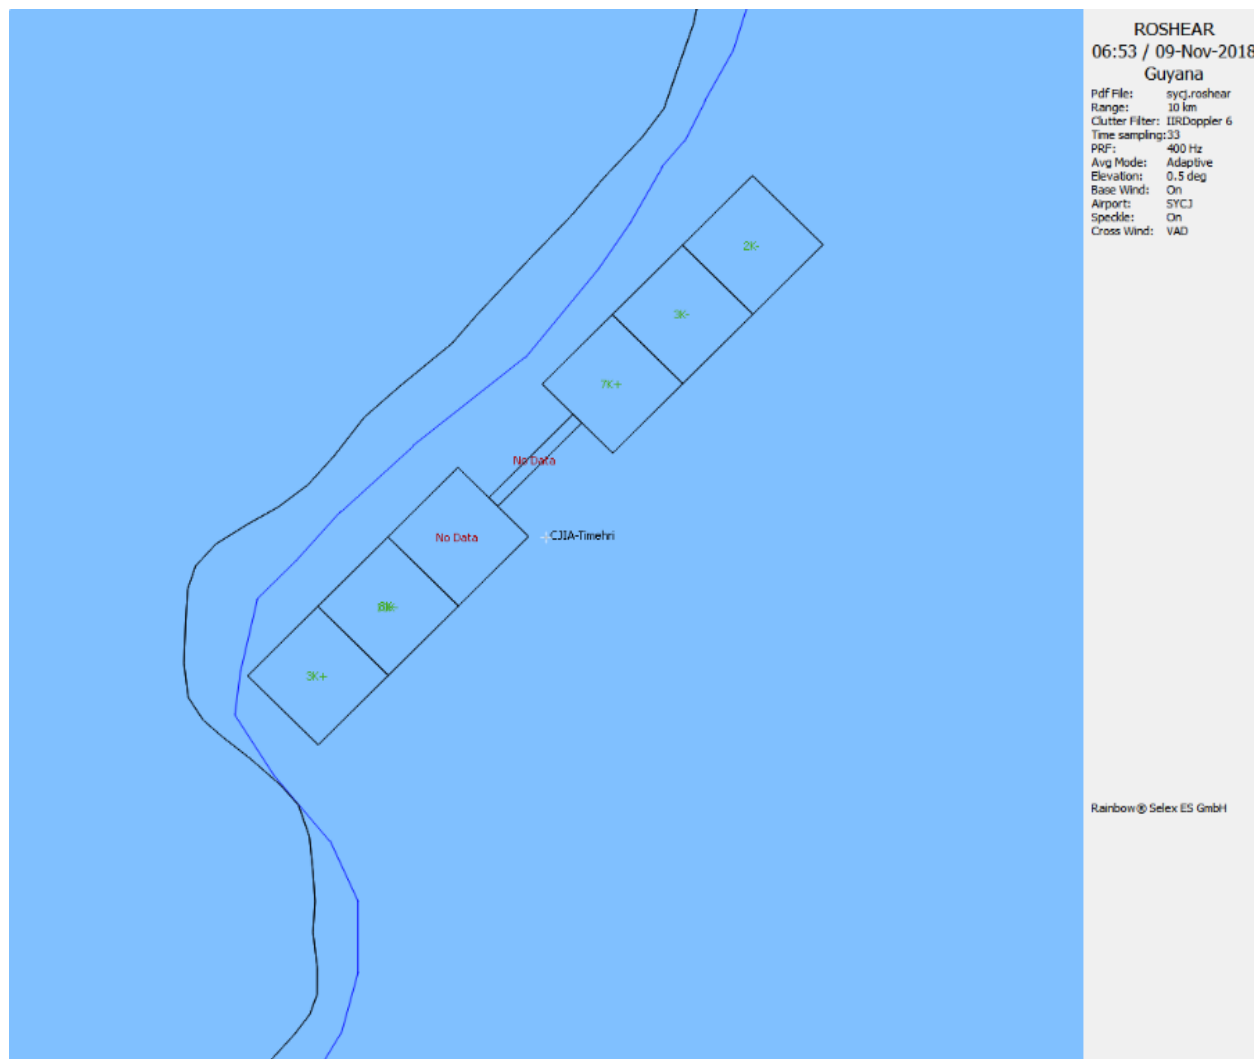
Figure 3: Radar generated Runway Oriented Shear (ROSHEAR) product valid 06:53 UTC 9th November 2018.

The ROSHEAR product showed Loss and Gain less than 10kt along the 3^o path towards and RWY06 and RWY24. This data shows that there was no need for the issuance of a wind shear warning at the time of this scan. Similar scans before the emergency landing also show that the wind shear along the glide path of 3^o, was not significant and hence did not warrant the issuance of a wind shear warning.

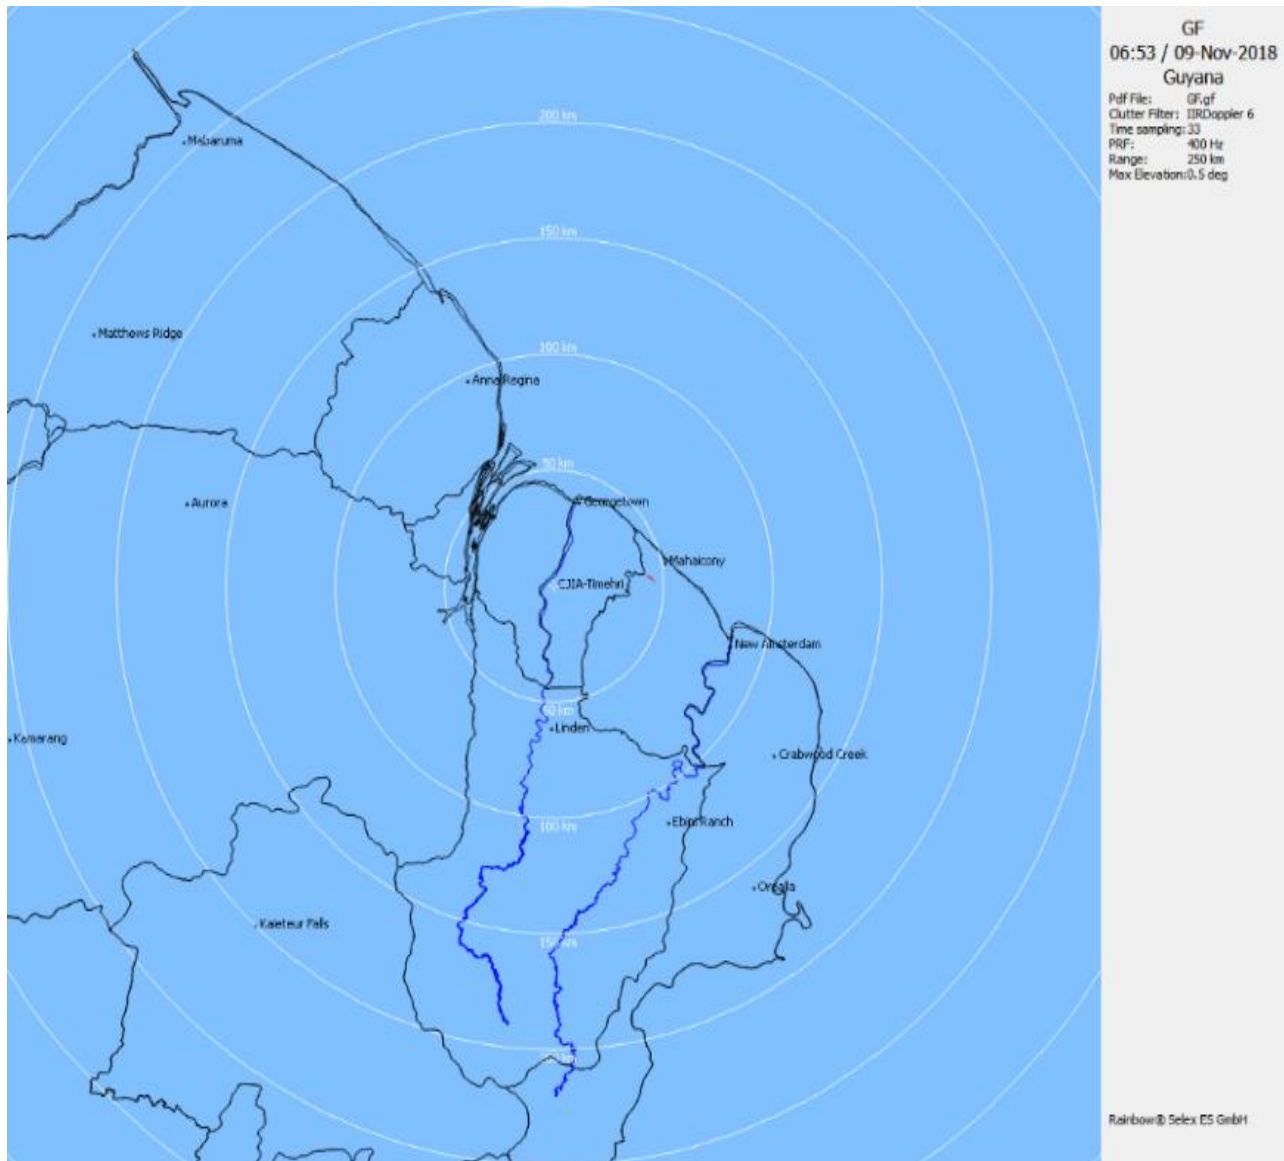
Figure 4: Radar generated Gust Front (GF) product valid 06:53 UTC 9th November 2018.

The Gust Front product showed no gust fronts at or near the aerodrome. The nearest and only gust front in the image is located 080° to the aerodrome and between 40Km and 50Km of same. In addition to this product, the METARs, PPI scan and Satellite image showed that there was no need for an aerodrome warning at the time of the emergency landing of the aircraft.

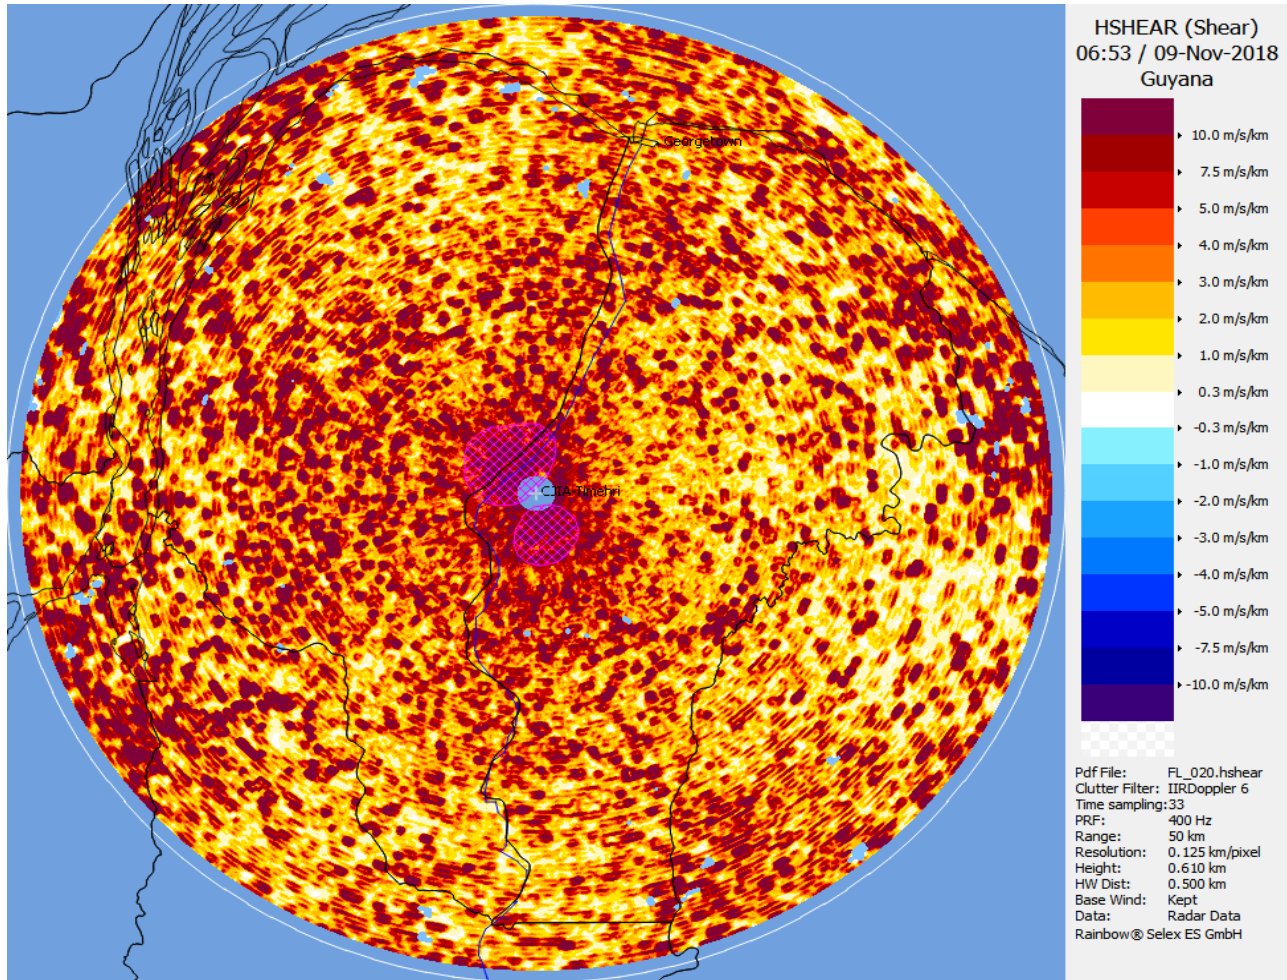
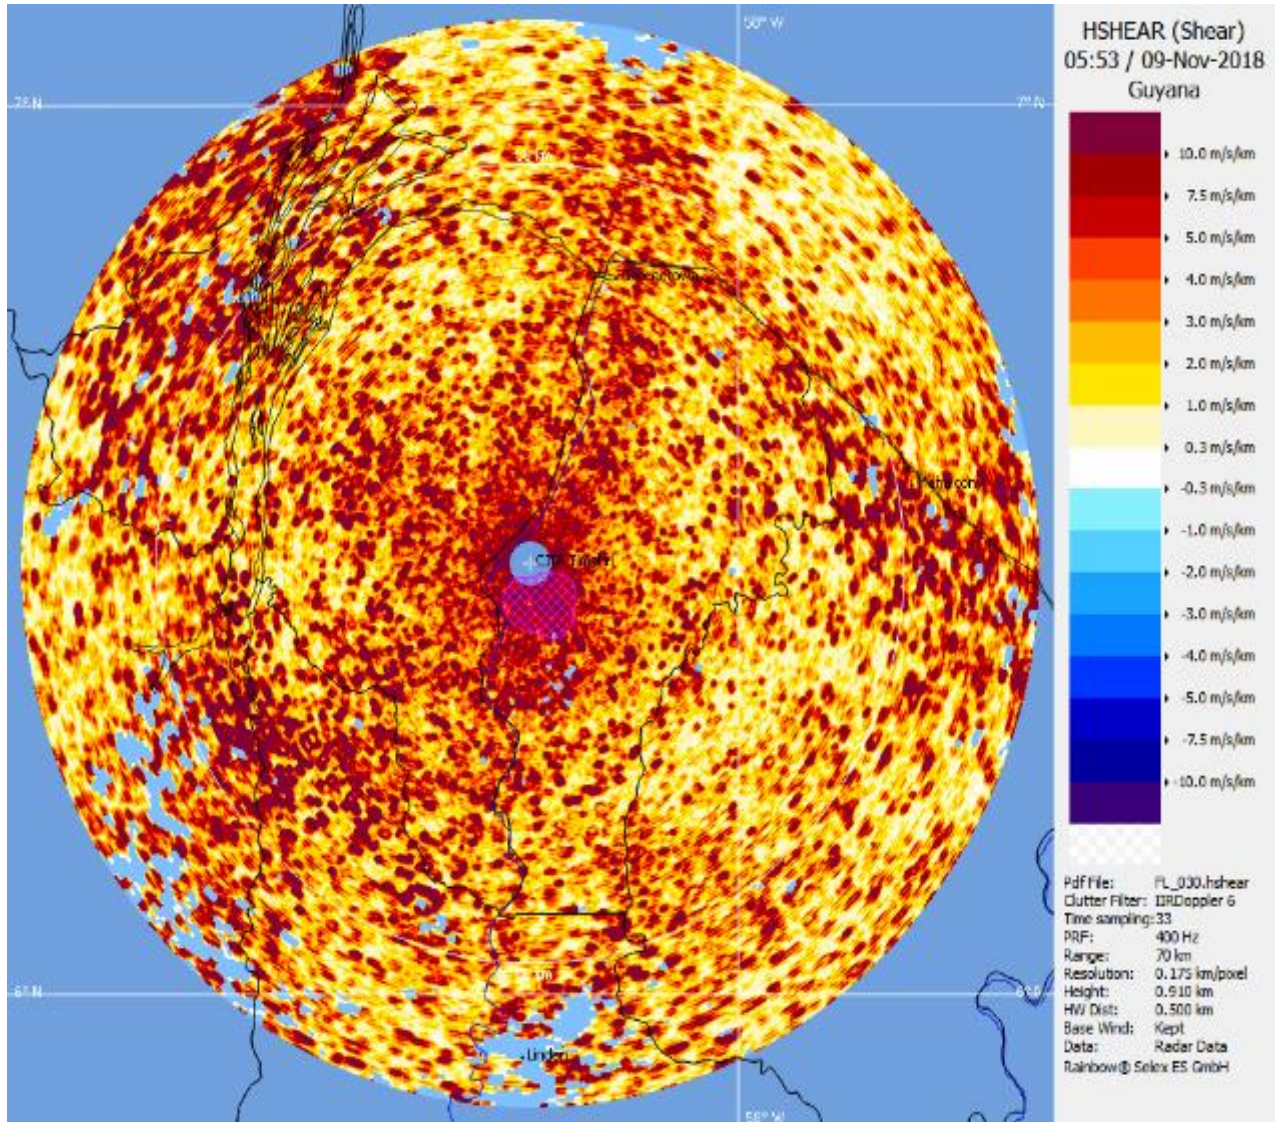
Figure 5: Radar generated Horizontal Shear (H-Shear) products valid 06:53 UTC 9th November 2018. A) FL020 and B) FL030.

The H-Shear product can be used to detect areas of shear at the different flight levels. This information is then used to infer areas with significant turbulence. According to the images in Figure 5, at the FL020 and FL030 horizontal wind shear was not significant within a 100km radius of the CJIA. Due to the lack of significant wind shear no AIRMETs were issued.

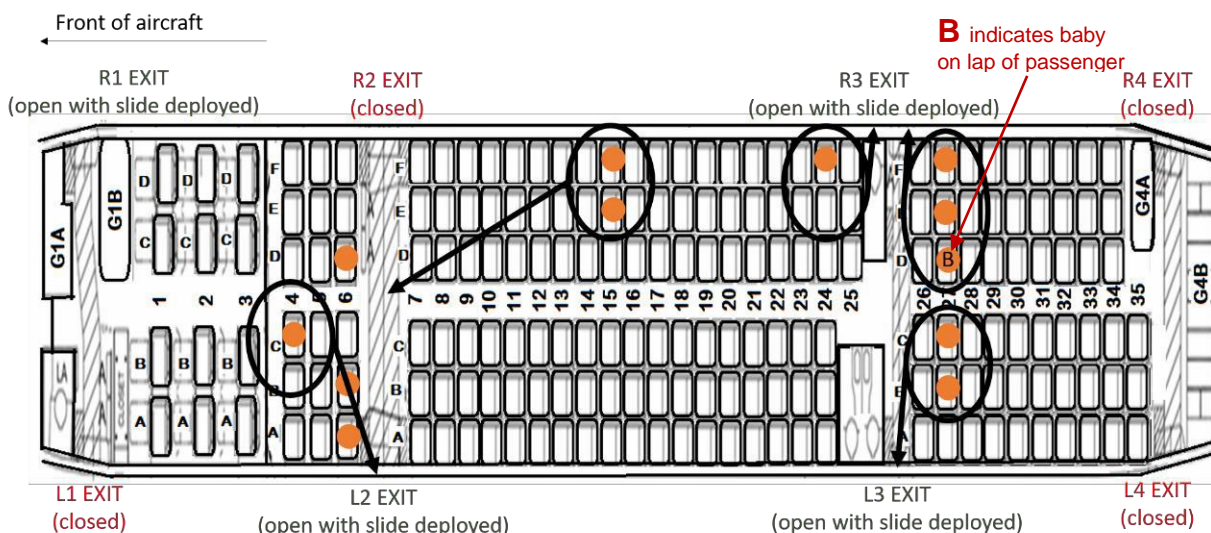
**FIGURE 5: SEAT INFORMATION FOR 14 PASSENGERS.
B INDICATES A BABY ON THE LAP OF A PARENT**

Figure 5 below, illustrates the aircraft layout and exit locations, including the open exits, as observed in post-occurrence images. Of the passenger information available, exact seat allocation was obtained for fourteen of the seventeen passengers. The seat allocation and evacuation routes are also indicated in Figure 5.

Although there were six Cabin Crew on-board, passengers who provided information to the TSB only referenced one Crew Member at the L2 exit and one Crew Member at the L3 exit. Some passengers reported having opened the exits themselves and one mentioned there was no Crew Member attending their evacuation slide.
