**AVIATION OCCURRENCE REPORT**  
**ROCKY POINT- CLARENDON**  
**SABRELINER 60 - REGISTRATION XB-JMR**  
**JANUARY 23, 2021**

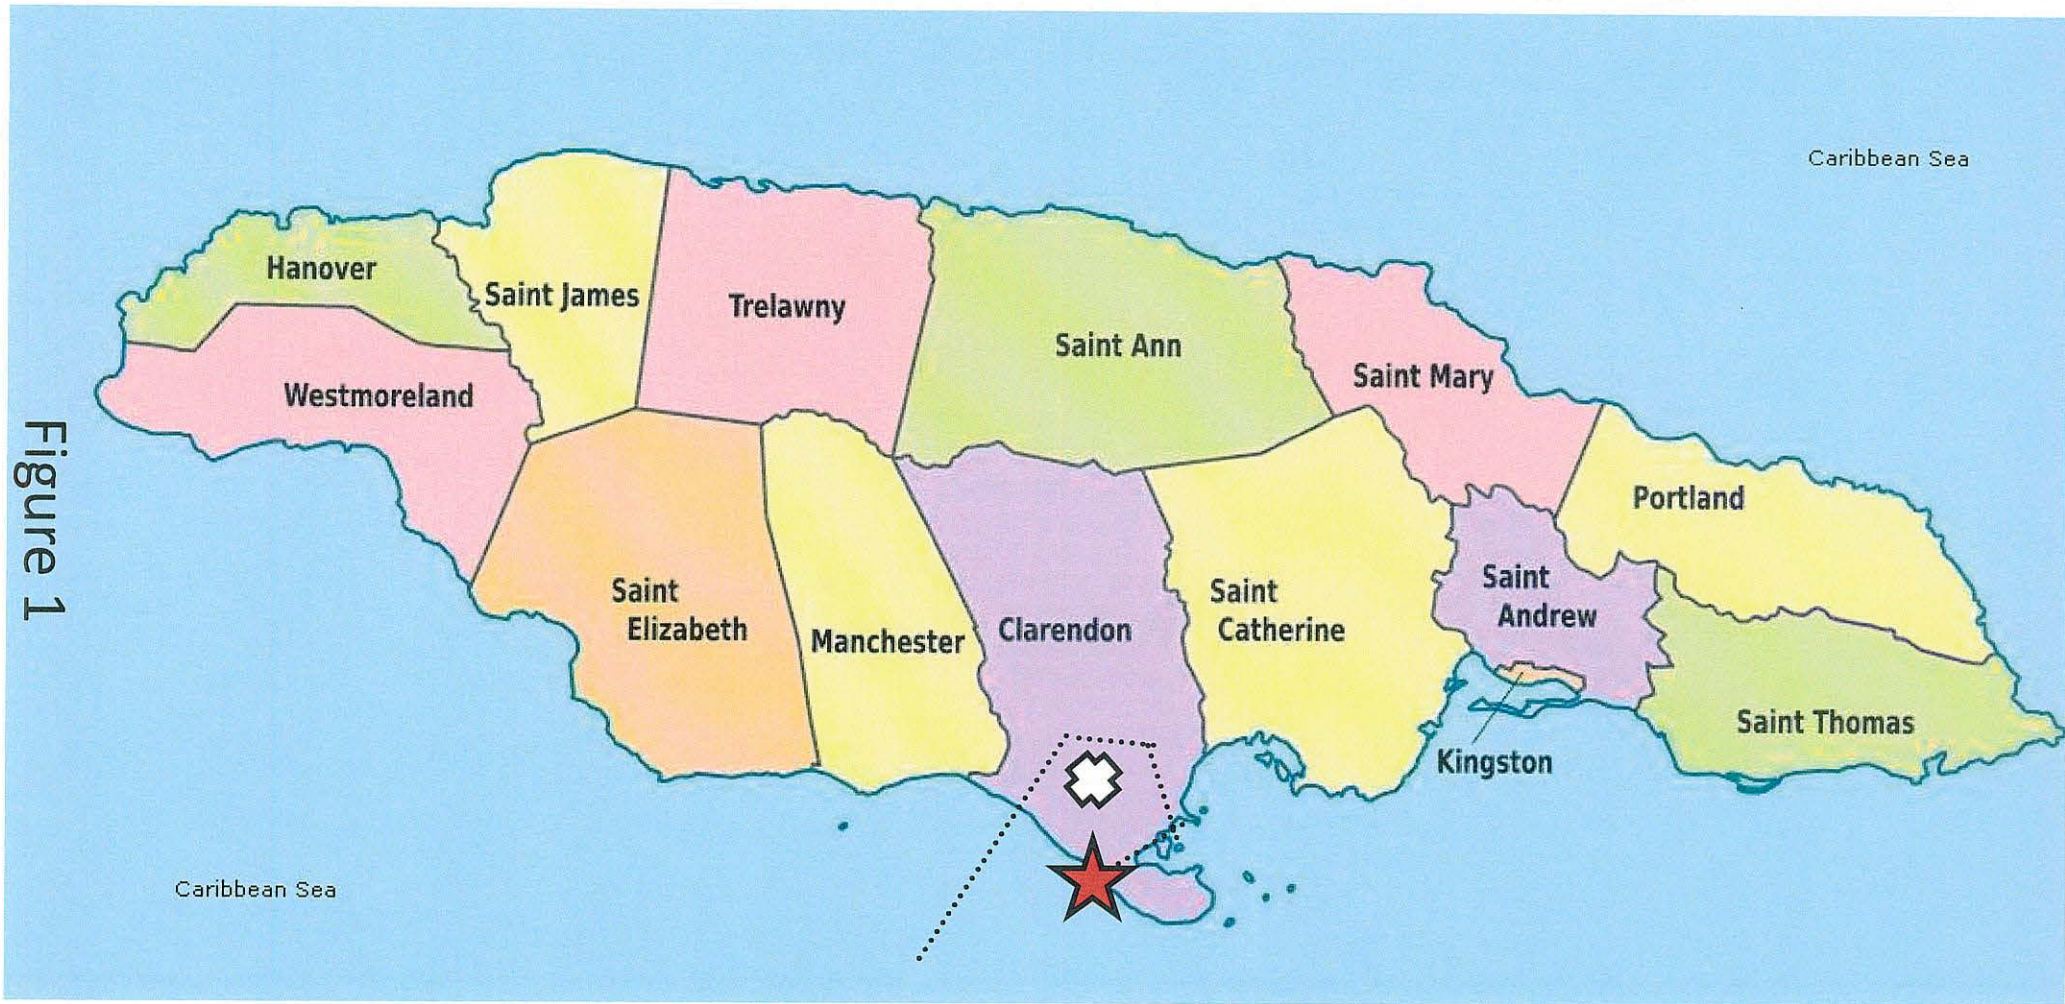
Figure 1

1.4 The Aircraft impacted the shoreline south-east of the White Sand Beach area of Rocky Point in Clarendon (17°45'55.69"N 77°15'42.94"W) at approximately 6:39pm local. (*Radar Tapes – January 23, 2021*). (Fig. 1- Rocky Pont).

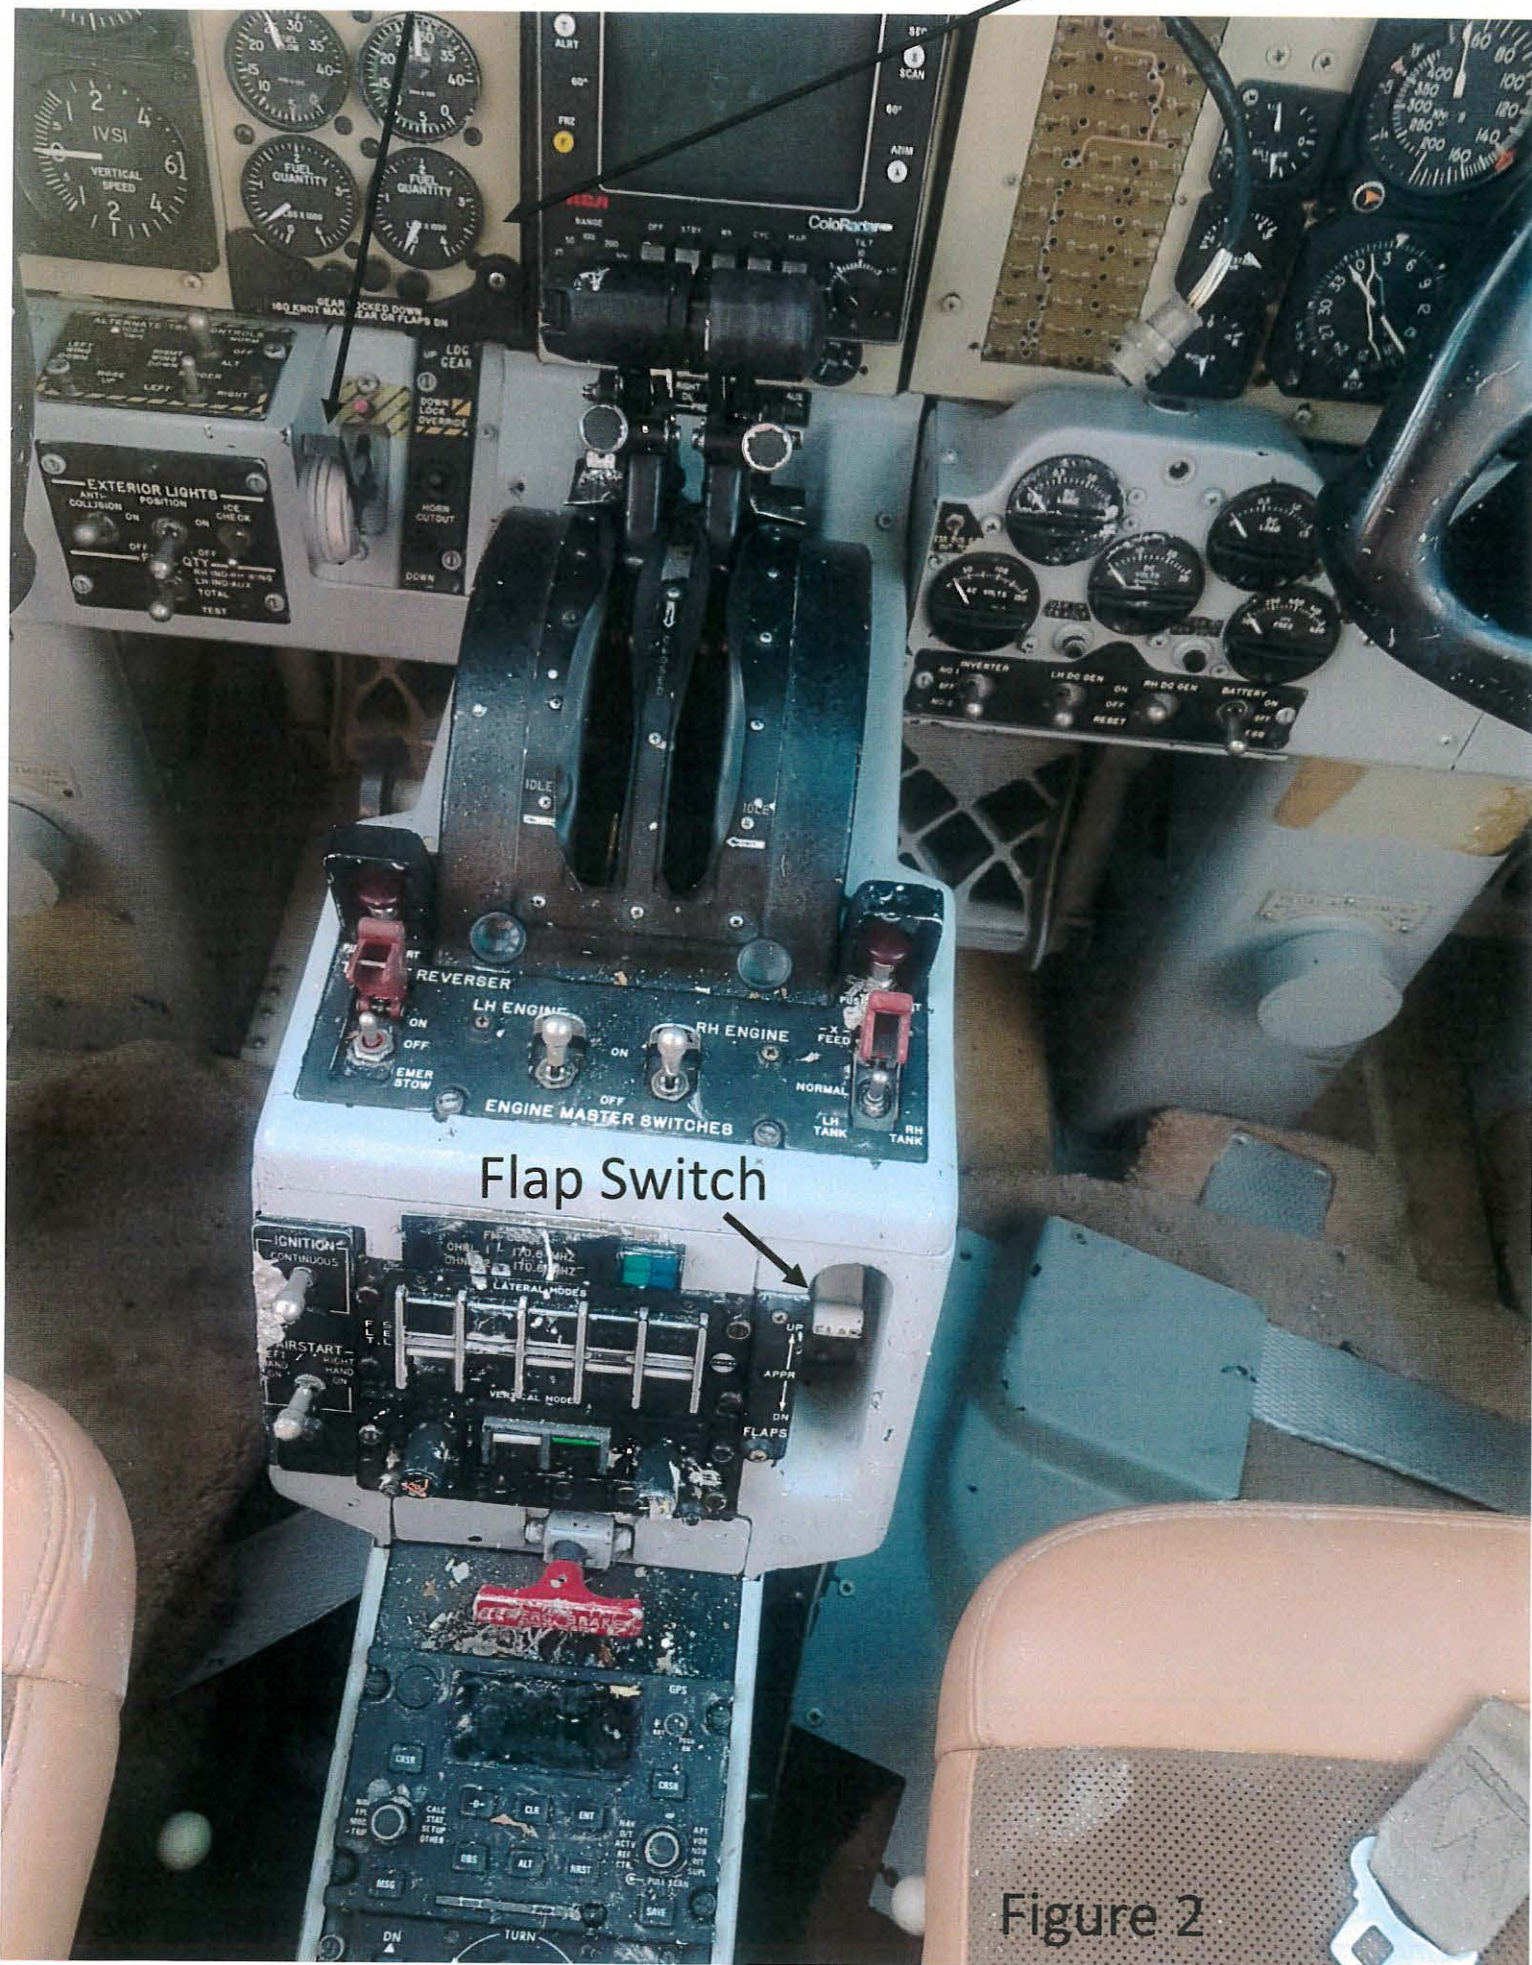
Figure 2

6.4 No post-crash fire observed. (Fig. 2).

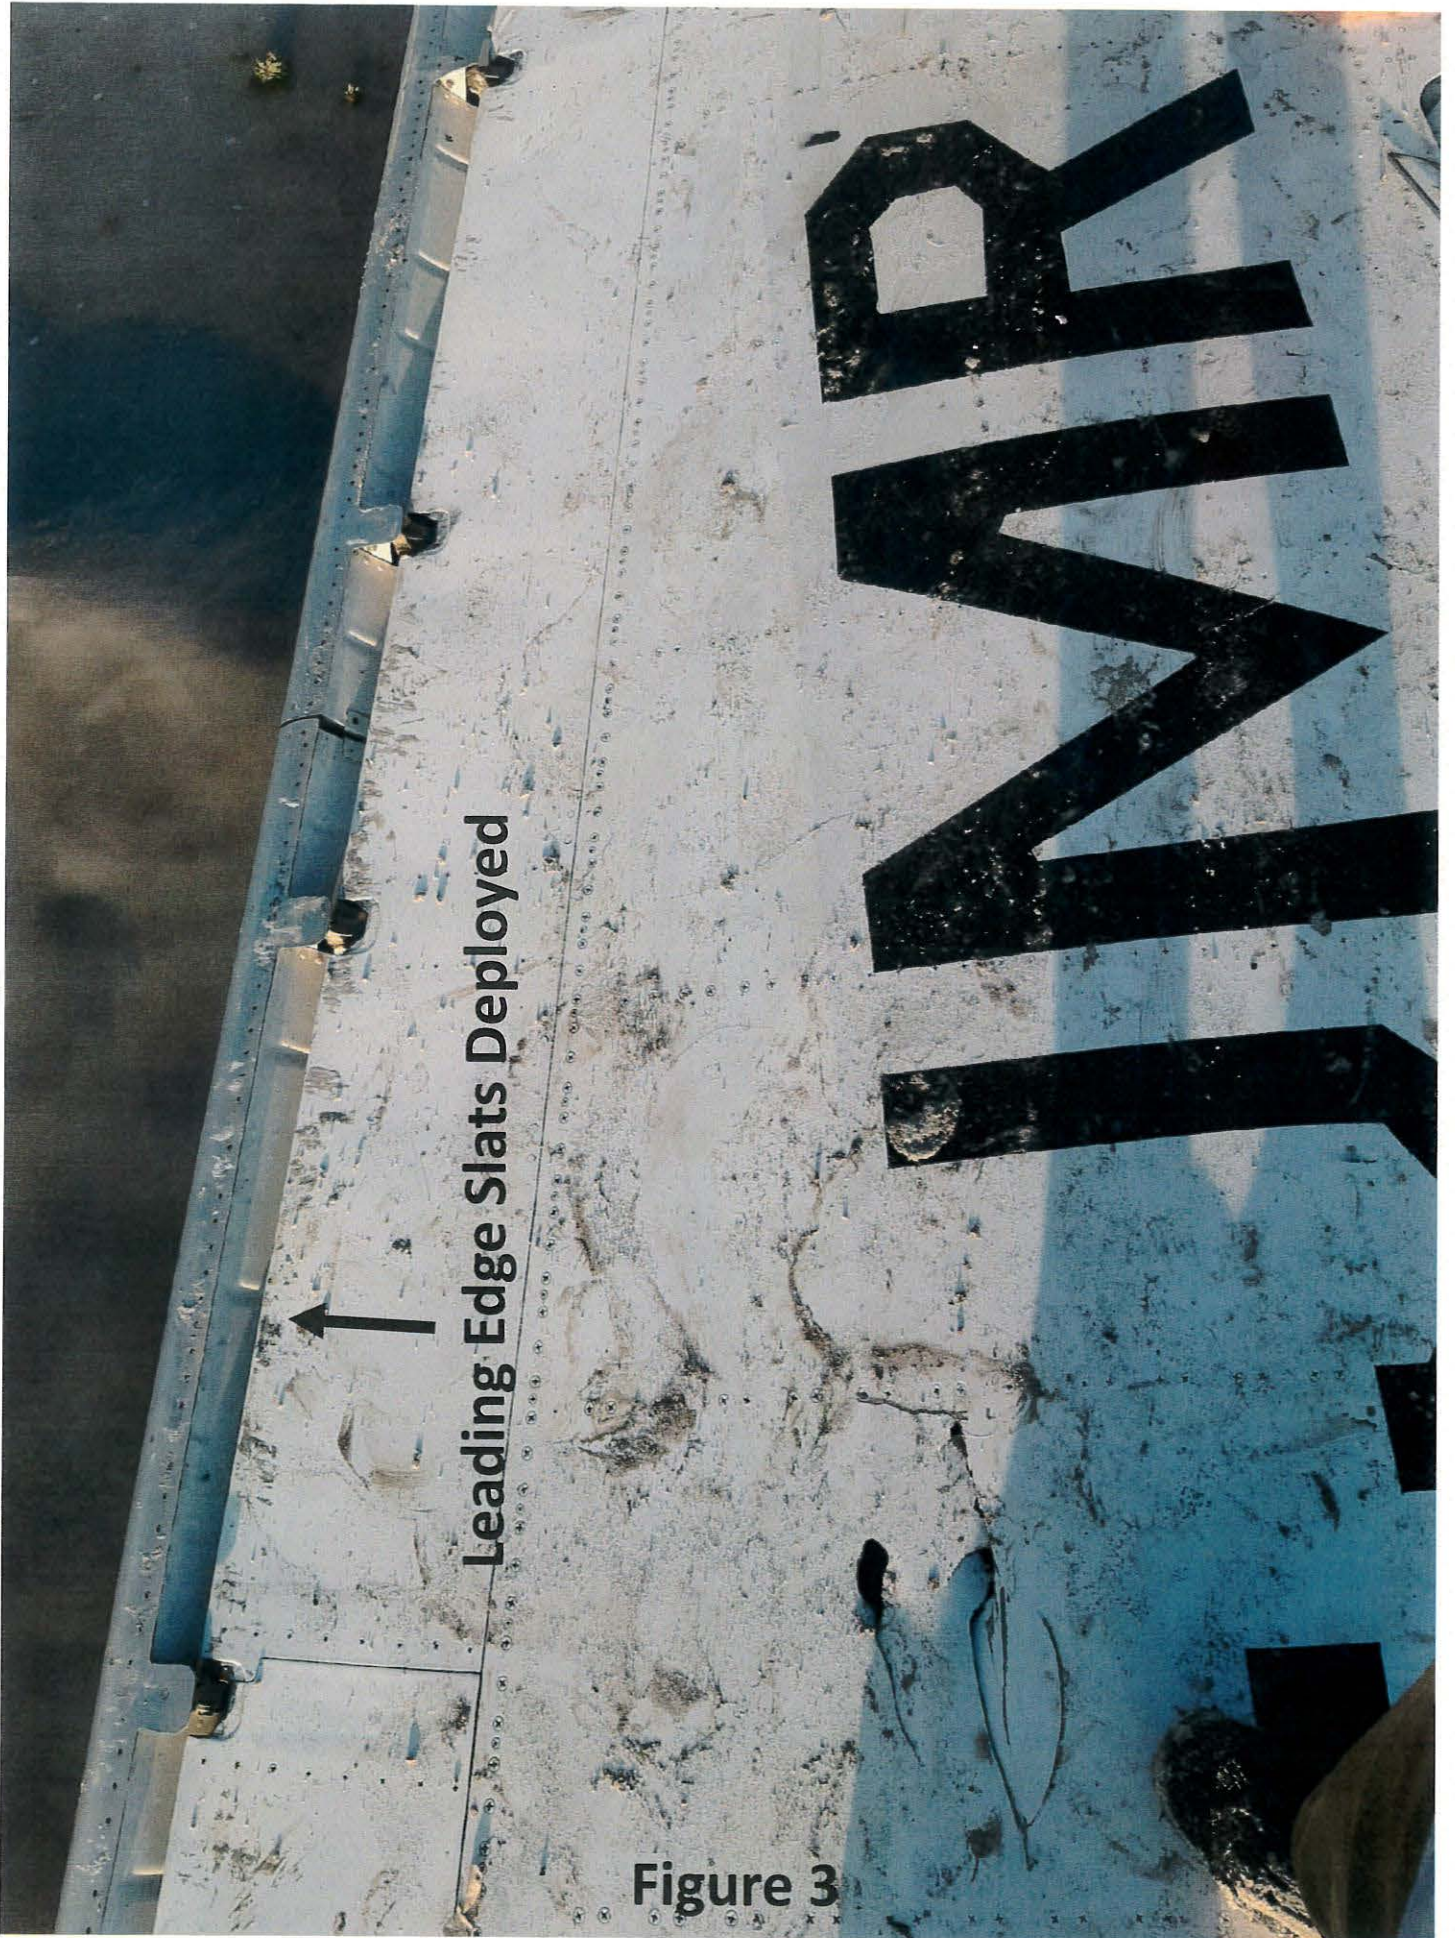
Figure 3

- 2.1 On Sunday January 24, 2021, a site visit was conducted by personnel from the Operations and Airworthiness units of the Flight Safety Division. With assistance from the Security Forces, photographic evidence of the site was collected.
- 2.2 Crash site and aircraft vandalized.
- 2.3 Aircraft may have made a gear up/flaps up landing (*Fig 2: Cockpit Switches*). Left-wing leading-edge slats were deployed indicating low airspeed and possible high angle of attack at time of impact (*Fig 3: Left Wing*).

Leading Edge Slats Deployed

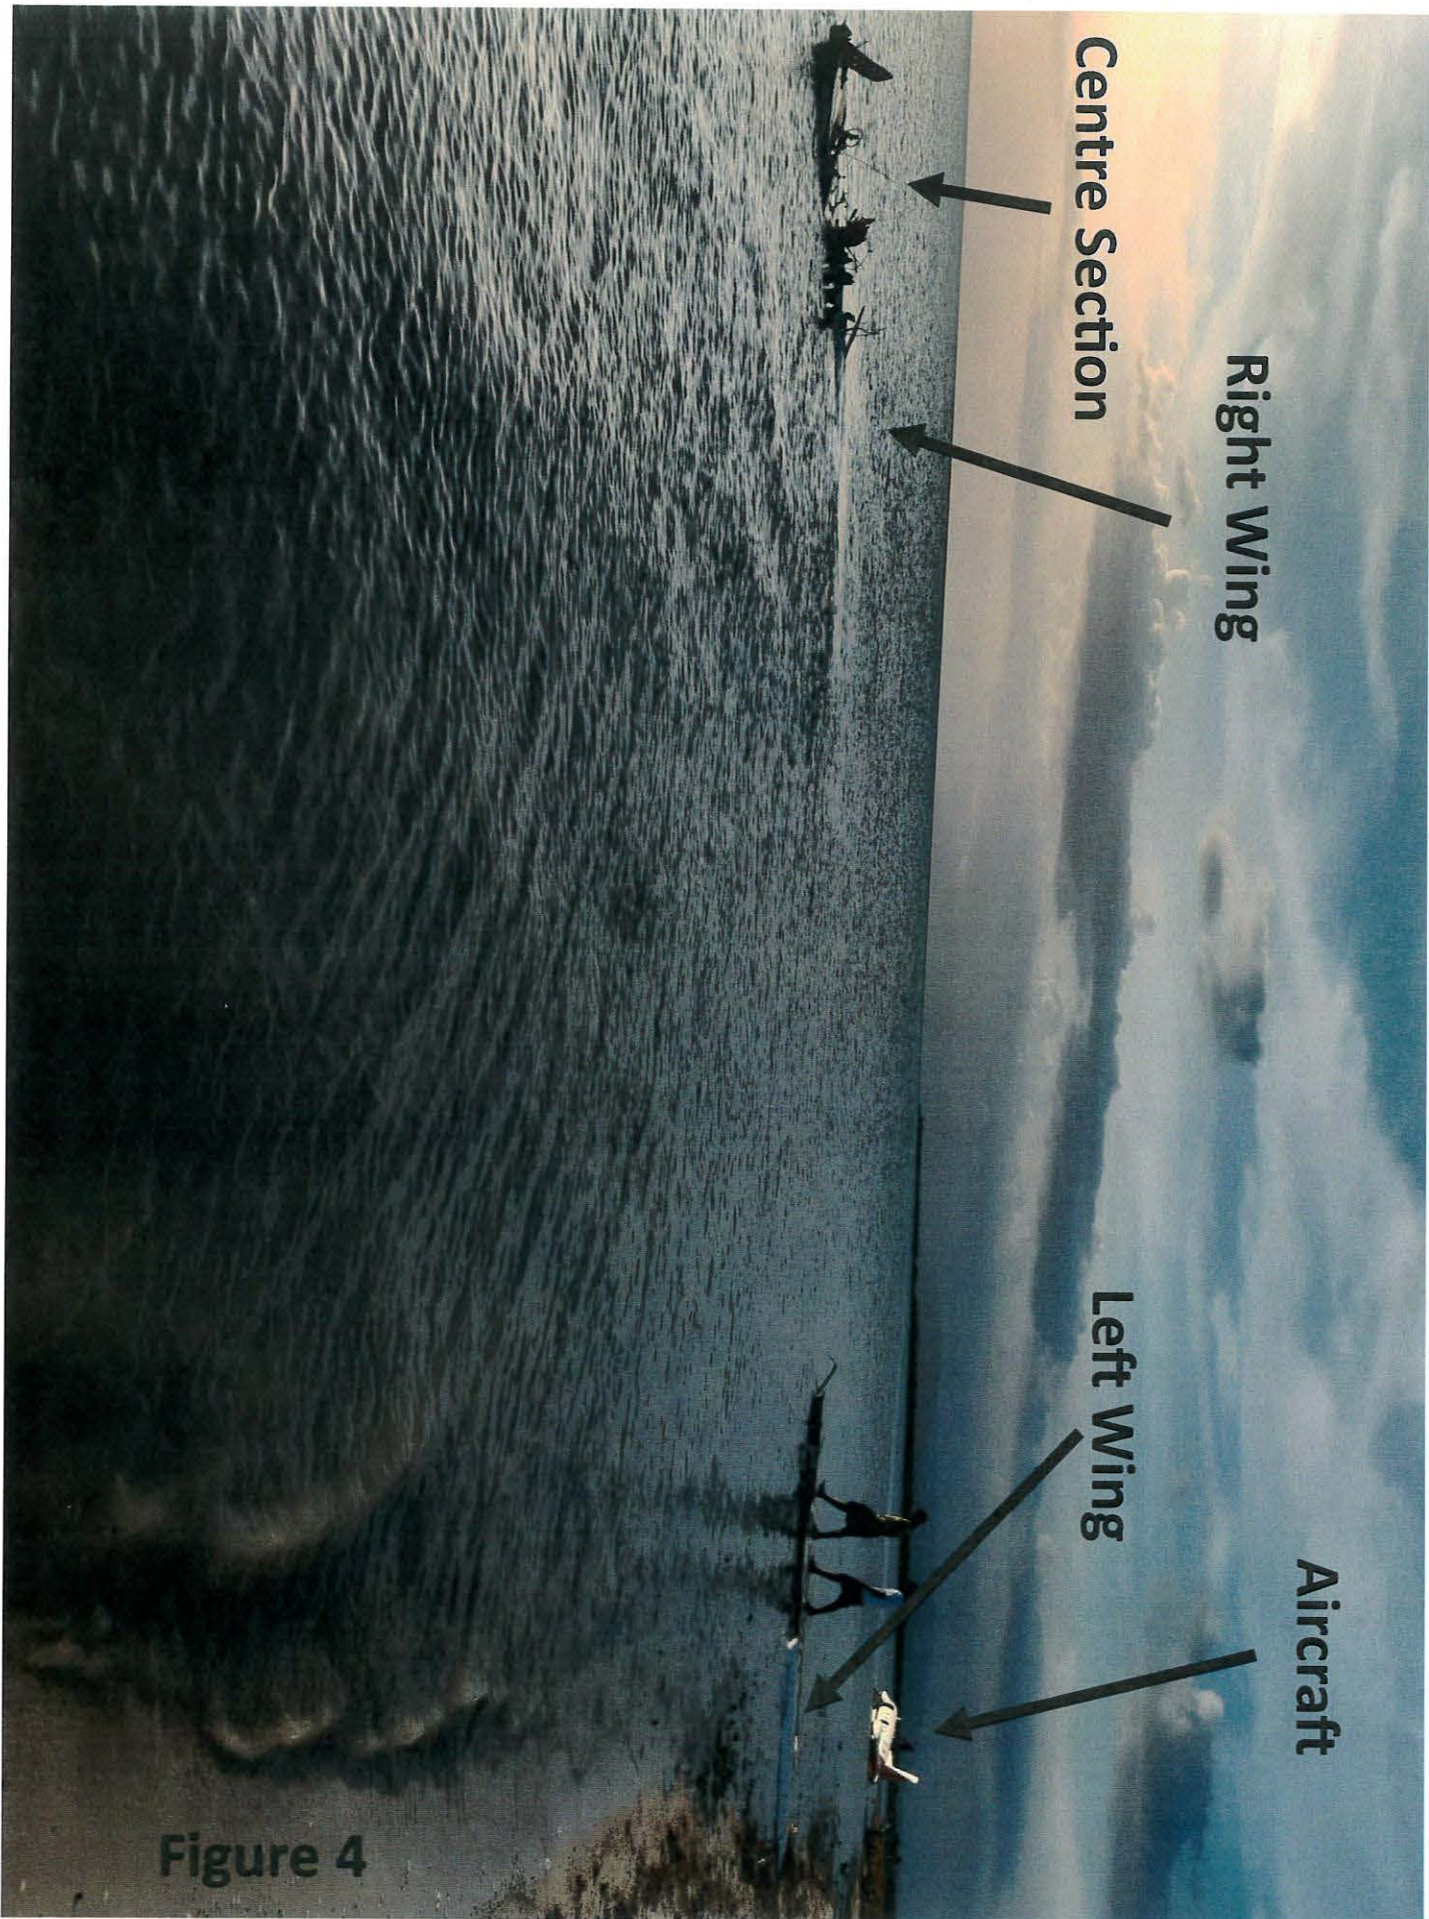
Figure 4

6.2 Substantial Damage: both wings and center section torn from fuselage (Fig. 4-impact damage).

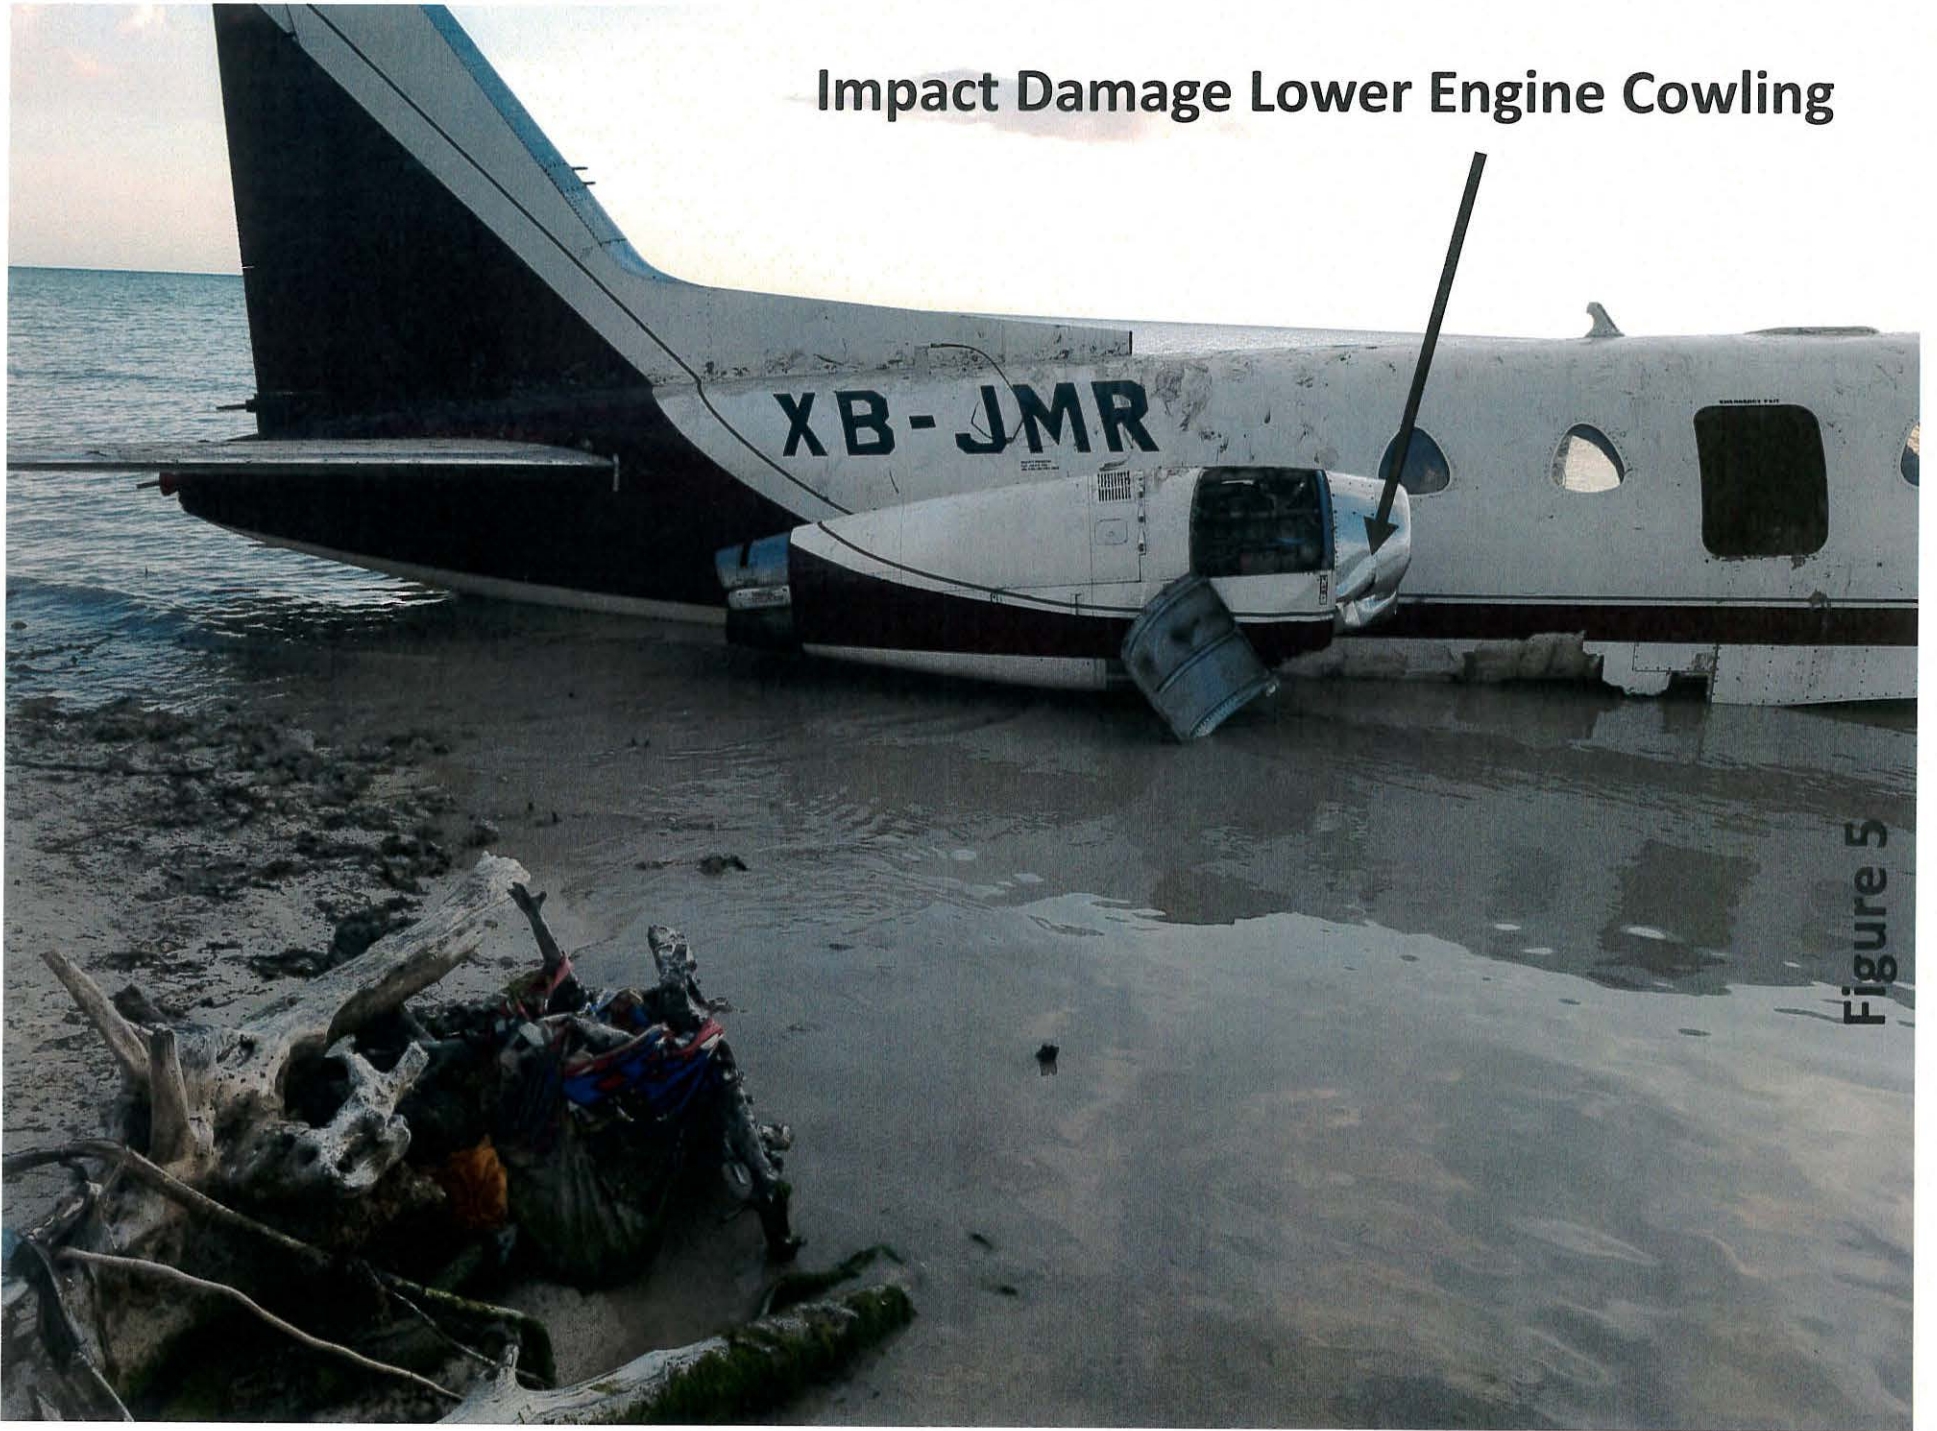
Figure 5

6.3 Both engines showing impact damage to lower engine cowling. (Fig 5).

# Impact Damage Lower Engine Cowling

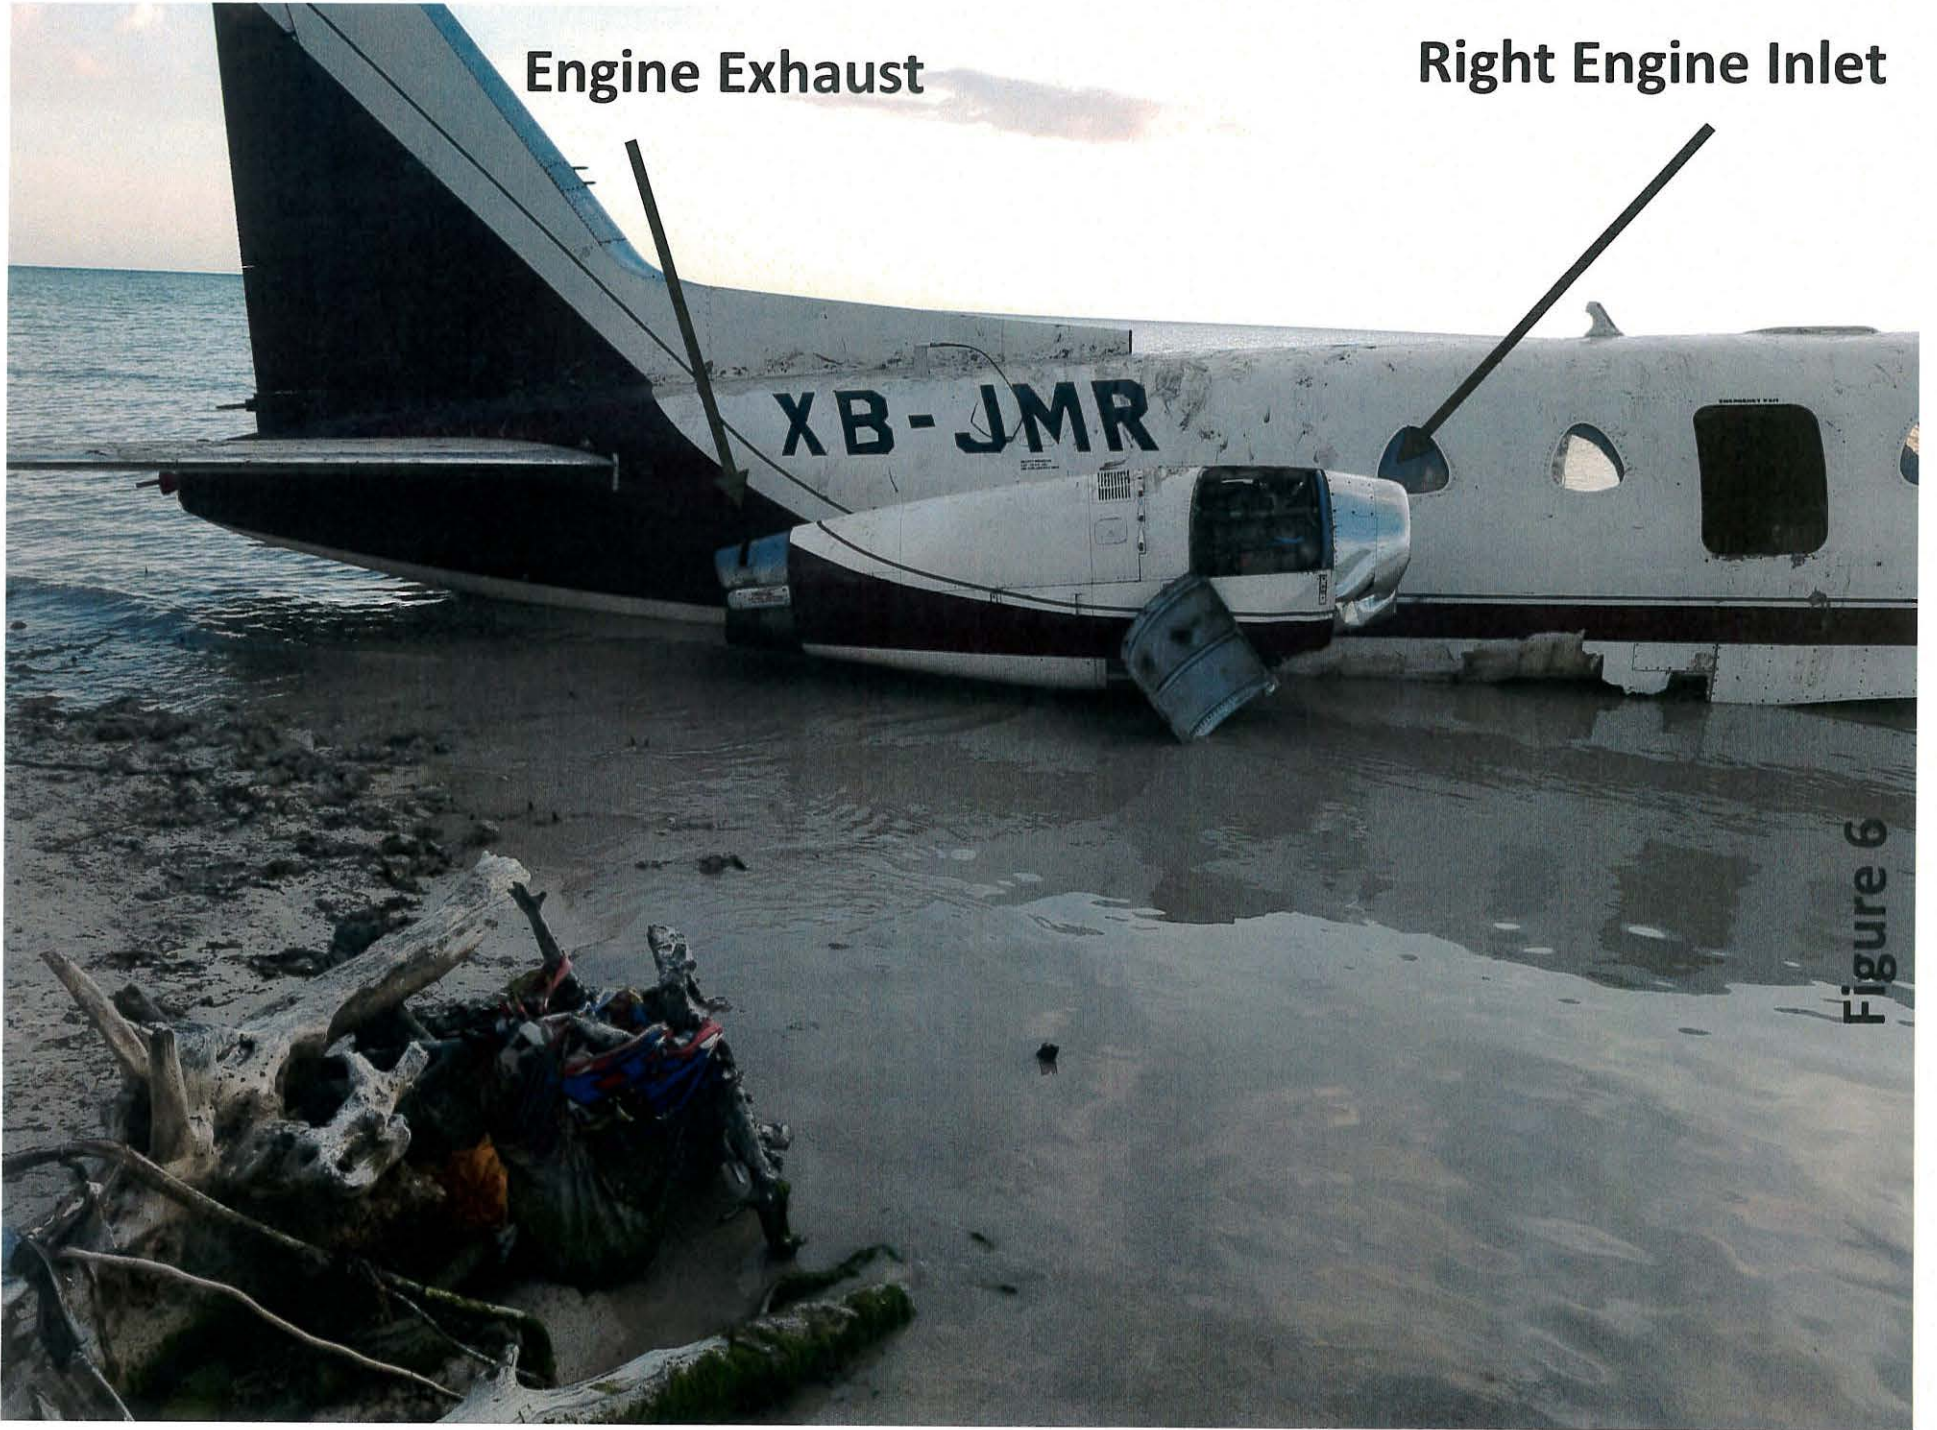
Figure 6

6.5 No signs of fire on both engine exhaust and inlet areas. (Fig. 6 & 6A).

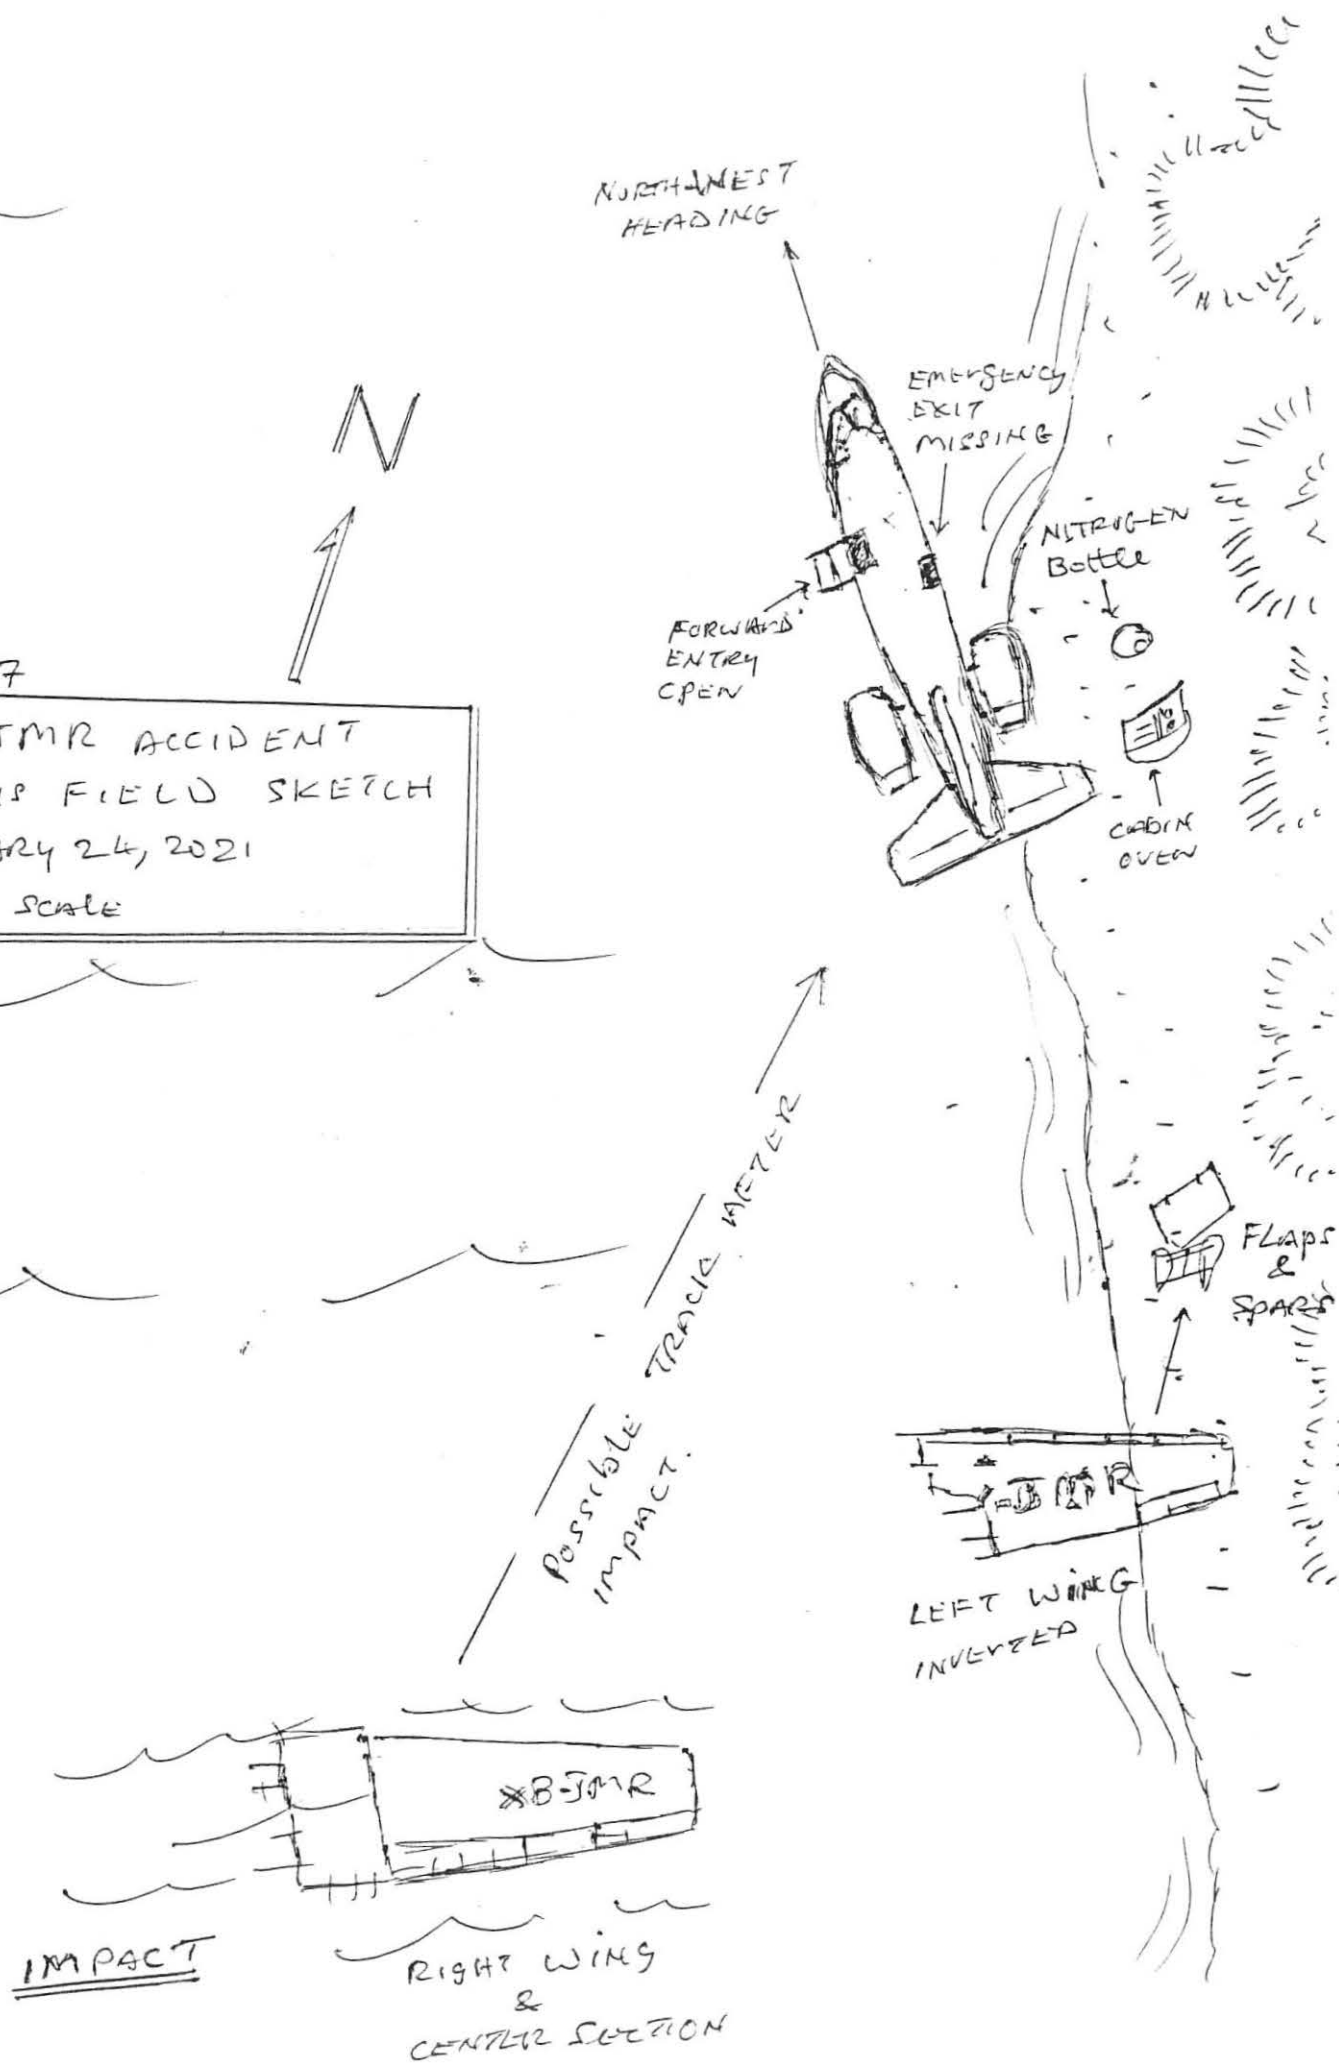
FIG 7  
NOTE: XB-JMR ACCIDENT  
DEBRIS FIELD SKETCH  
JANUARY 24, 2021  
NOT TO SCALE

6.7 The impact broke the aircraft into three sections. See Debris Field Diagram (Fig.7).

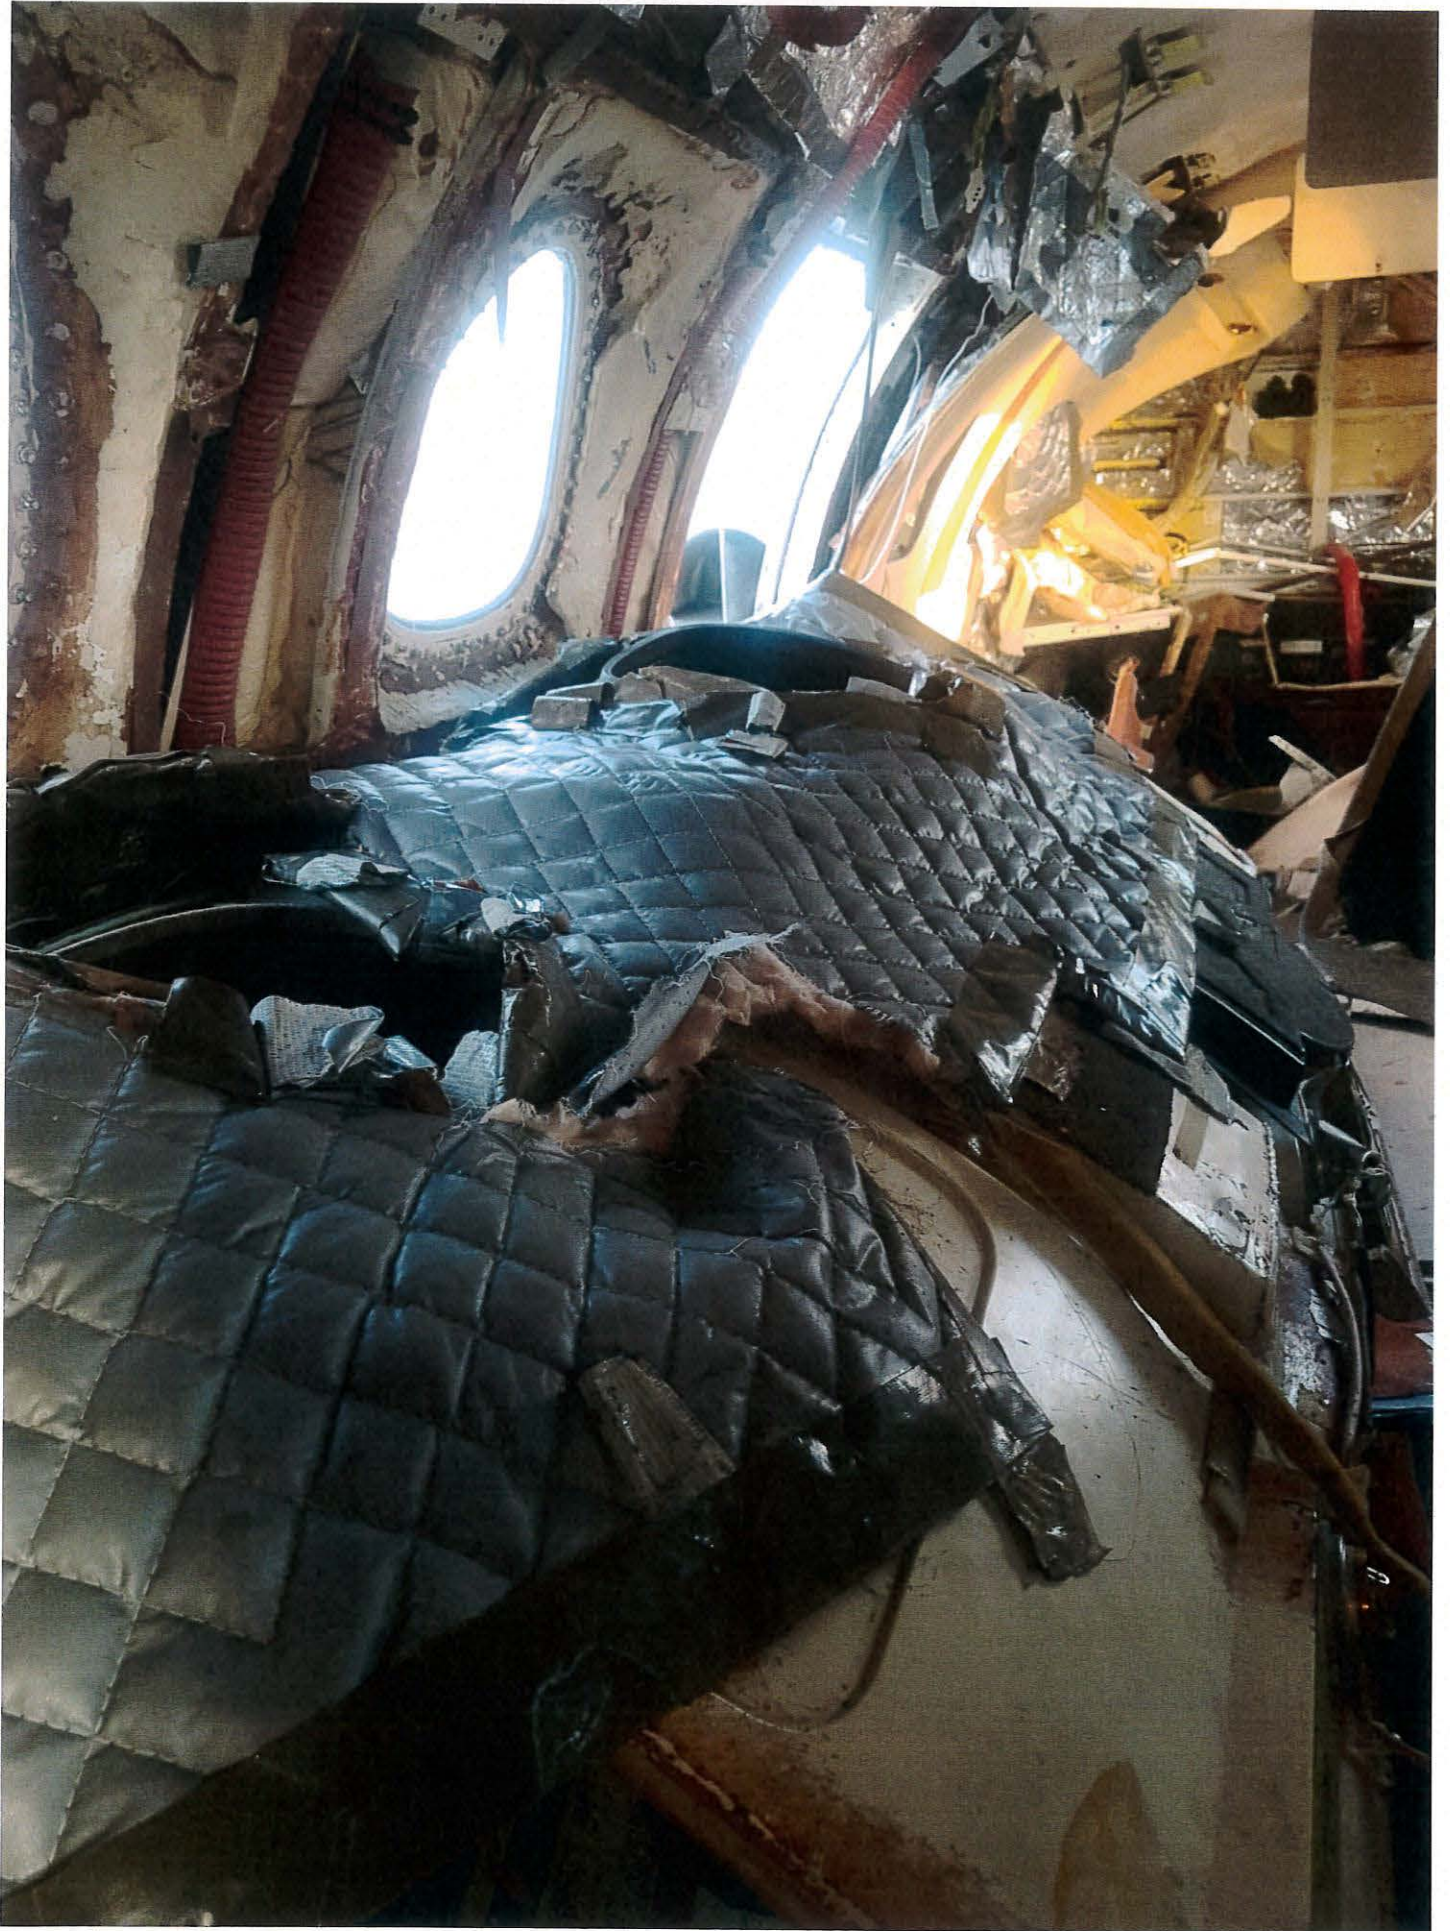
**Figure 8**

6.8 The aircraft cabin had evidence of possible vandalism (Fig. 8).
