AVIATION ACCIDENT INVESTIGATION REPORT

RUNWAY OVERRUN ON LANDING

FLIGHT AA331

REPORT NUMBER JA-2009-09

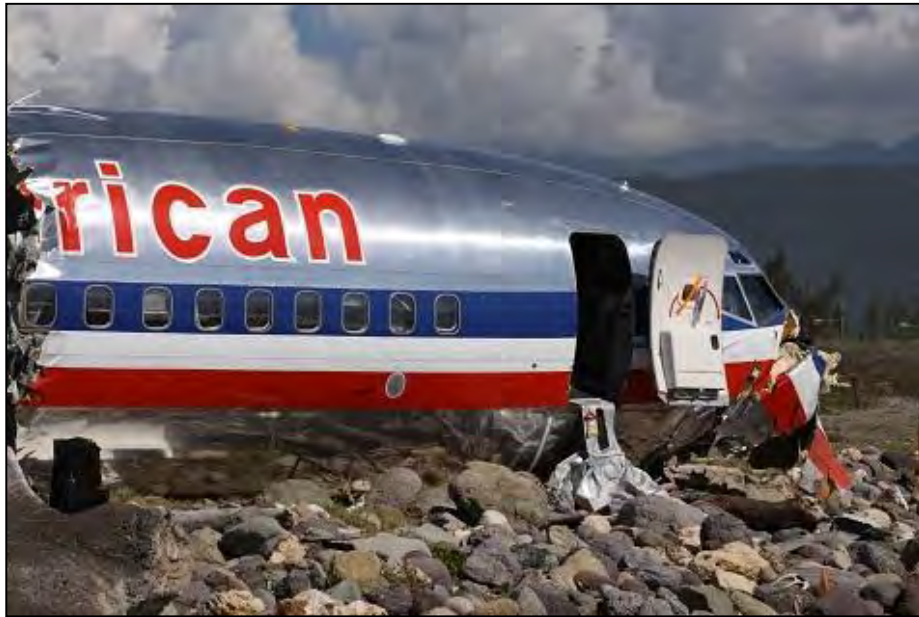
Photo 3 Forward Fuselage

Of the three sections into which the aircraft broke, the forward section consisted of the flight deck, the forward cabin crew seats, and passenger seats from rows three through six. The centre section contained passenger seat rows 7 through 22, including the four over wing emergency exits. The aft section consisted of the aft fuselage of the aircraft from passenger seat row 23 through to the tail of the aircraft.

There was no evidence of pre-impact damage to, or pre-impact failure of, any part of the aircraft's fuselage, wings or control surfaces.

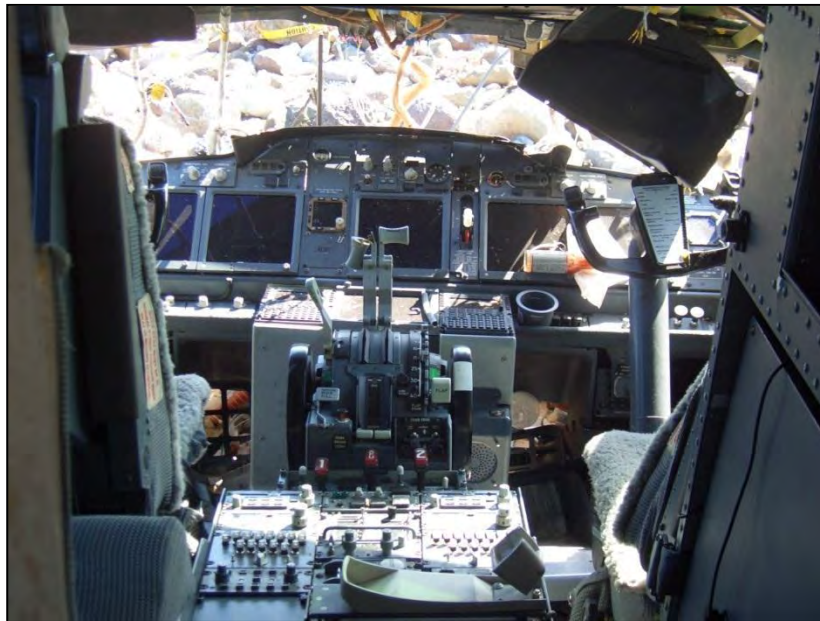
Photo 15 View into Flight Deck

Both the captain and first officer's seats were subjected to high horizontal forces during the impact. A mathematical calculation was conducted by IPECO, manufacturer of the flight deck seats, and it was estimated that the G-loads during the impact sequence were between 10 and 12.7 G for a forward deceleration.

The captain's seat crotch belt was found broken loose from the seat structure because the captain's crotch belt bracket was broken.⁴⁷ Both the crotch belt and the outboard shoulder harness were found buckled. The captain's outboard shoulder harness was locked in the extended position and the inboard shoulder harness retracted normally.
